COMMONWEALTH of VIRGINIA

OFFICE OF DRINKING WATER

System Sanitary Survey Report

SUBJECT: Richmond City
Waterworks: Richmond, City Of
PWSID: VA4760100

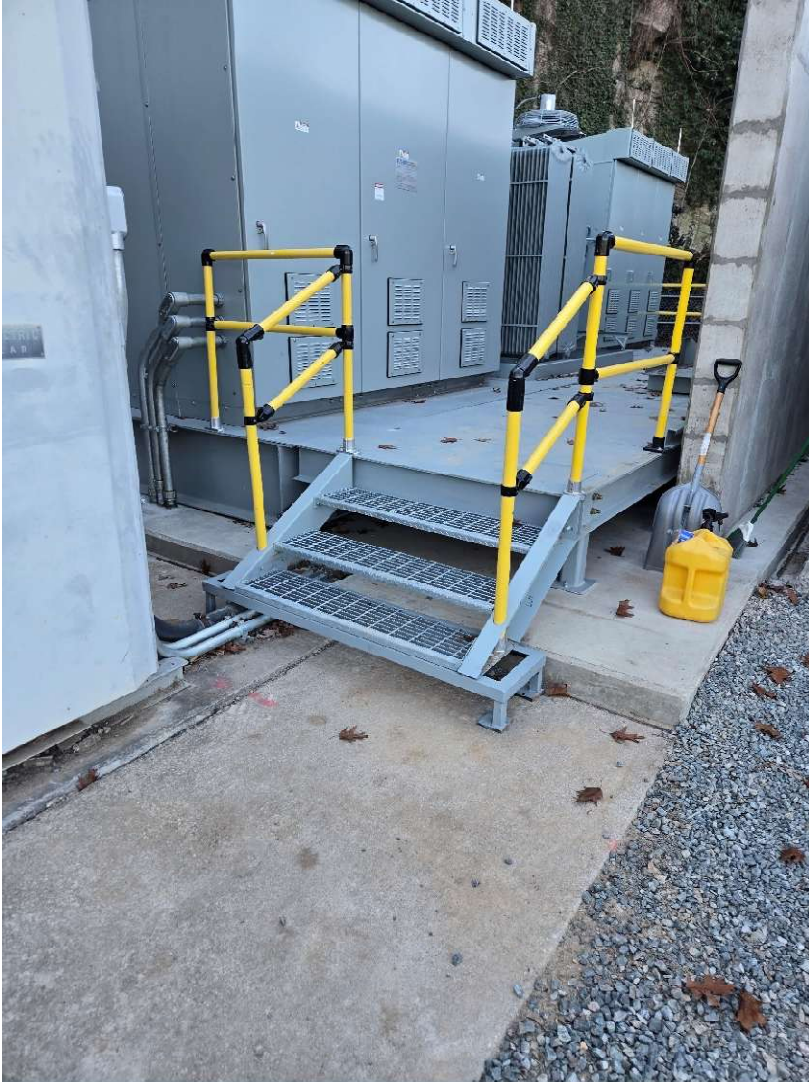
- Electrical substation project was in progress to replace/rehab the substation (Figure 1)
- Automatic transfer switch was installed to allow automatic activation of the generators should both substation feeds go down. The transfer switch was tested and worked successfully. (Figure 2)

Figure 1. Electrical substation

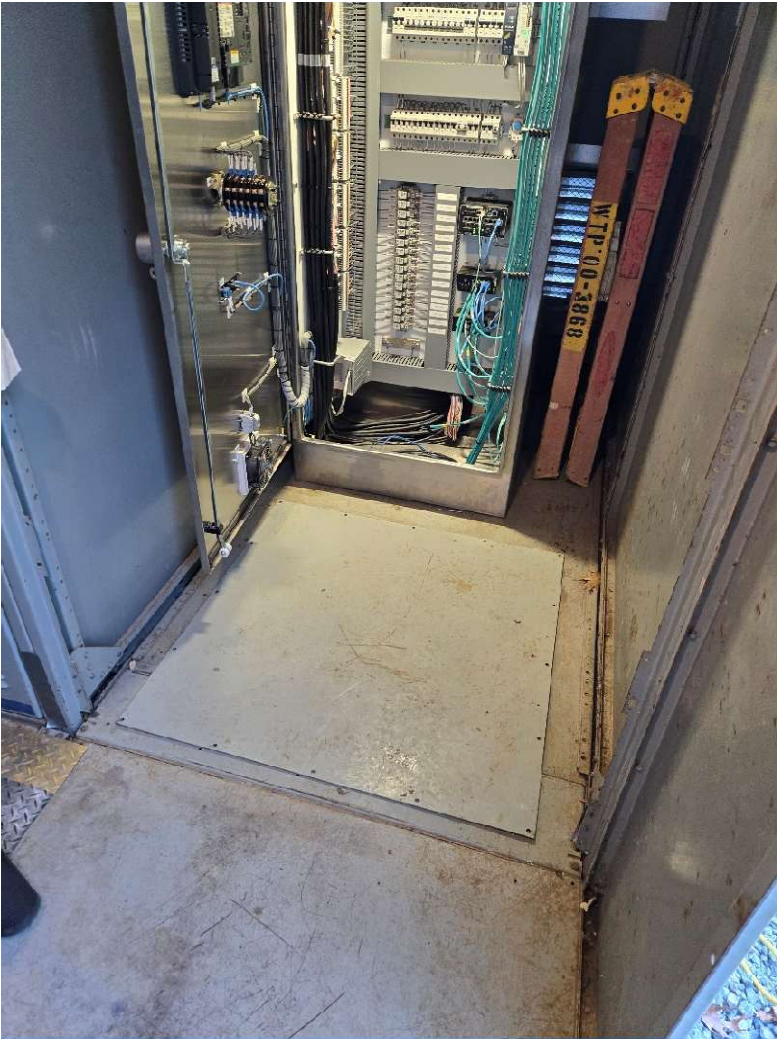
Figure 2. Automatic transfer switch installed

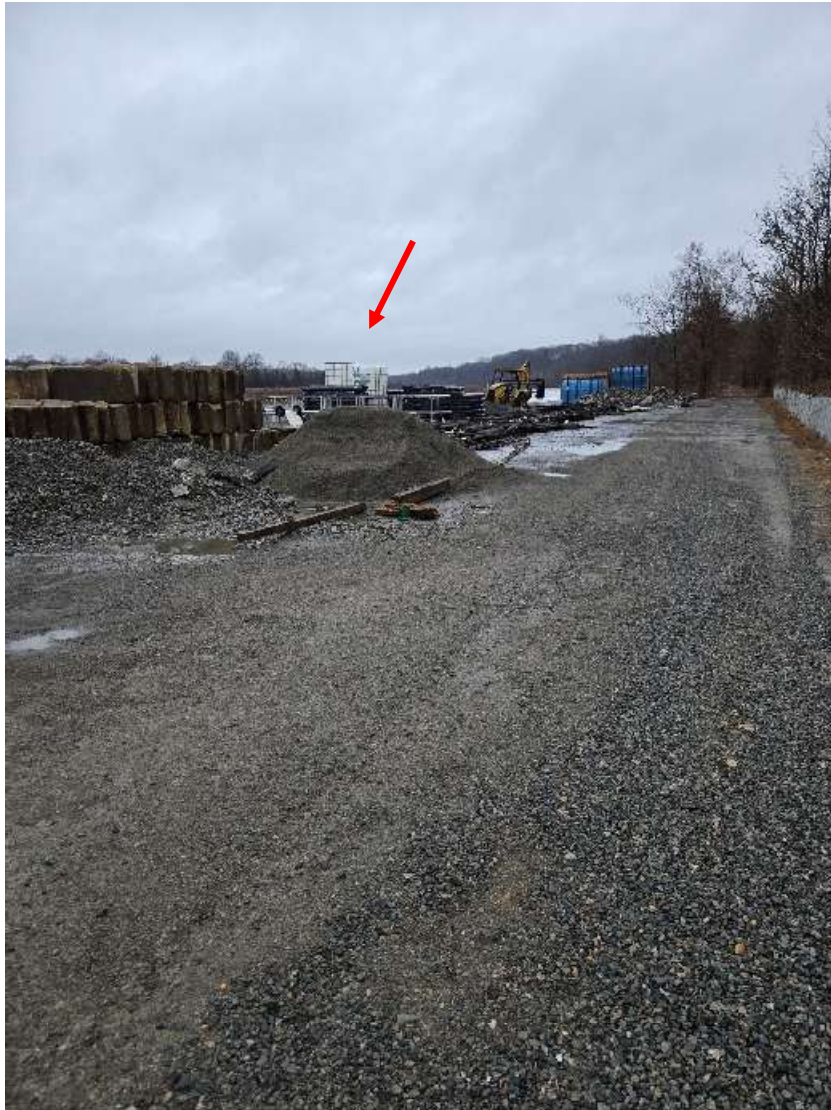
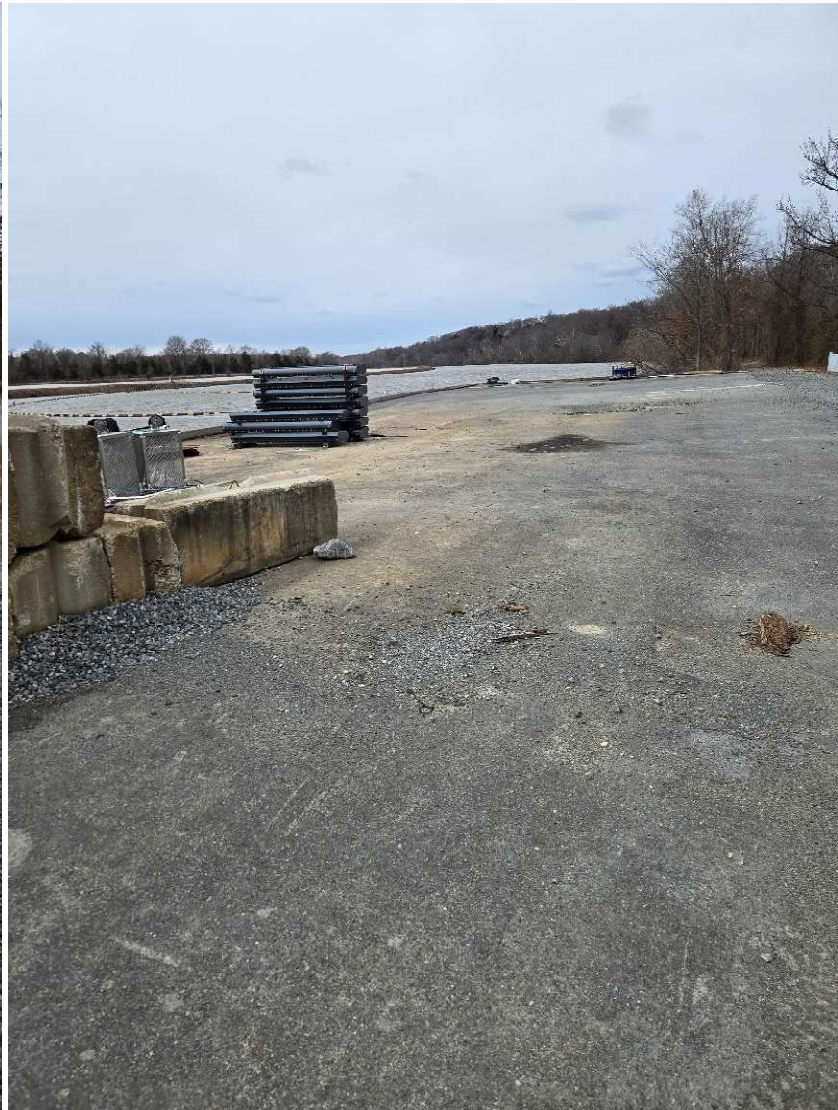
- Floodwall tested by Army Corps of Engineers
- No chemical totes observed near pre-sedimentation basin (Figure 4)
- No trash buildup observed at travelling screen collection bins (Figure 5)
- Dredging projects planned for waste lagoon and pre-sedimentation basin in March 2026
- Elevated raw water turbidity compared to average due to recent rain/snow events, no issues with treatment observed
- Copper sulfate SOP drafted, minimal use of copper sulfate
- Plant growth on earthen berm appeared to be minimized (Figure 6)
- System scheduled to install water quality monitoring at head of pre-sedimentation basin to provide advanced time to react to water quality data

Figure 4. Chemical totes at pre-sed(2025 left), No chemical totes observed (2026 right)

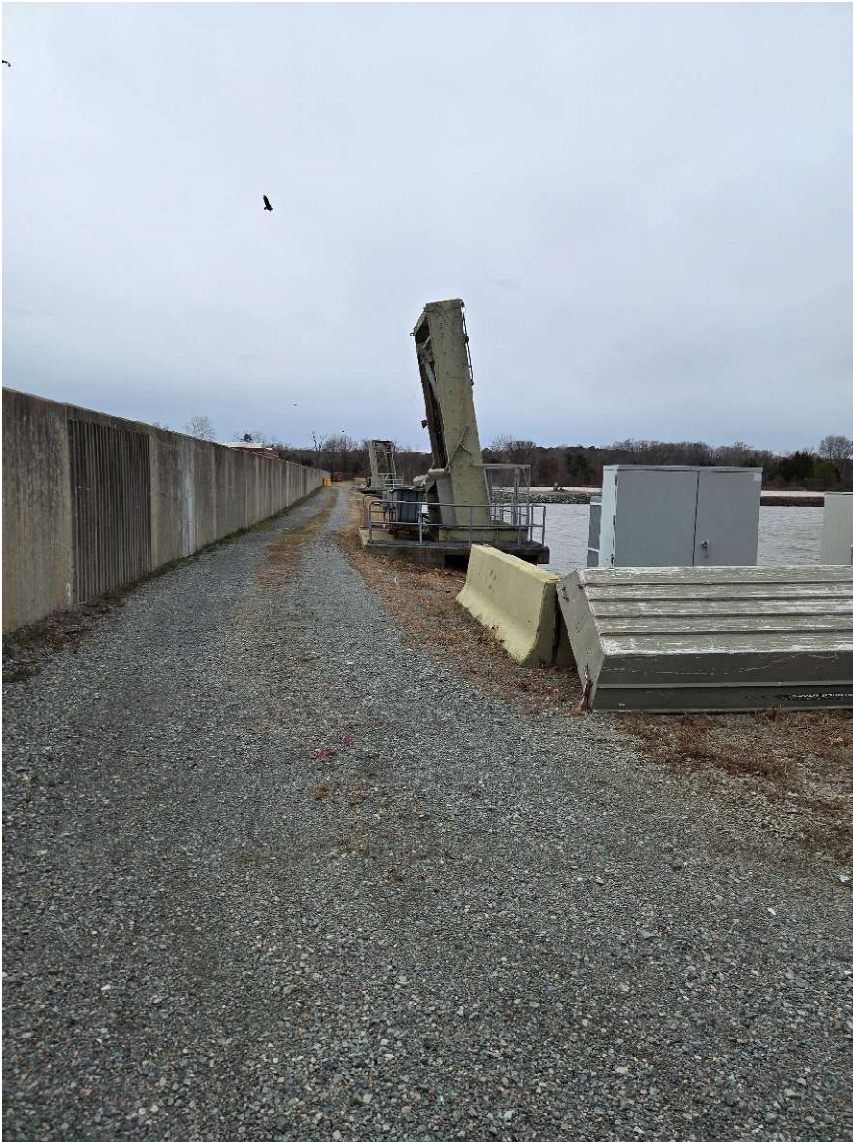
Figure 5. Pre-sed traveling screens

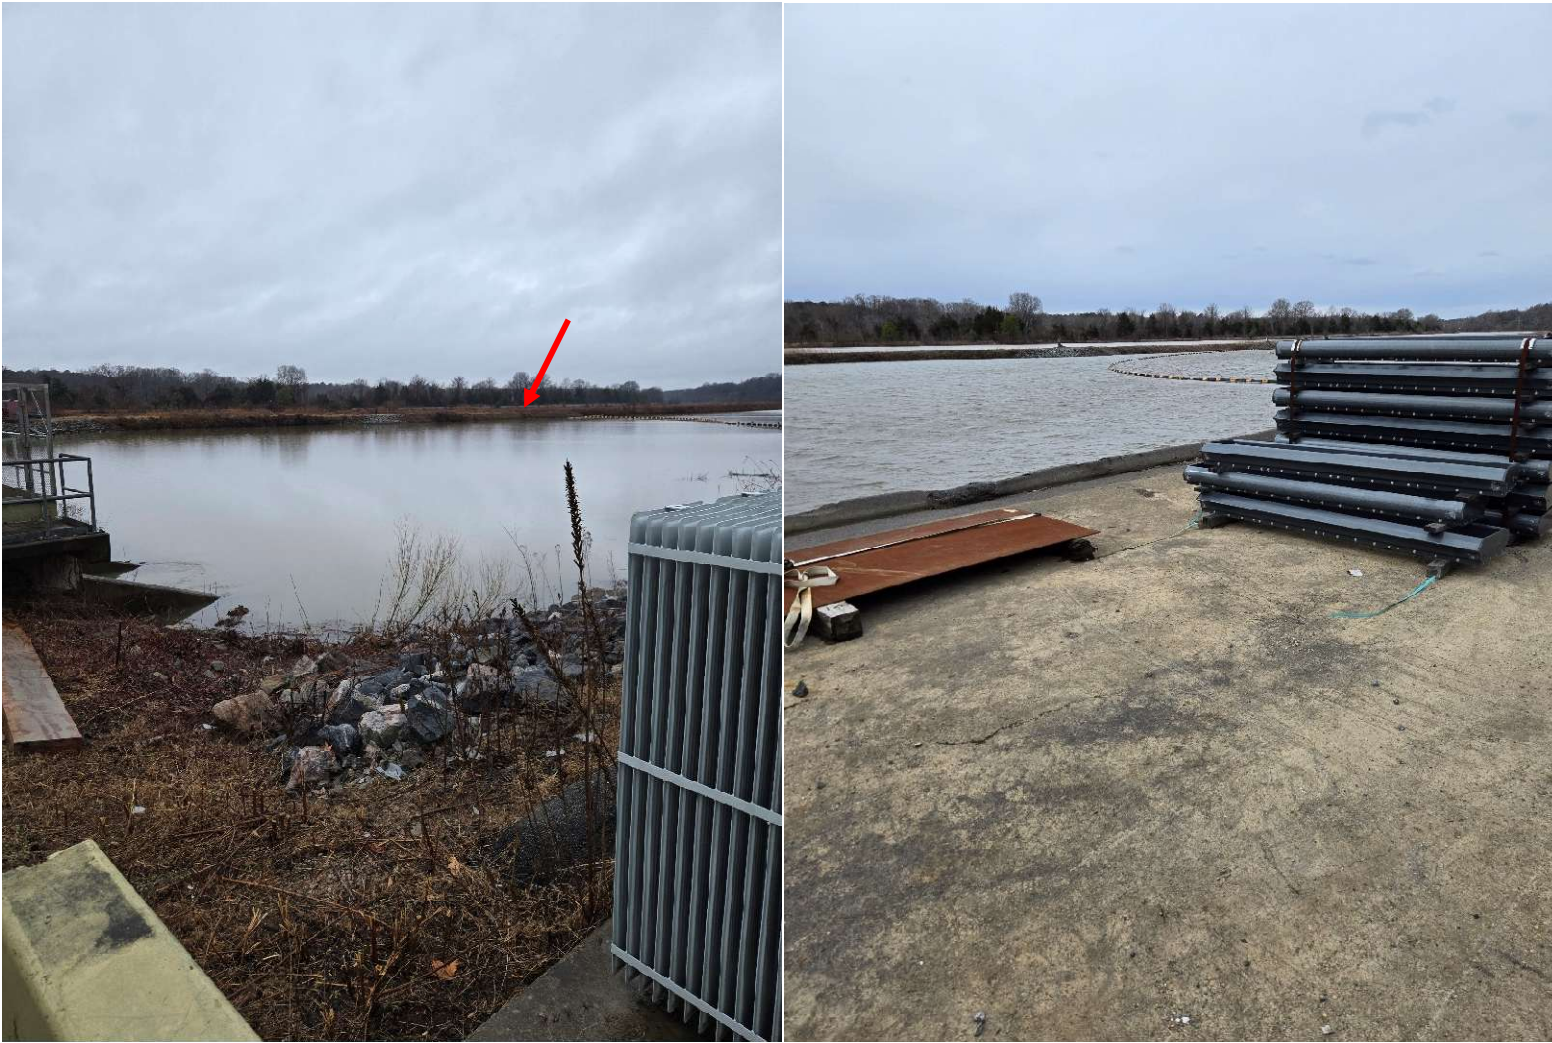
Figure 6. Earthen berm between lagoon and raw water intake channel (2025 left), Shrubs less growth observed (2026 right)

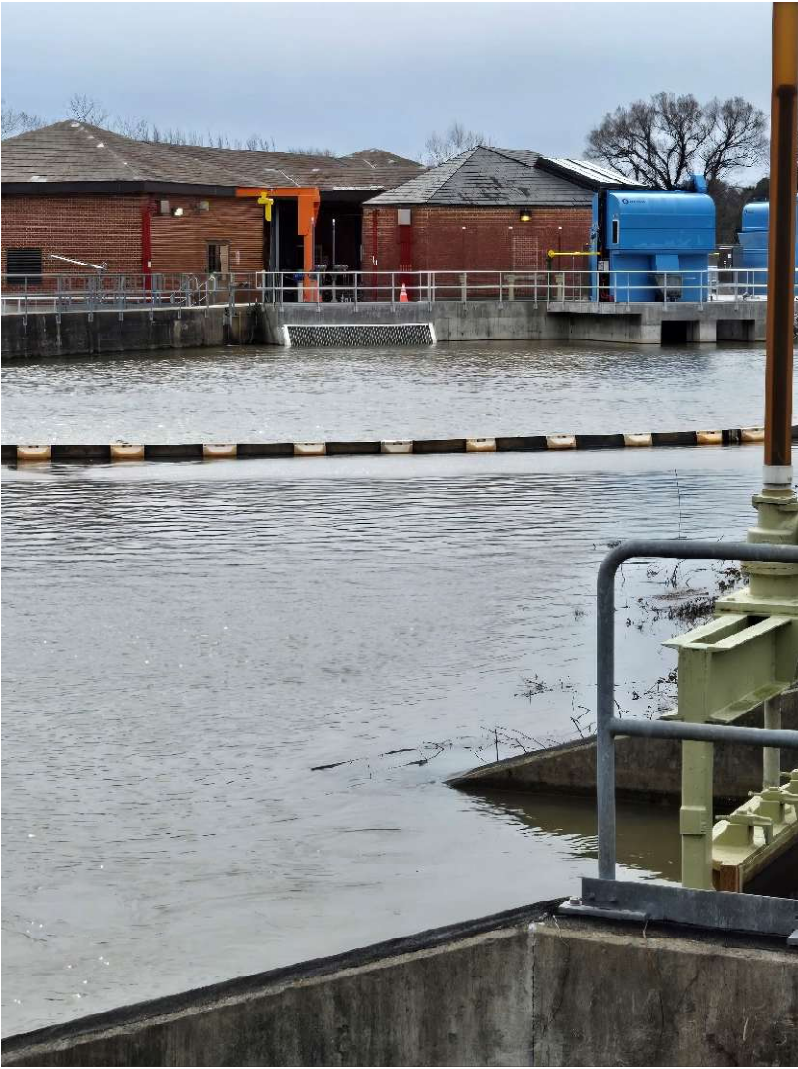
- Flow only from Pre-sedimentation basin, no flow from canal
- No issues observed at raw water basins (Figure 7)
- Screens at raw water pumps all new, project mostly complete only punch-list items remain (Figure 8)

Figure 7. Raw water basins

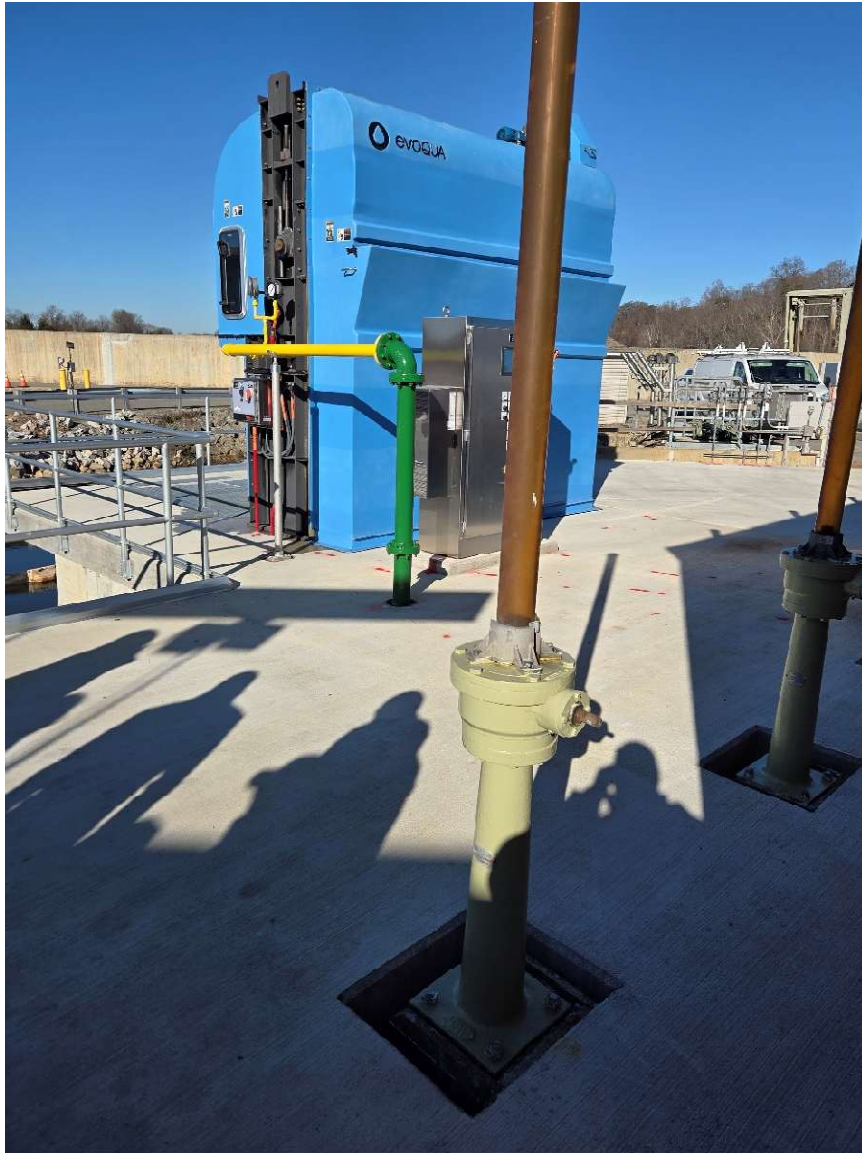
Figure 8. New raw water screens

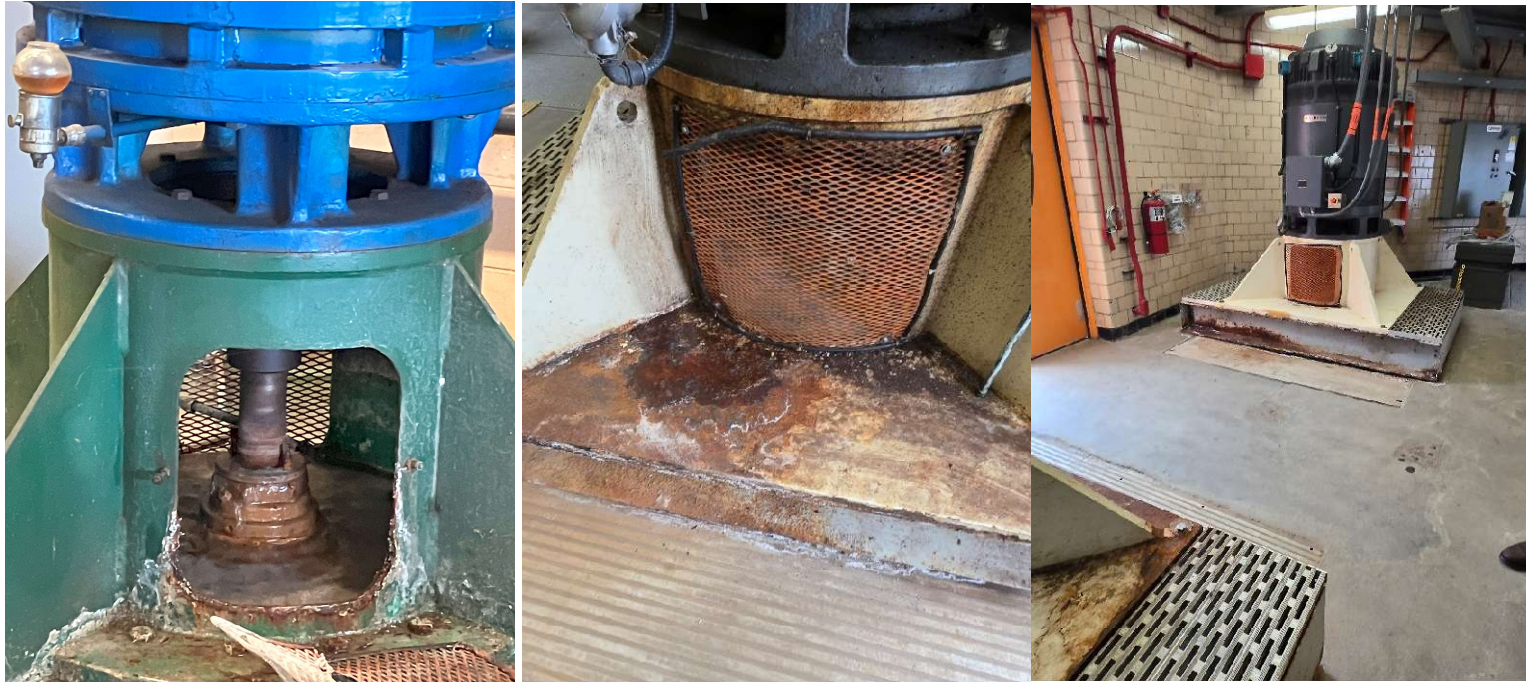
- Raw water pump shaft safety guards all in place and intact (Figure 9)
- No bird droppings or trash observed in raw water pump buildings, all buildings clean and orderly (Figure 10)
- All pumps operable
- Permanganate being fed year round downstream of raw water pumps (Figure 11)

Figure 9. Raw pump motor screen (2025 left), Screen intact, all raw water pumps checked (2026 two photos on right)

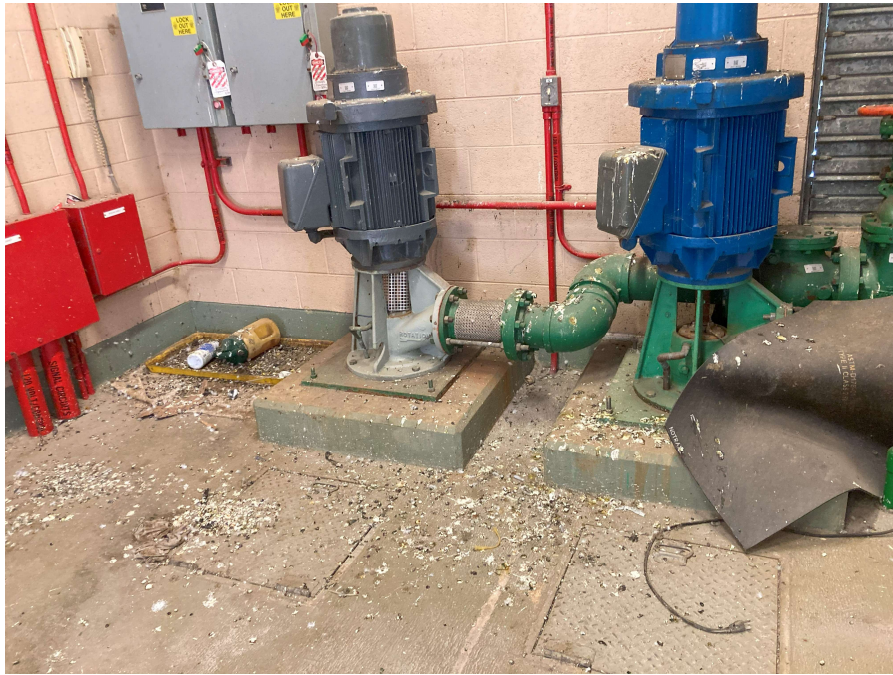
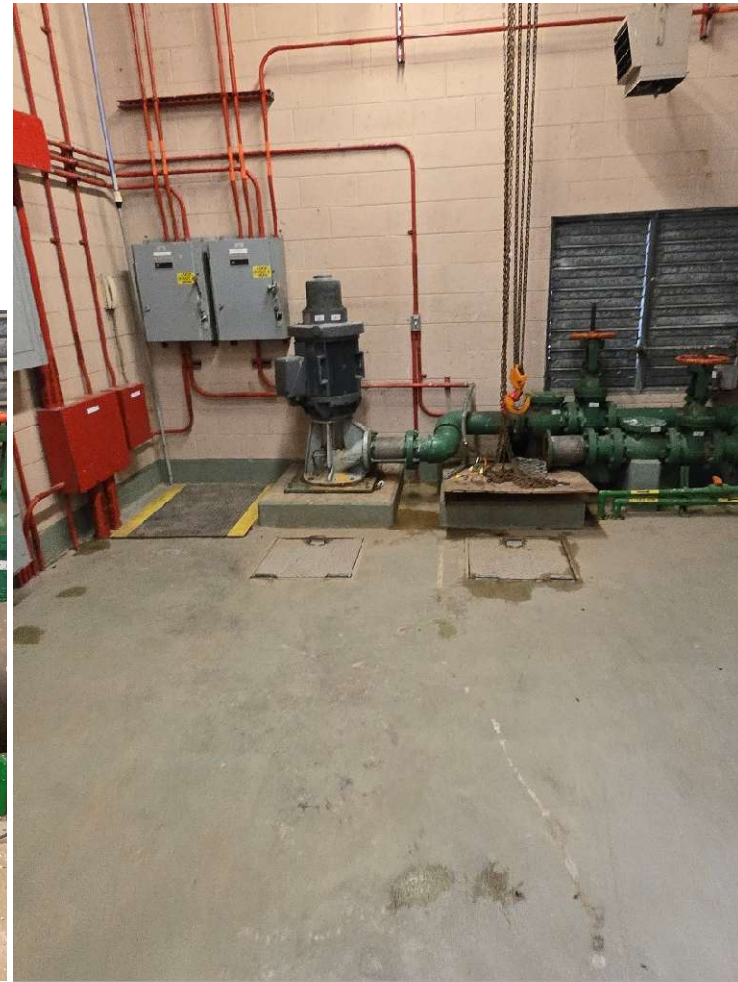
Figure 10. Housekeeping- Bird droppings (2025 left), Cleaner area observed (2026 right)

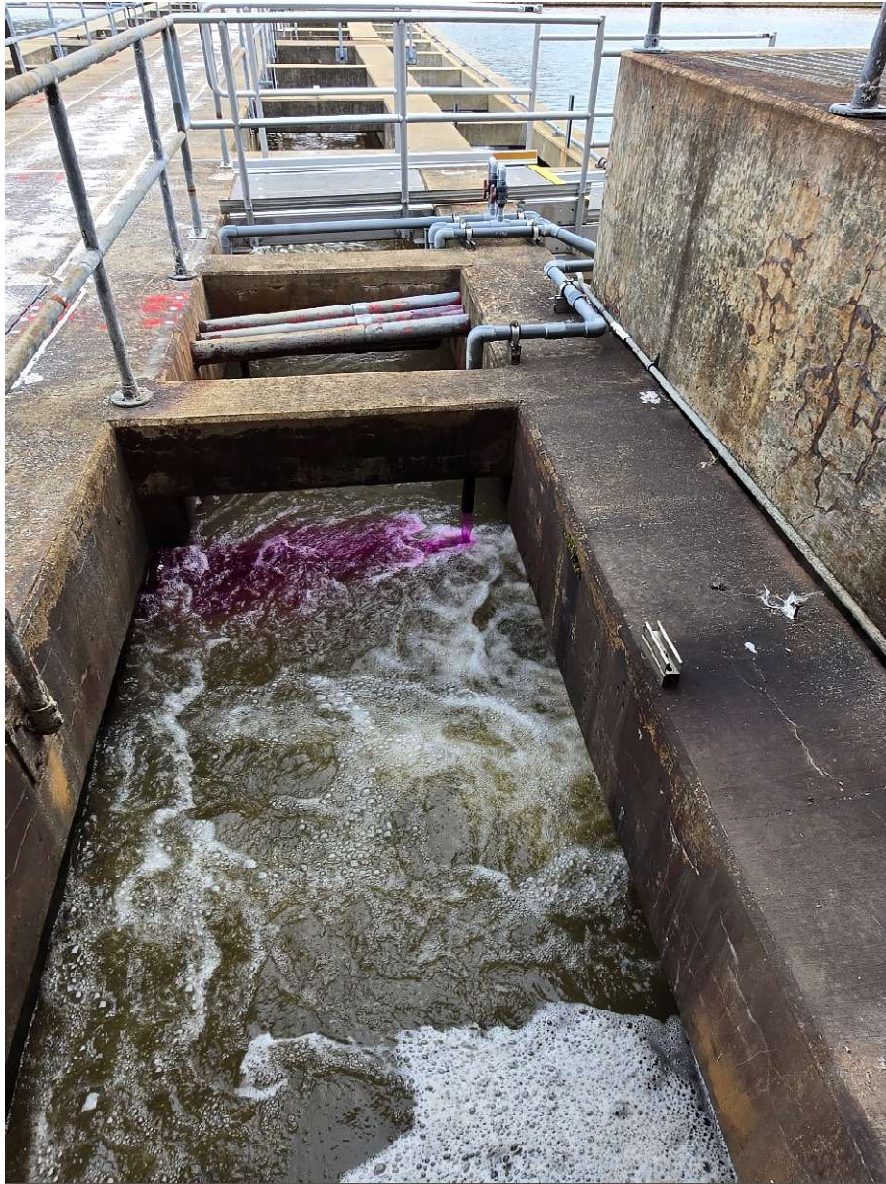
Figure 11. Permanganate feed year-round

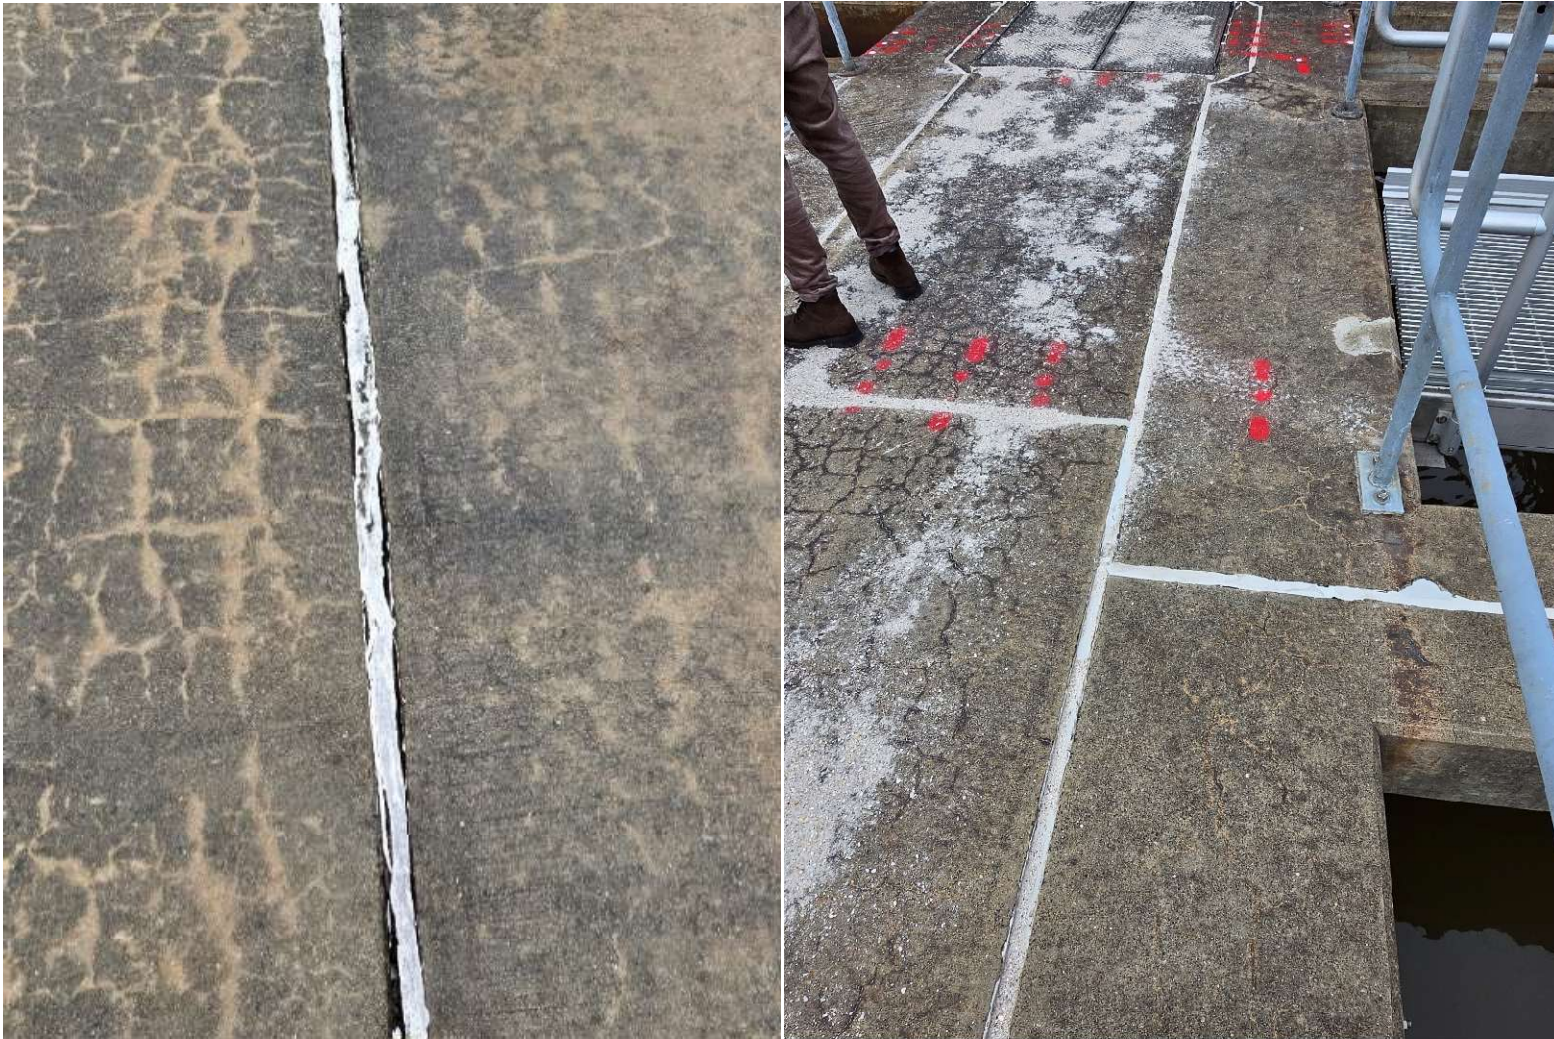
- Walkway between Plant 1 and Plant 2 from raw water pump buildings to WTP main building had repaired the sealant between concrete sections (Figure 12)

Figure 12. Sedimentation basin walkway (2025 left), sealed (2026 right)

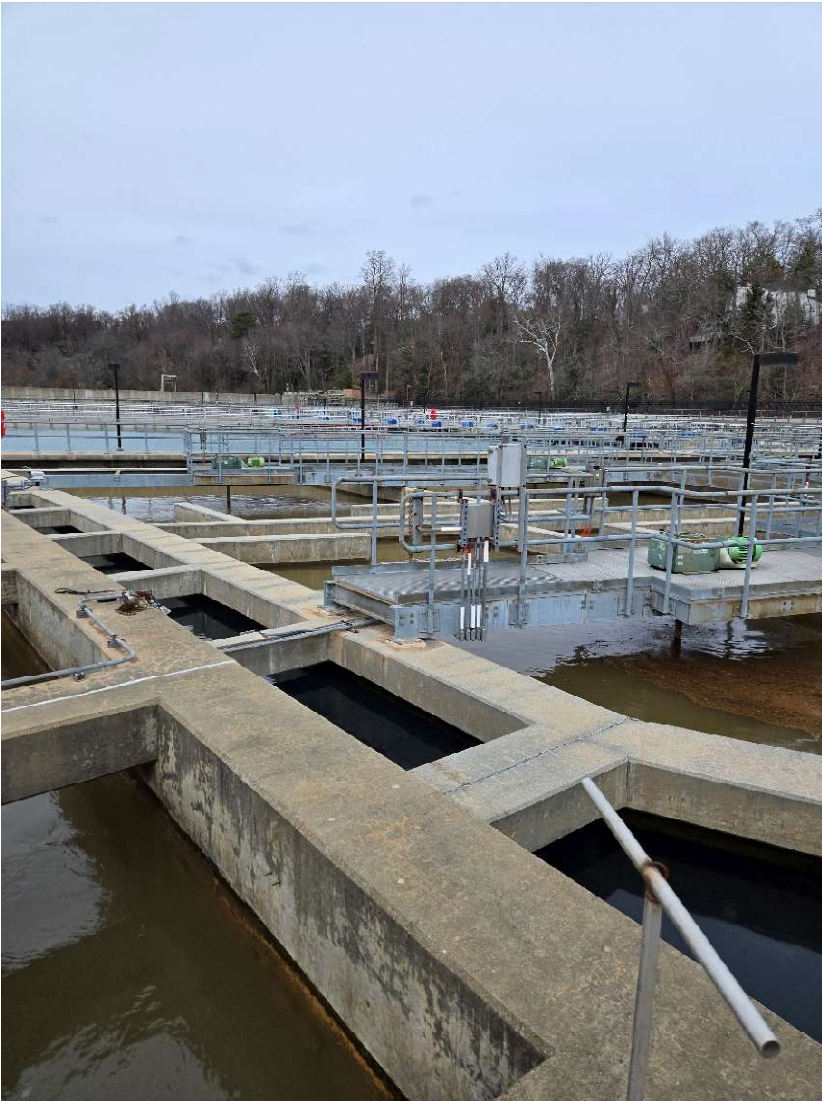
Figure 13. Floculators

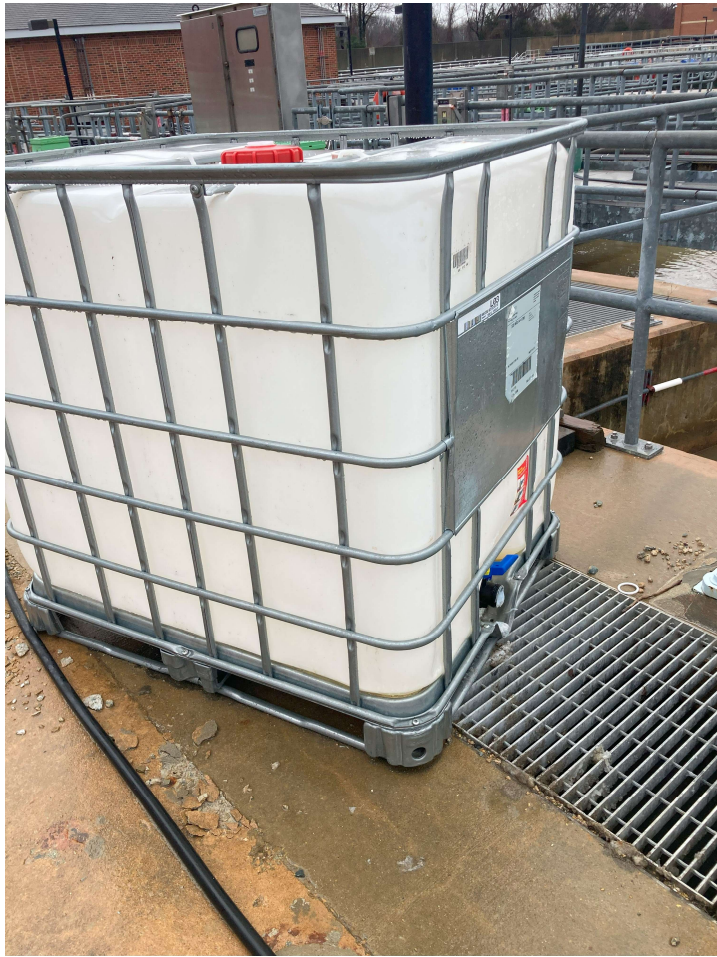
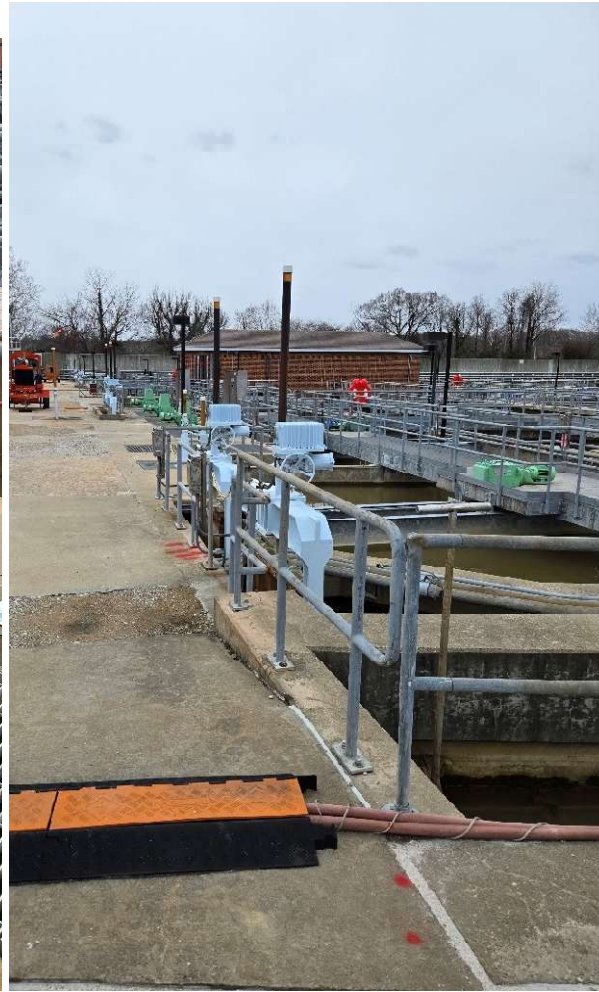
- No chemical totes observed near flocculators (Figure 14)
- Turbidimeters for settled water moved closer to sample point, shortens travel time to analyzer to provide more accurate readings

Figure 14. Chemical totes near sedimentation basins (2025), No totes observed (2026)

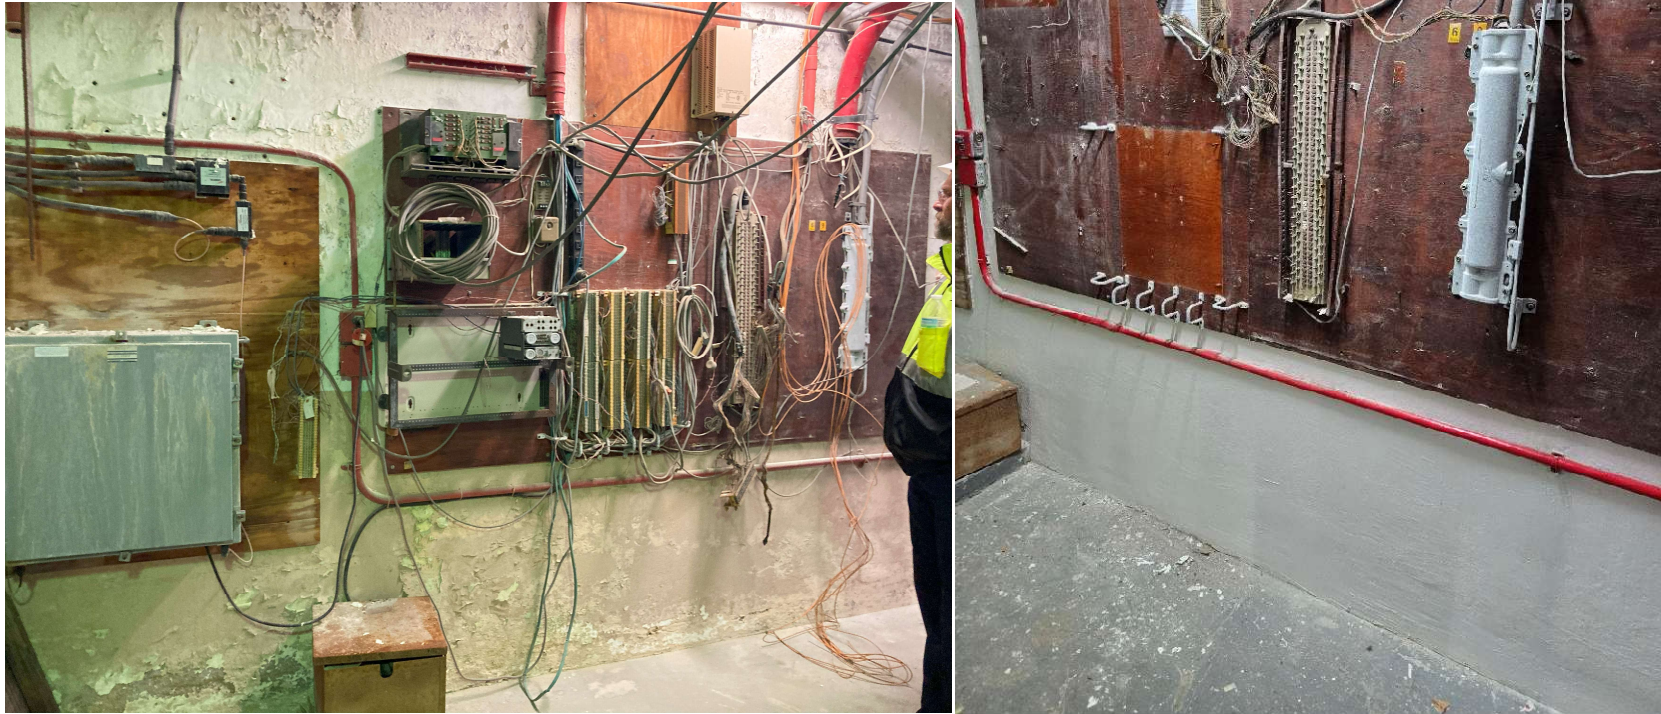
- System has resumed filter drop tests, backwash expansion tests. Plans to incorporate routine filter rise tests in 2026.
- Some of the obsolete electrical wires and associated equipment that were previously observed in the filter gallery have been removed as much as feasible and cleaned up (Figure 15)

Figure 15. Obsolete equipment abandoned in place (2025), Wiring removed as much as possible (2026)

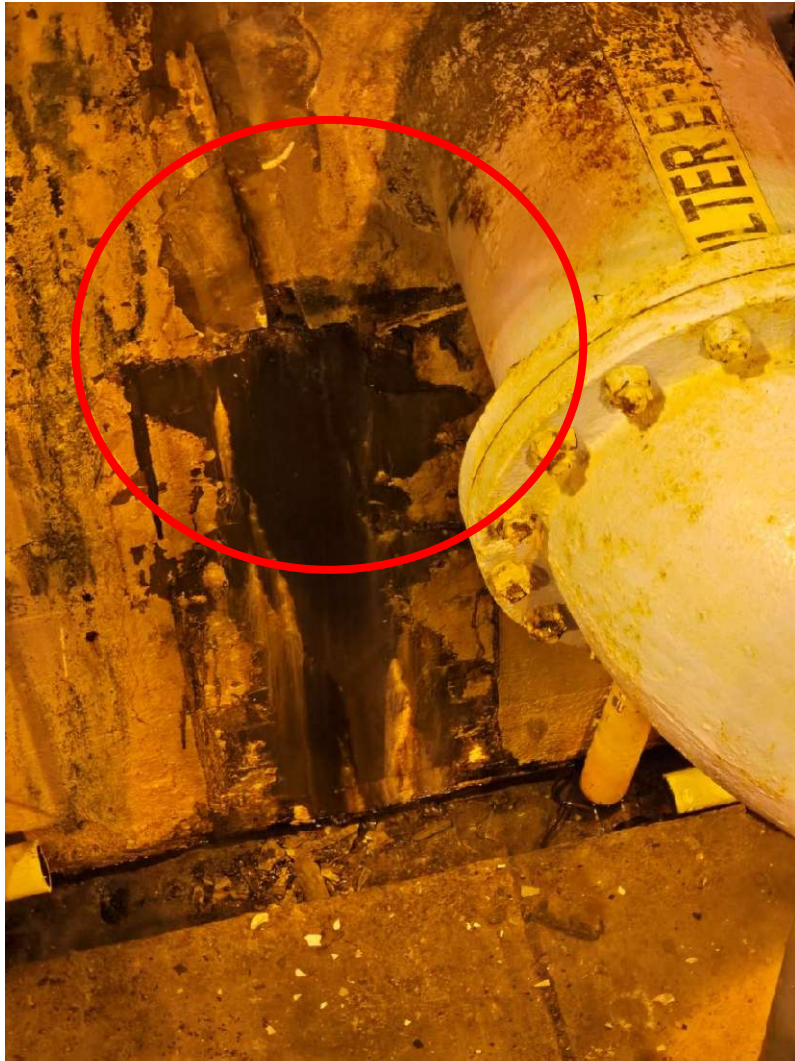
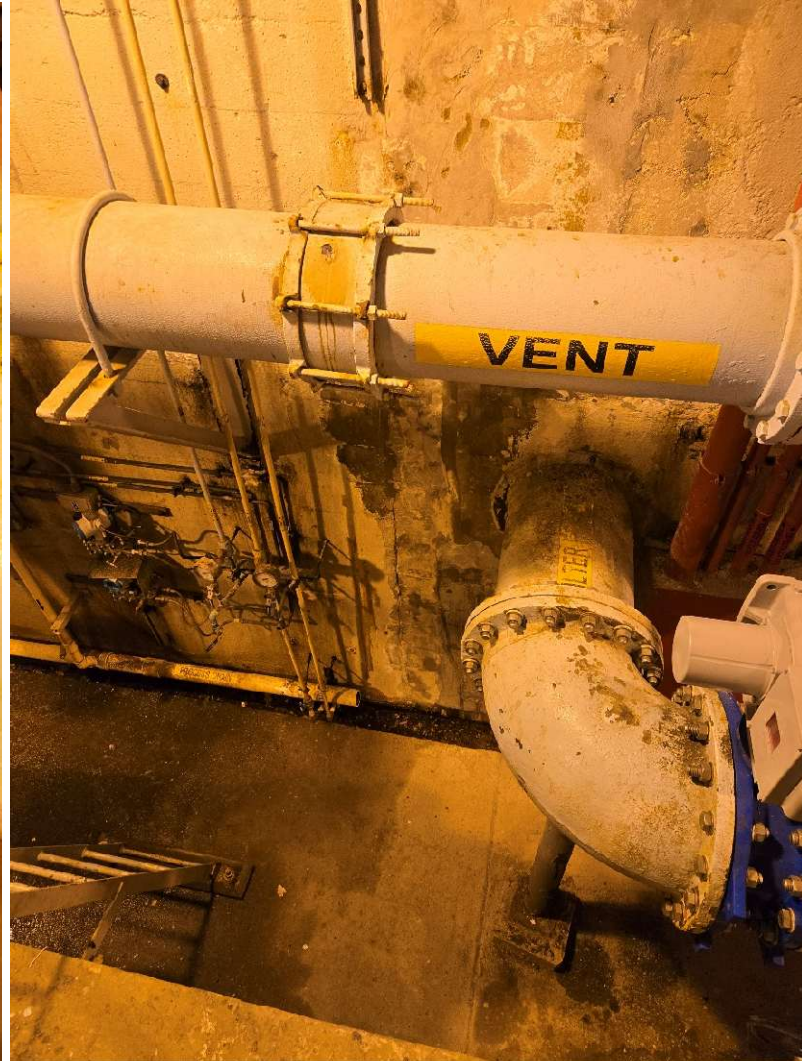
- No active leaks or biological growth observed (Figure 16, Figure 17)
- Backwash waste area appeared to have less standing water (Figure 19)

Figure 16. Filter 6 leaking through wall (2025); No leak observed (2026)

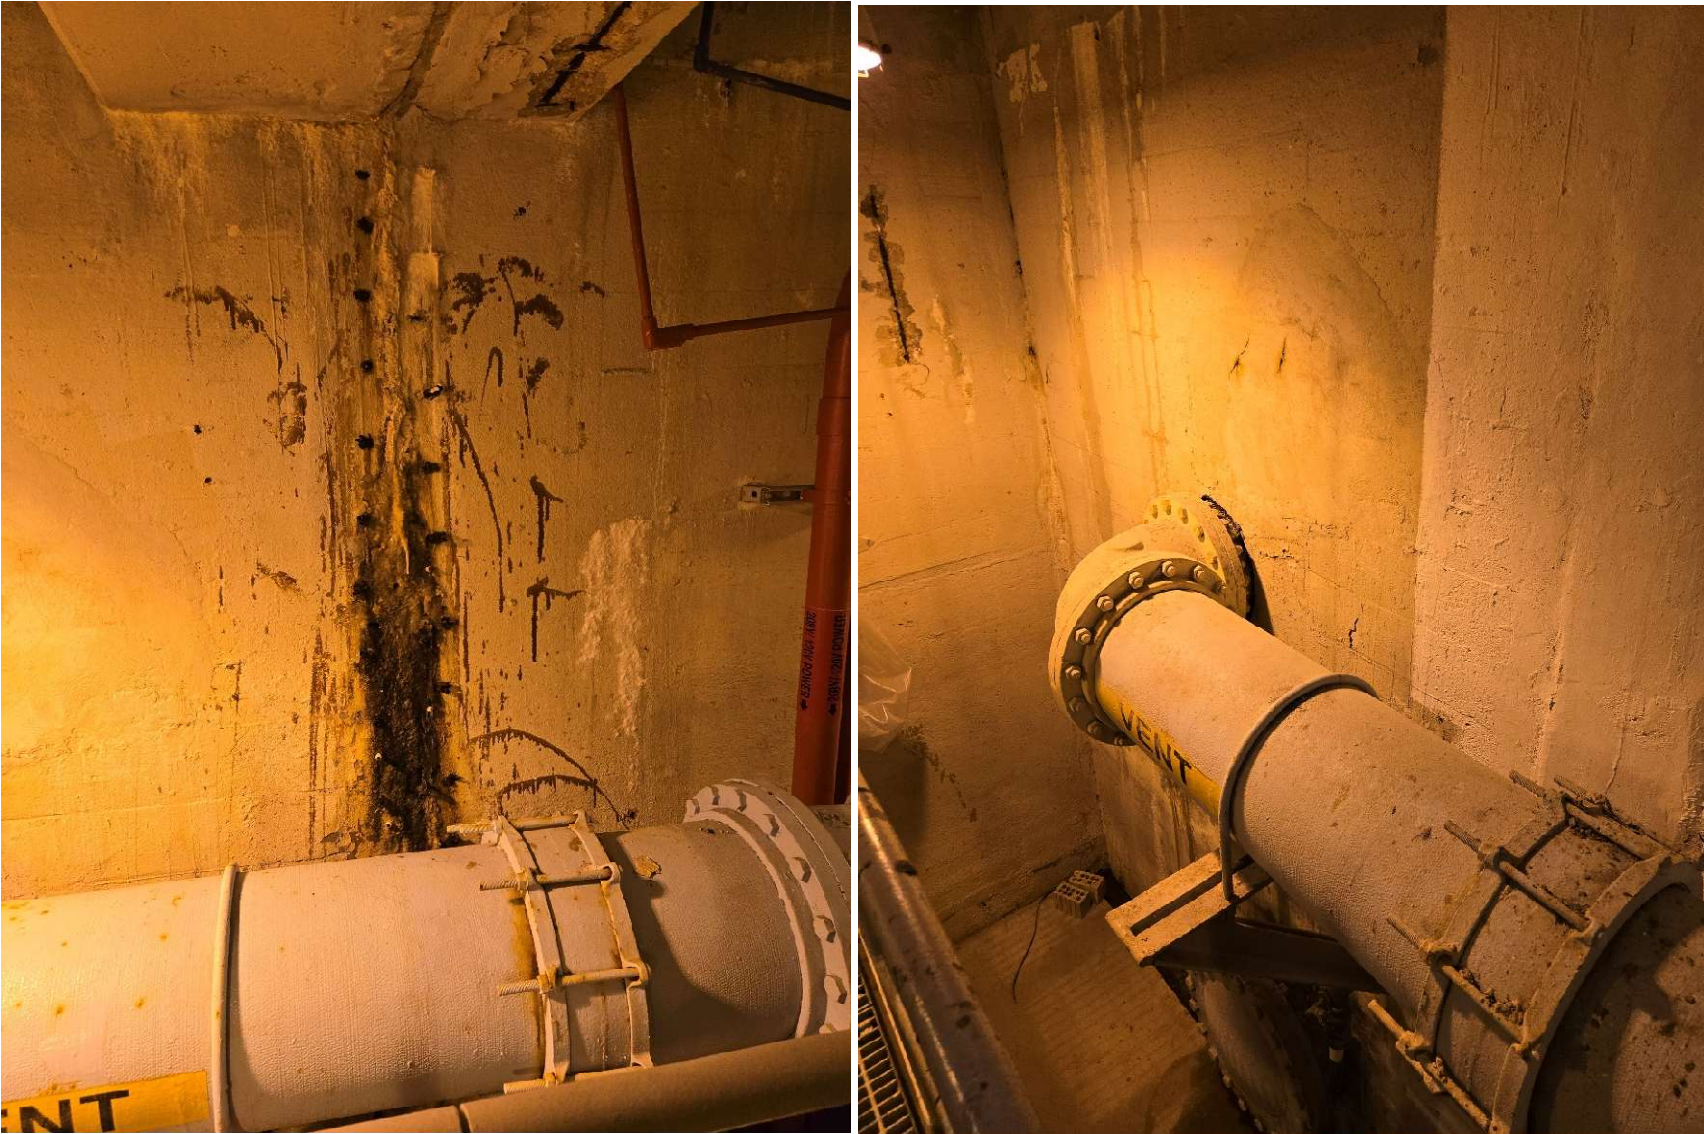
Figure 17. Leak and biological growth (2025); No leak observed (2026)

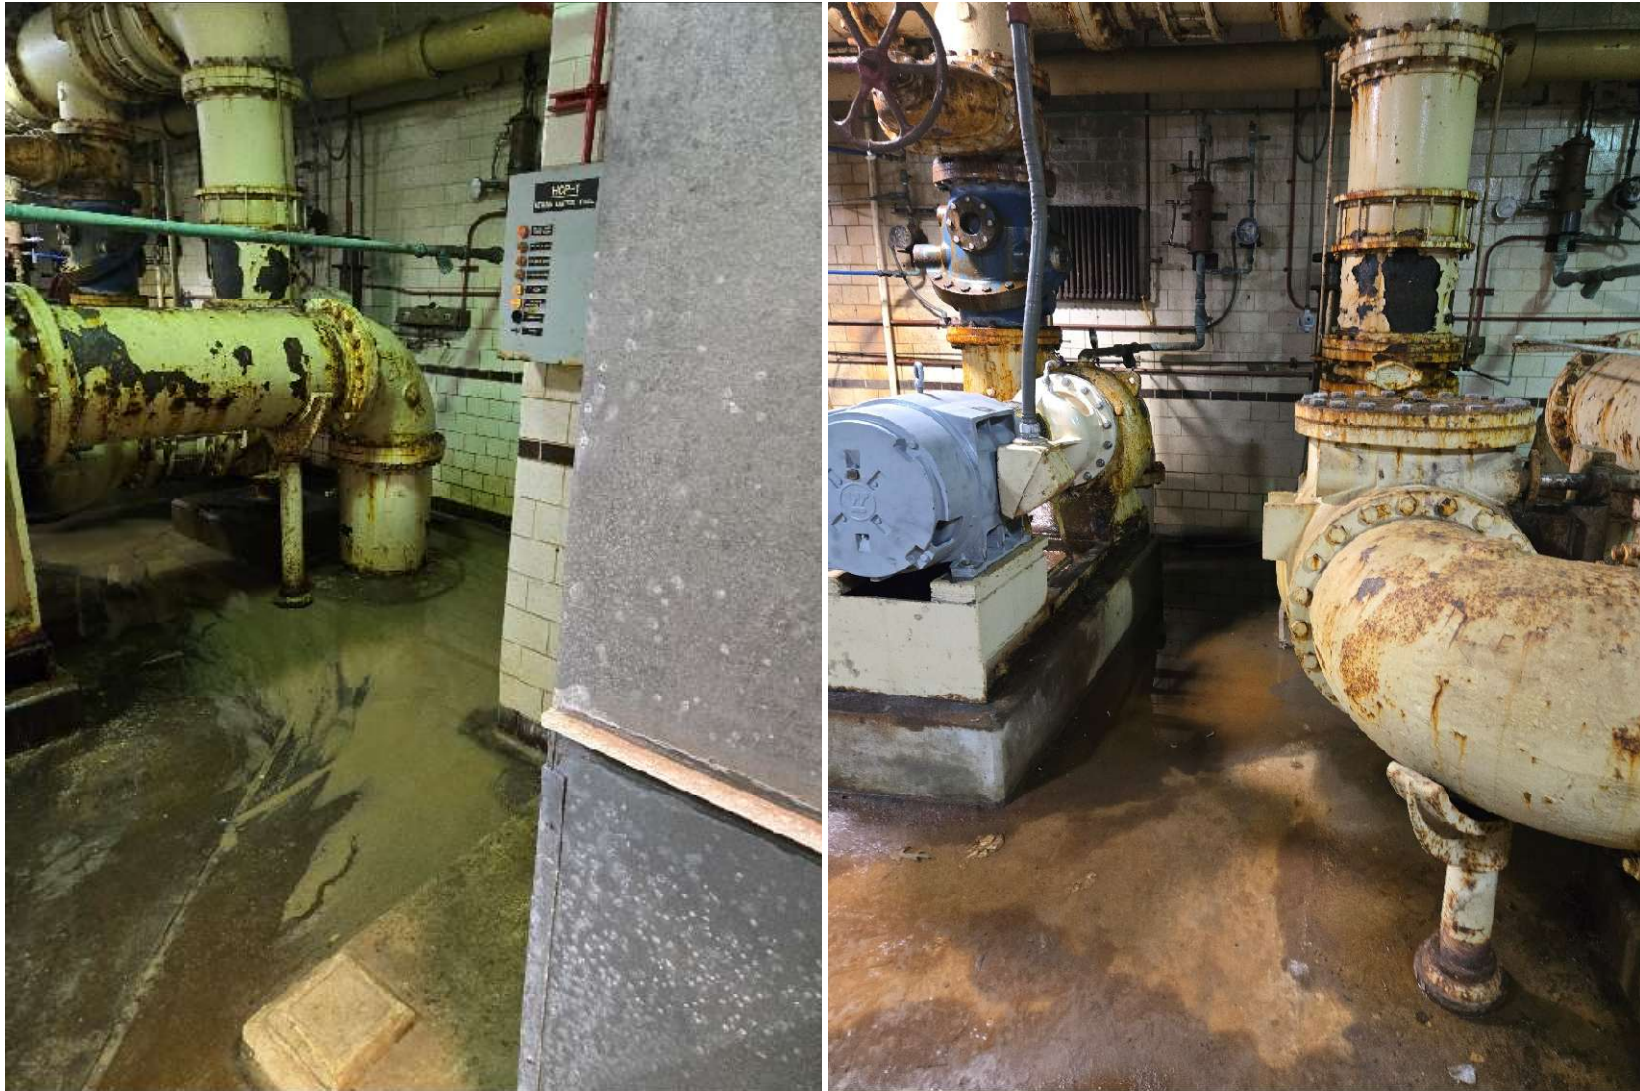
Figure 19. Backwash waste area (2025); (2026)
