COMMONWEALTH of VIRGINIA

OFFICE OF DRINKING WATER

System Sanitary Survey Report

SUBJECT: Richmond City
Waterworks: Richmond, City Of
PWSID: VA4760100

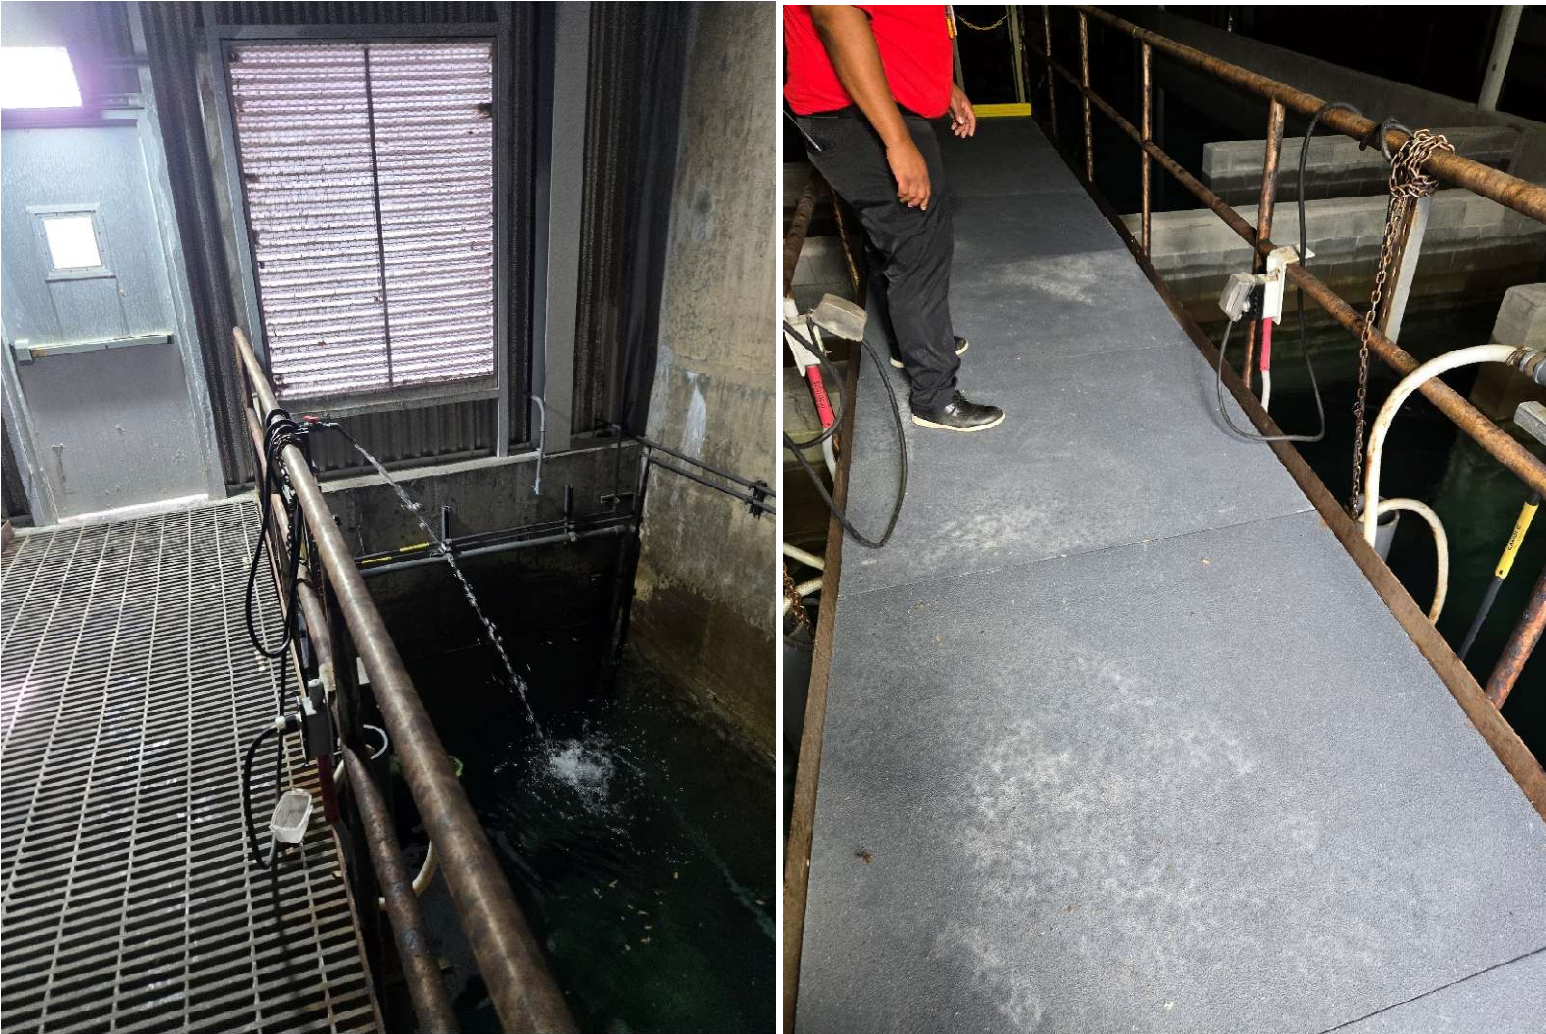
- All walkways into finish water basins have curbing, solid walkways to prevent dirt from falling into water (Figure 20)
- Walkways appeared clean with no debris observed (Figure 20)
- No scum observed at end of basins (Figure 21)
- System instituted routine cleaning of basins
- Previously observed obsolete PVC lines have been removed (Figure 22)
- Finish water basin lighting appears to have improved, brighter inside basins

Figure 20. Water beneath grates visible, no solid base on walkway (2025); Grates covered (2026)

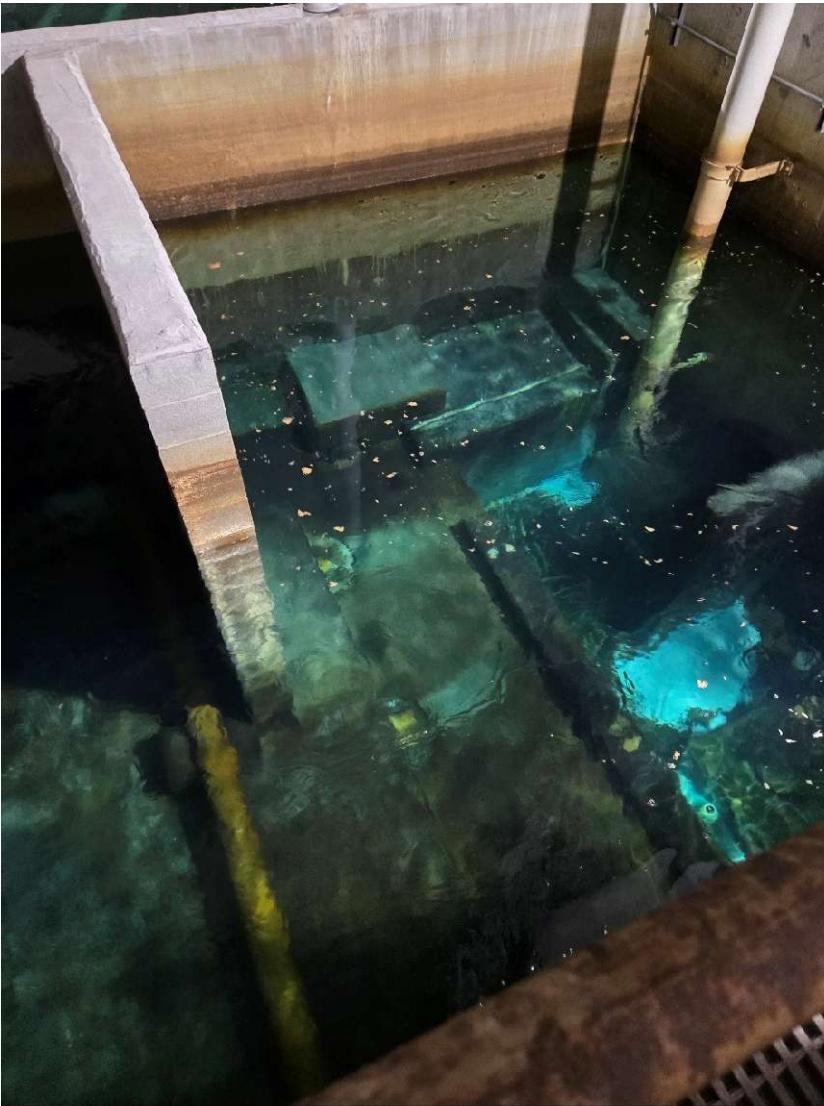
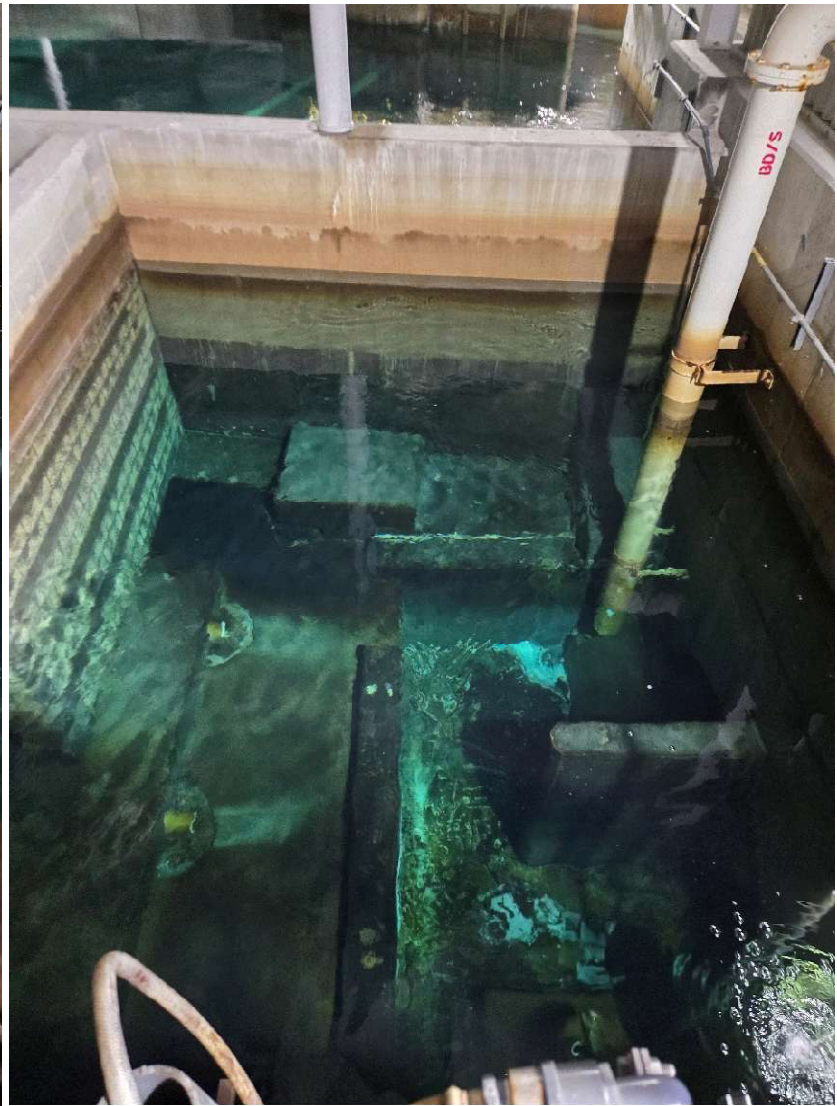
Figure 21. Scum observed end of aeration basin (2025); Not observed (2026)

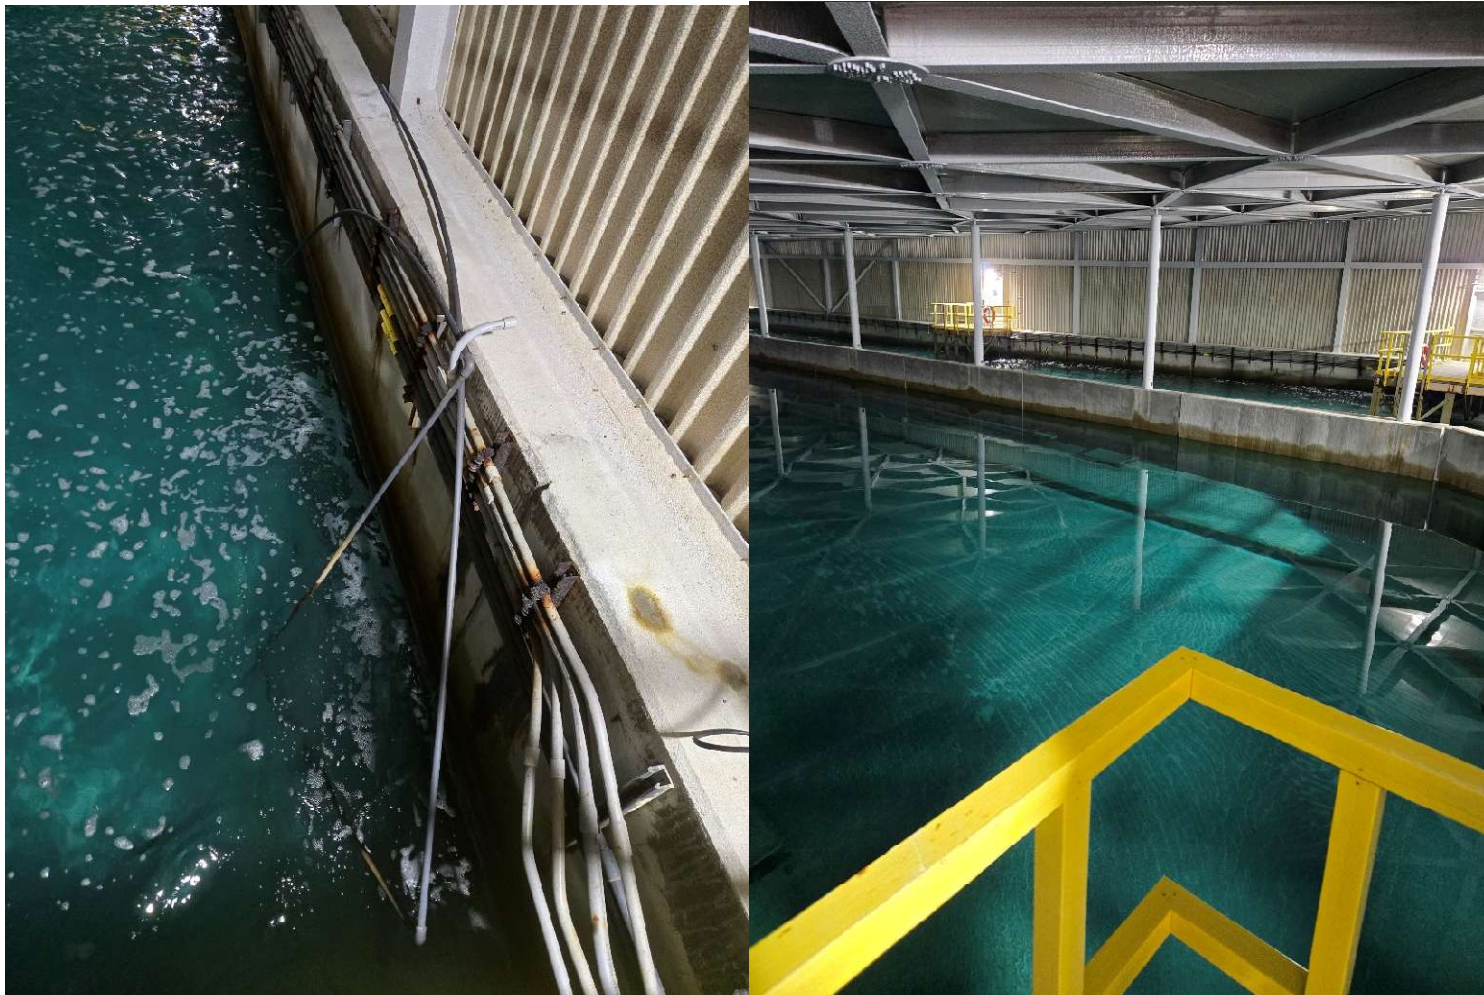
Figure 22. PVC pipe in water (2025), No hanging piping observed on sides (2026)

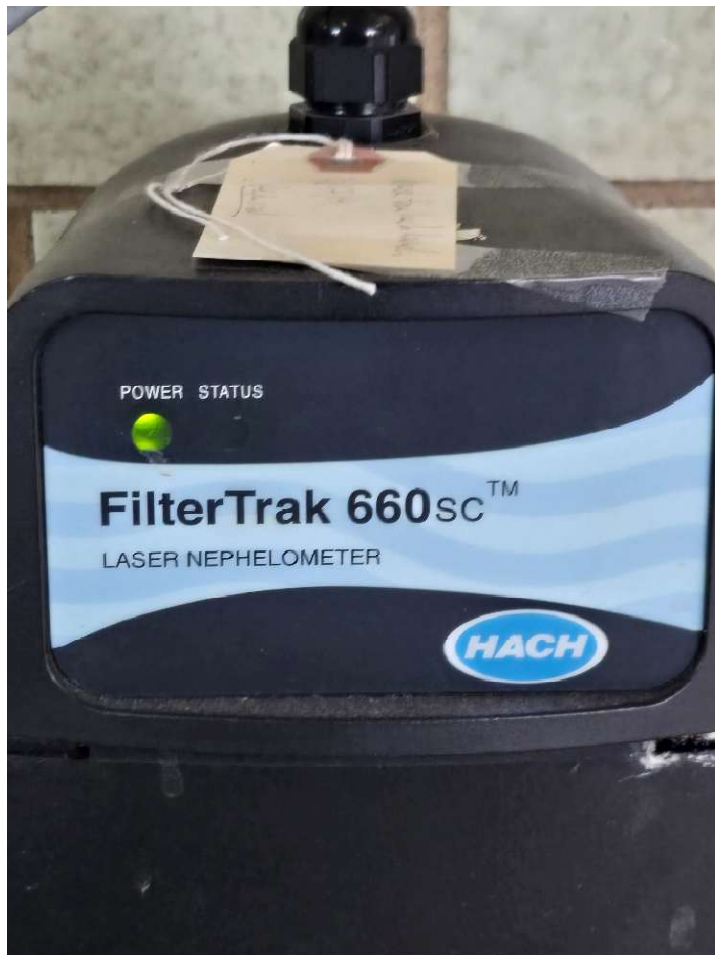
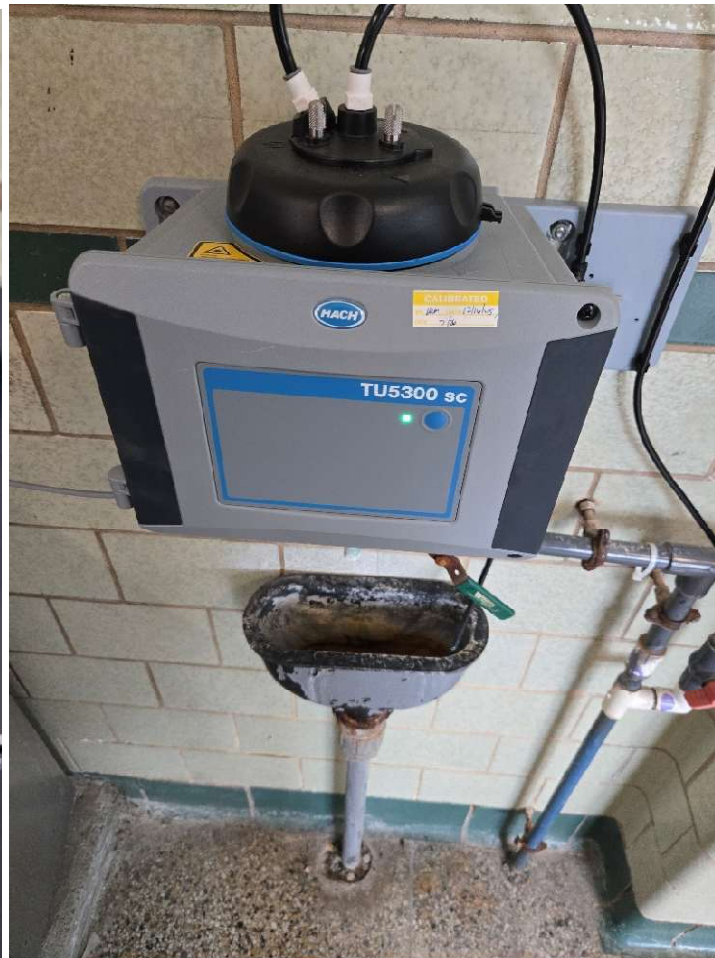
- Filter turbidimeters have been replaced with new equipment that have approved analytical methods (Figure 23)
- After around June 2025, there were no instances of individual filter turbidity readings of 2.00 NTU or greater on the monthly operation reports. Appeared to be a SCADA issue. System indicated they investigated signal span and have corrected previously observed issue

Figure 23. Obsolete turbidimeters (2025), New turbidimeters (2026)

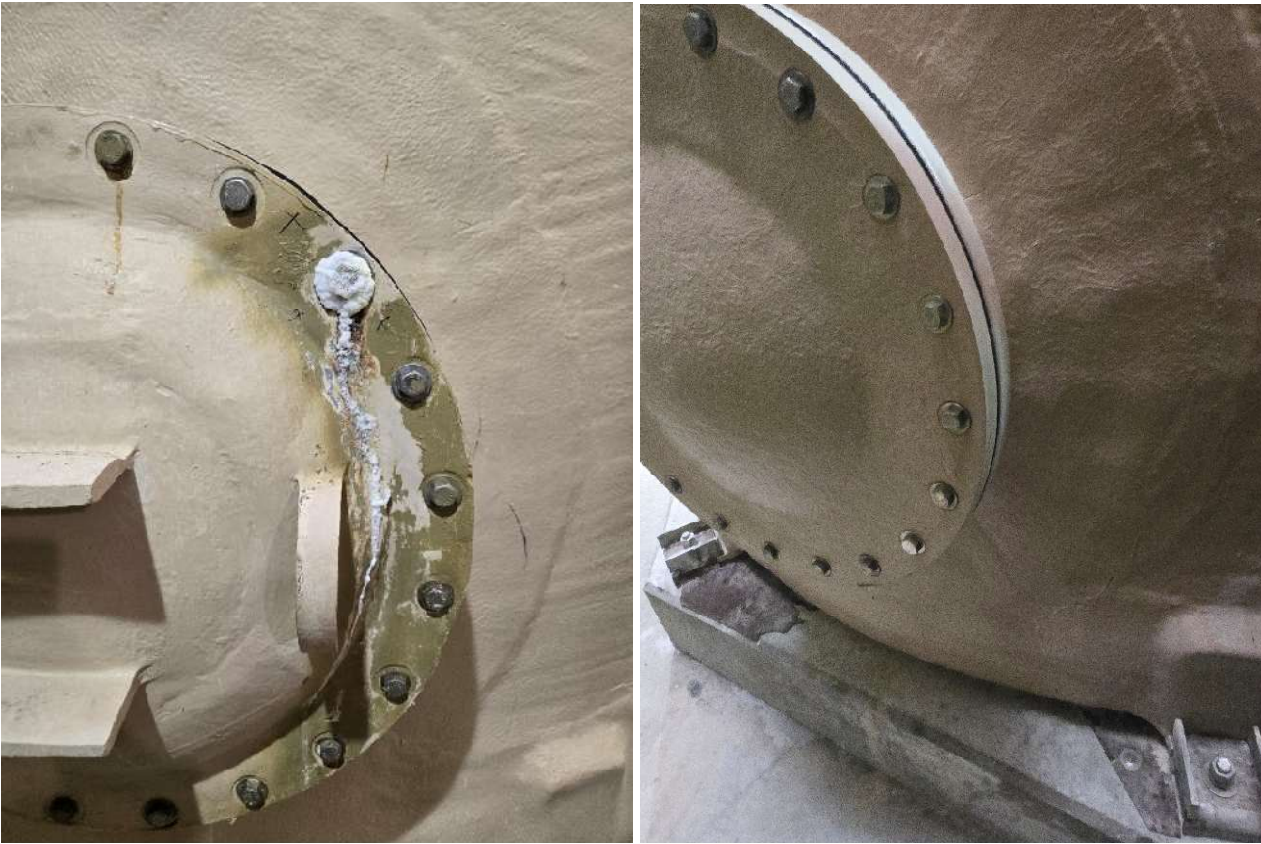
- All chemicals except polymer are now flow paced
- Polymer transfer pumps have been secured, rooms appear to be cleaner than previously observed
- No active leaks observed at sodium hypochlorite or alum storage tanks, area appears clean with no crystallized chemical observed on the floor or around manways (Figure 24)

Figure 24. Chemical leaks (2025), Not observed (2026)

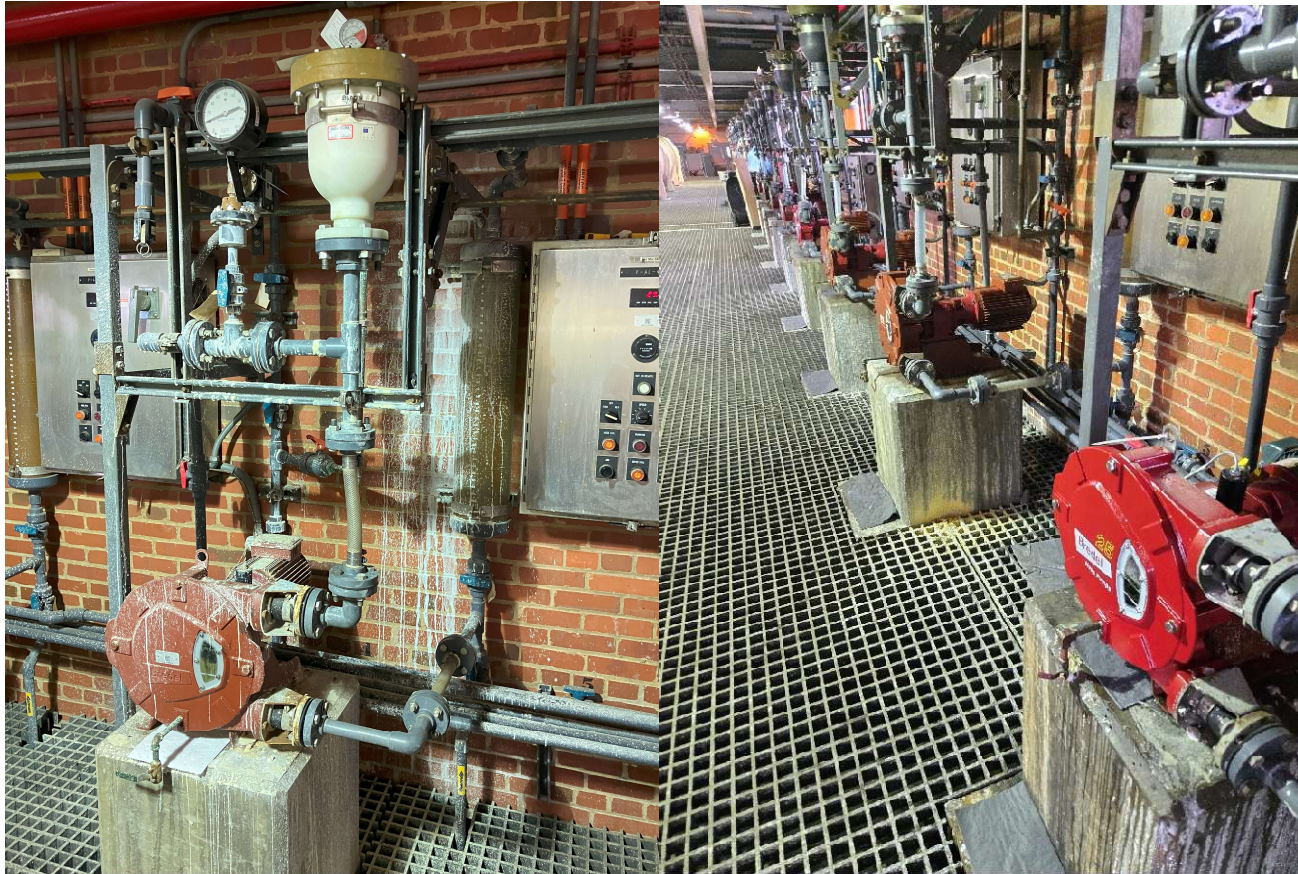
- Alum feed pumps all appear functional, no leaks or mess observed (Figure 25)
- No active chemical leaks observed at Korah pump stations
- System conducts routine calibration and feed rate testing of chemical feed pumps, spreadsheets observed

Figure 25. Chemical leaks (cont.) (2025), Not observed (2026)

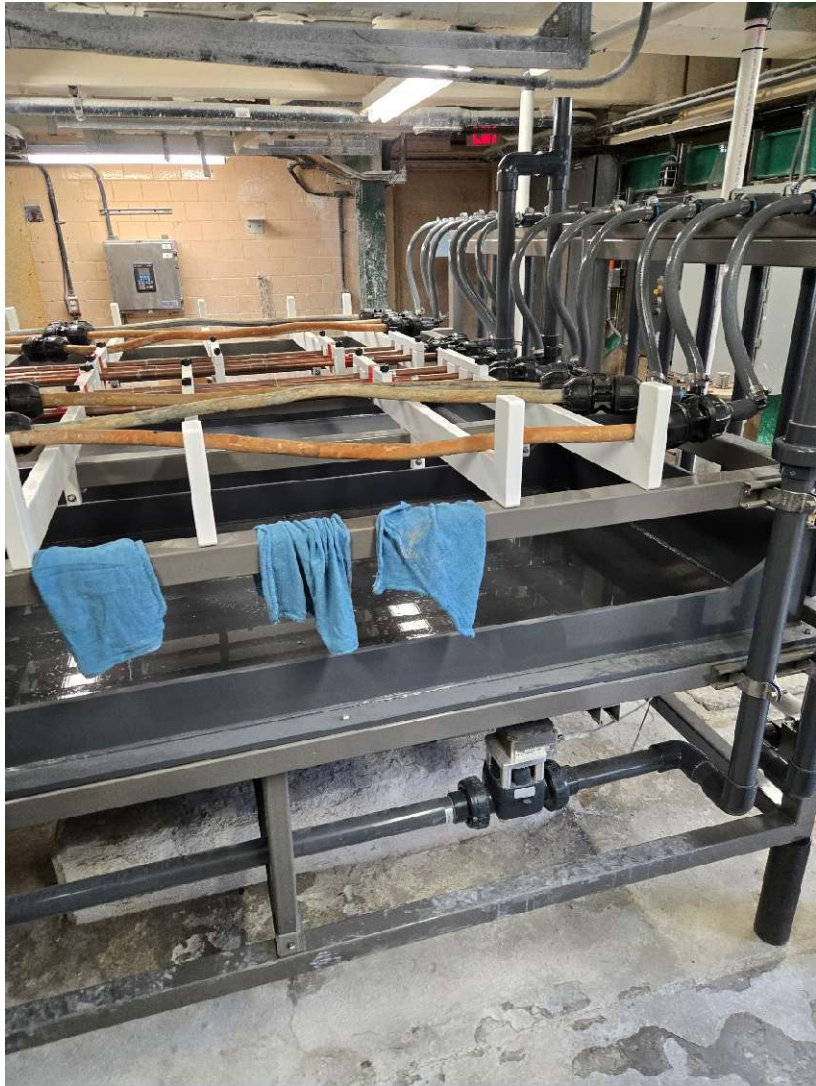
Figure 26. Pipe loop installation

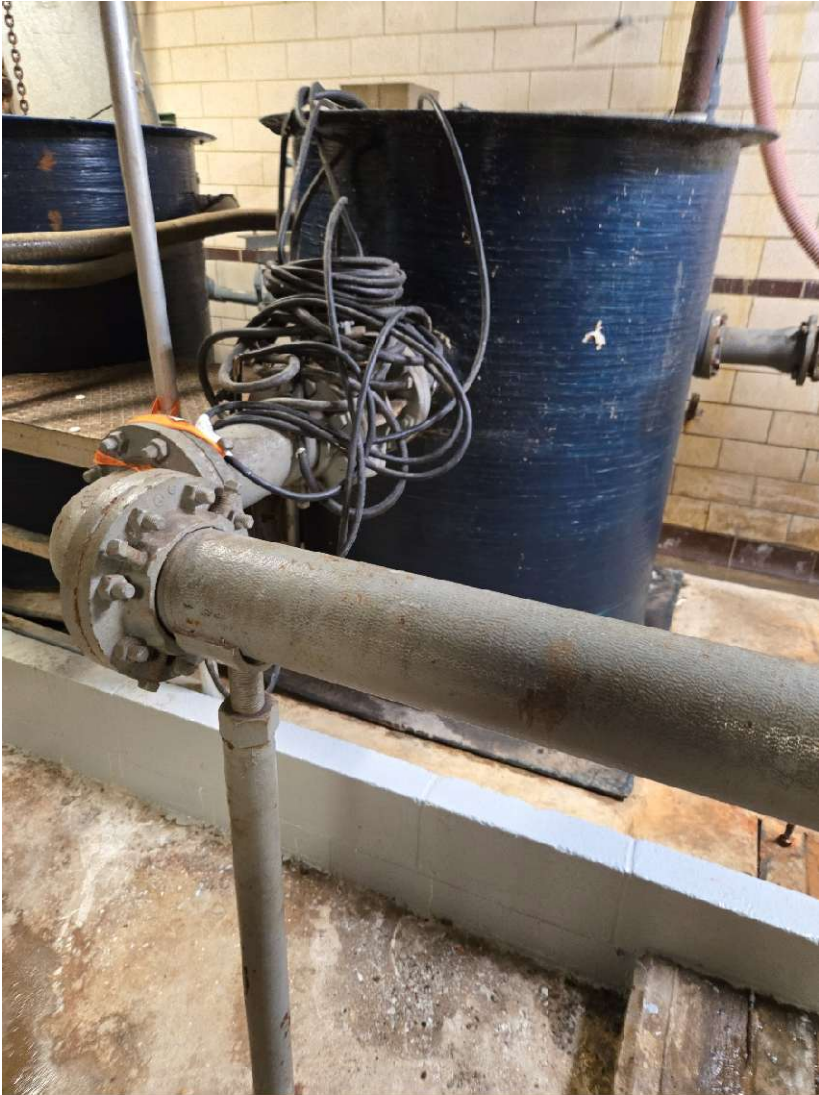
Figure 27. Sanitary waste storage tank with concrete containment curbing

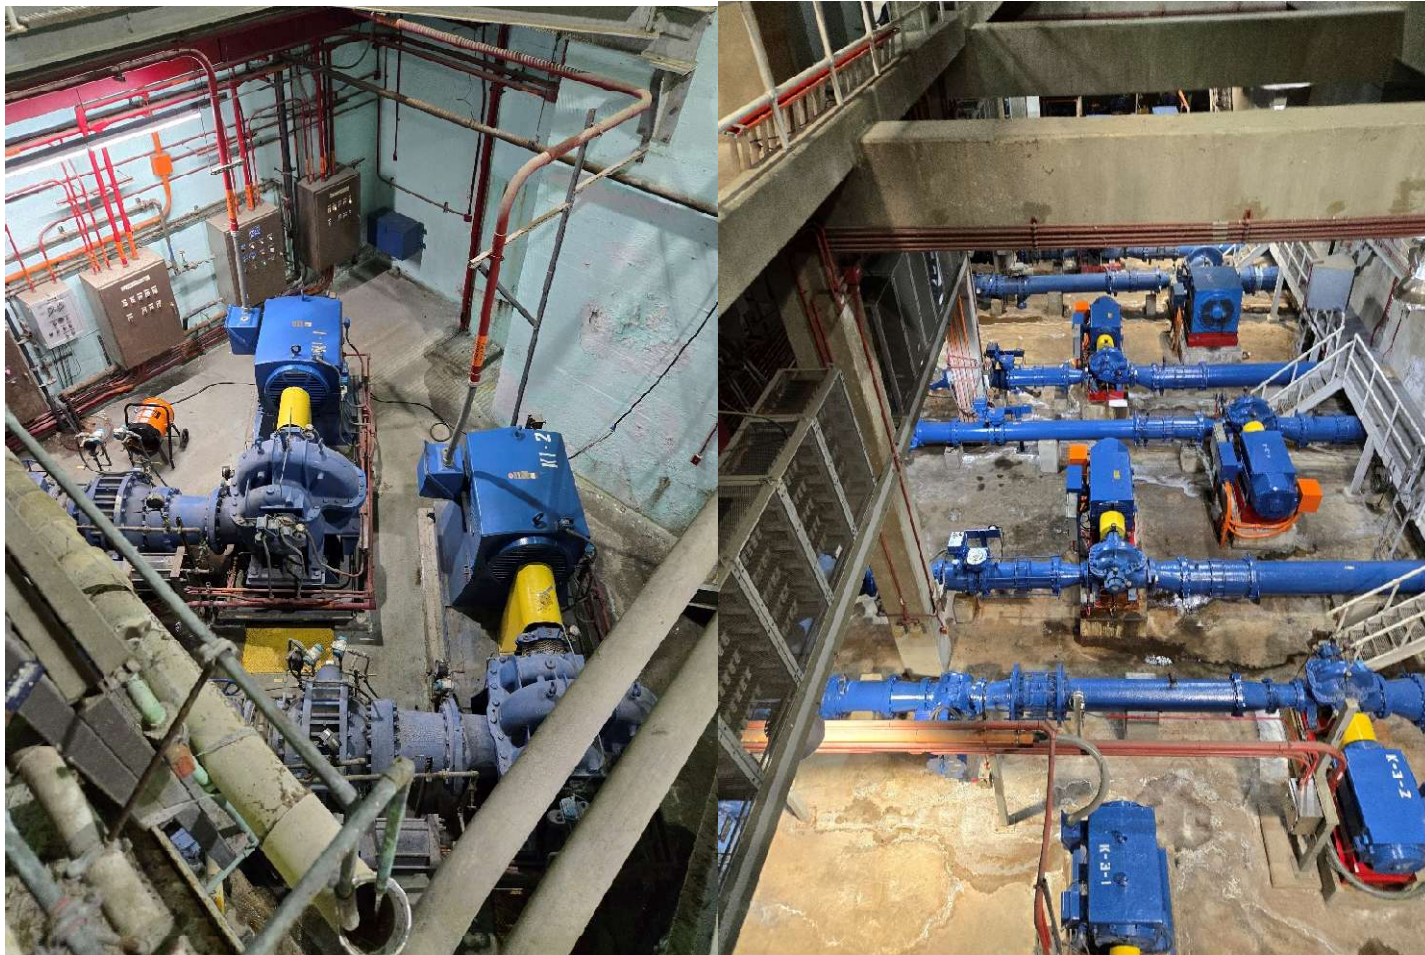
Figure 28. Korah Pump Stations

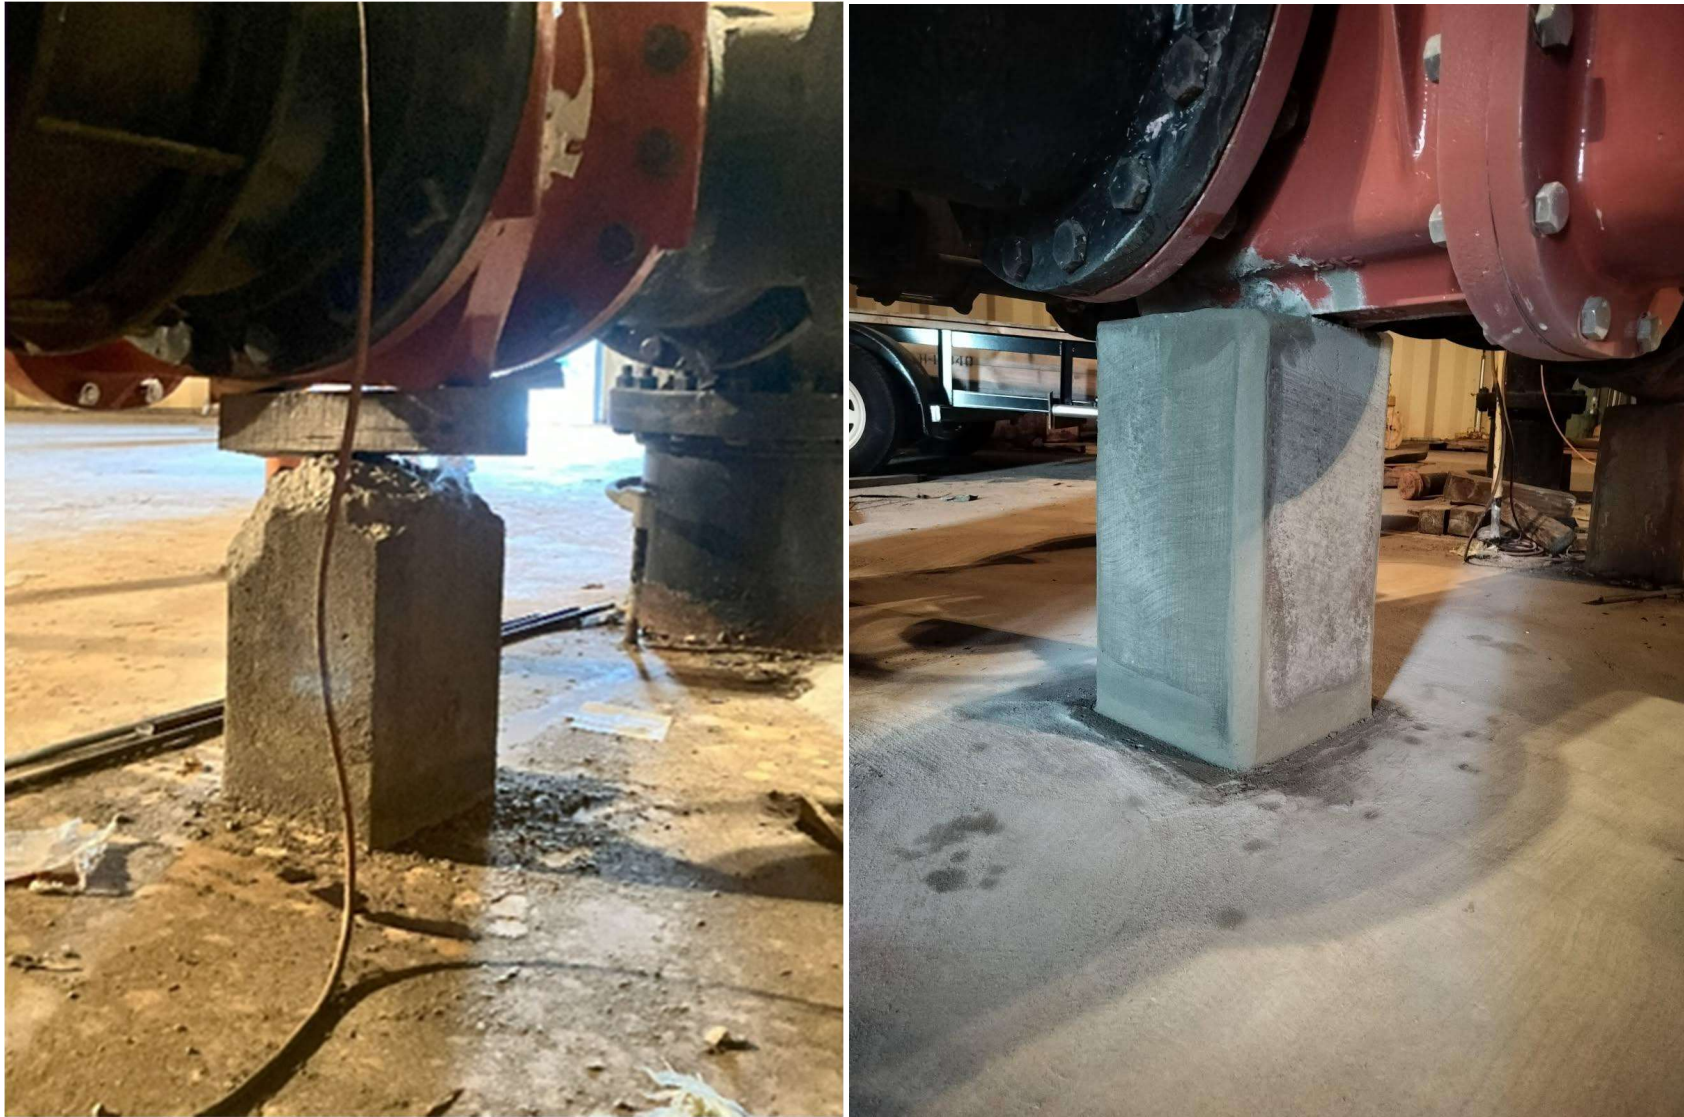
Figure 29. Wood supporting valve due to eroded concrete support (2025), Support repaired (2026)

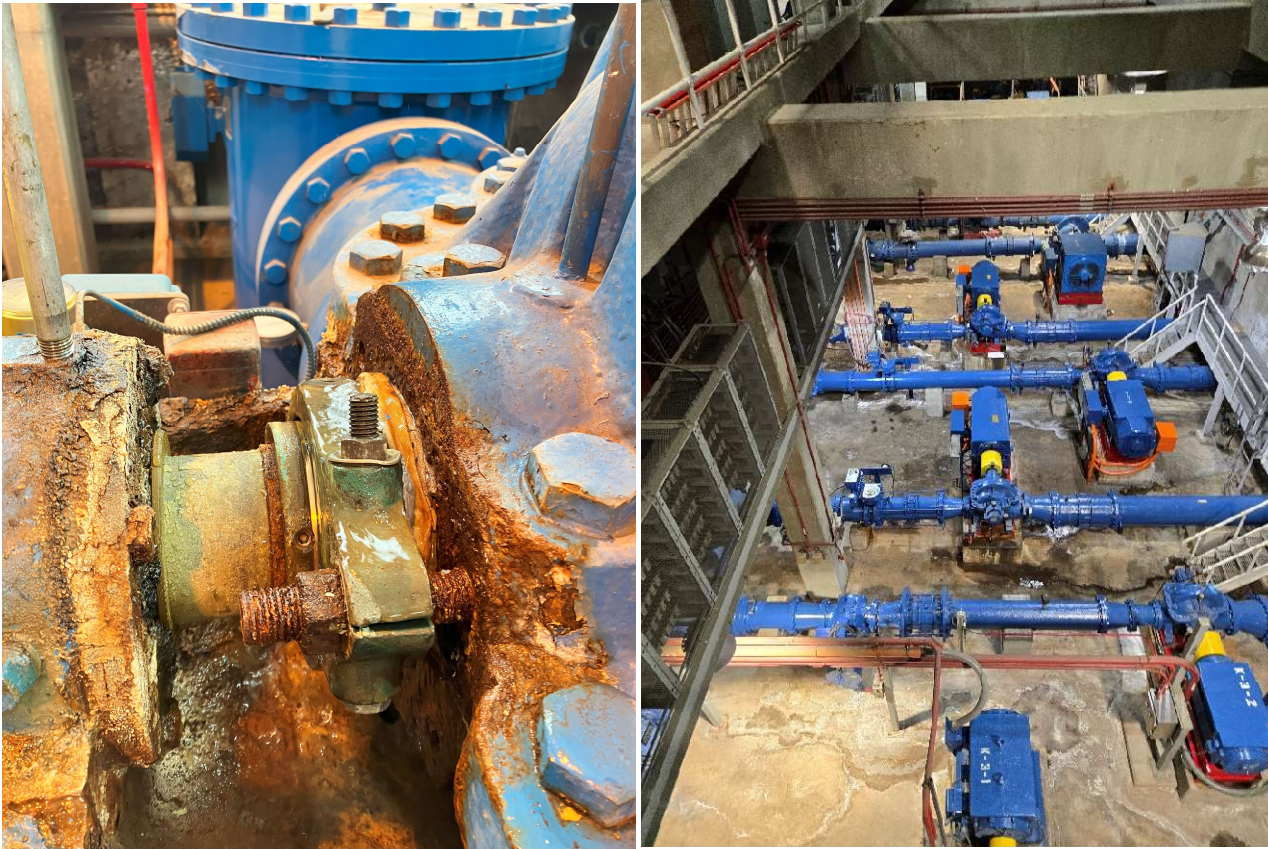
- Project to move new vacuum priming systems upstairs
- Pumps have been painted, no visible rust
- Minimal standing water observed, all pump seal water was routed to nearby floor drains
- All pumps available for use

Figure 30. Corrosion at several pumps (2025), Pumps painted and no visible corrosion (2026)

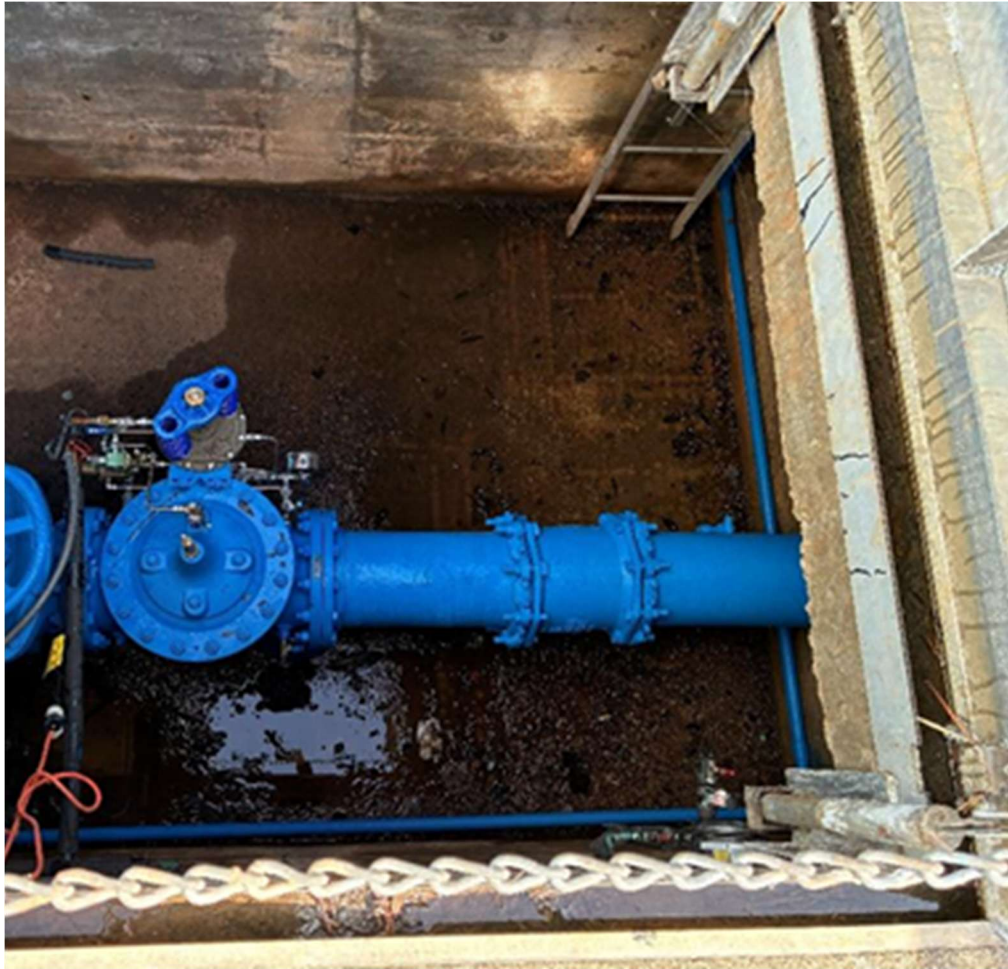
Figure 31. Valve vault in Distribution System
