**Subject:** Environmental Protection Agency (EPA) Safe Drinking Water Act Compliance  
Inspection Report.

**Follow-Up Site Visit Conducted by Virginia Department of Health-Office of  
Drinking Water's (VDH-ODW) Richmond Field Office**

**Author:** James Reynolds, PE- Field Director Richmond Field Office

The City of Richmond (COR) owns and operates a public waterworks (PWSID 4760100). The system is served by a Class 1 surface water treatment plant with a permitted capacity of 132 million gallons per day (MGD).

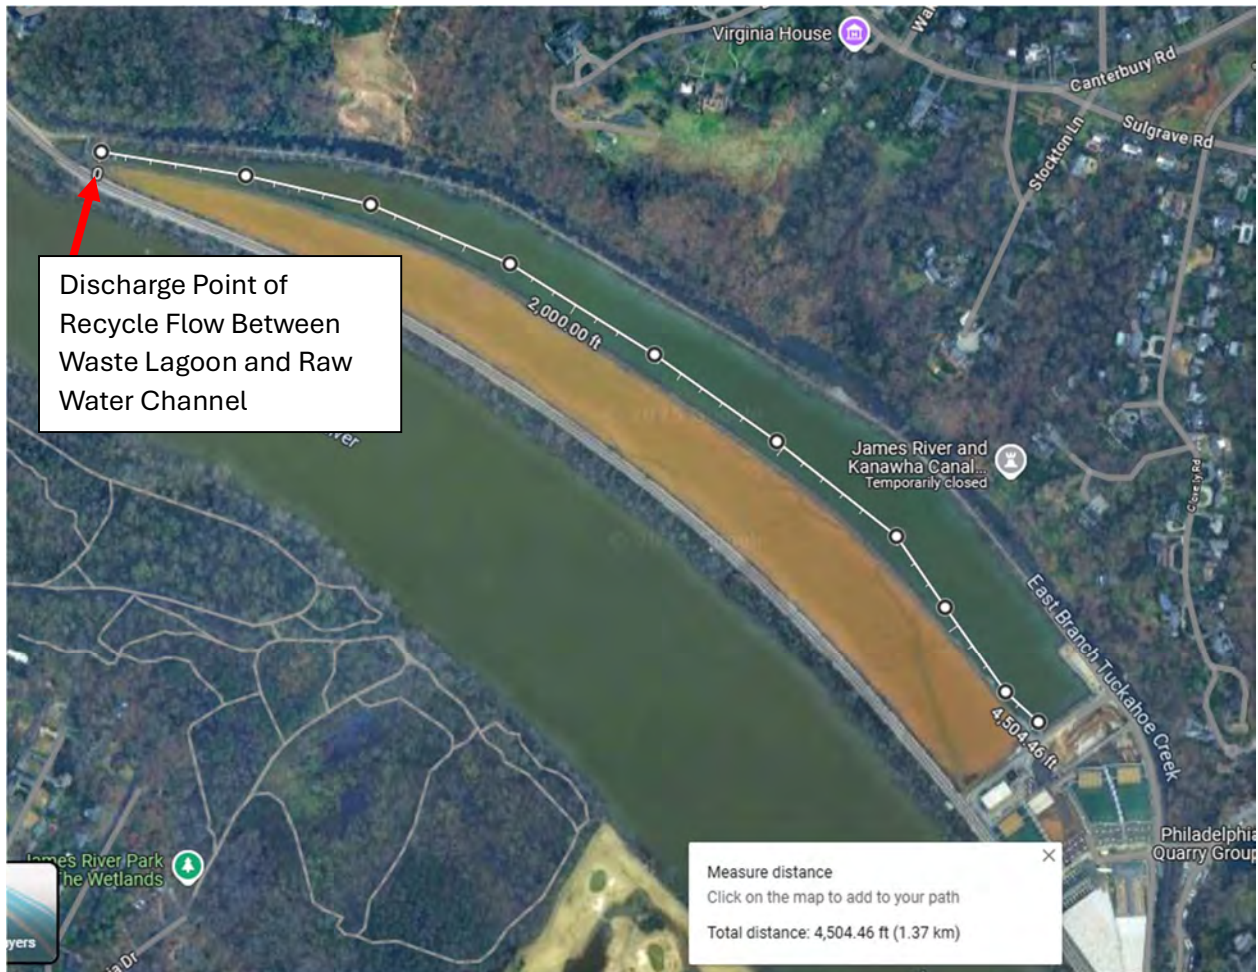
Figure 1. Distance of recycle discharge point and head of raw water pump stations (VDH)

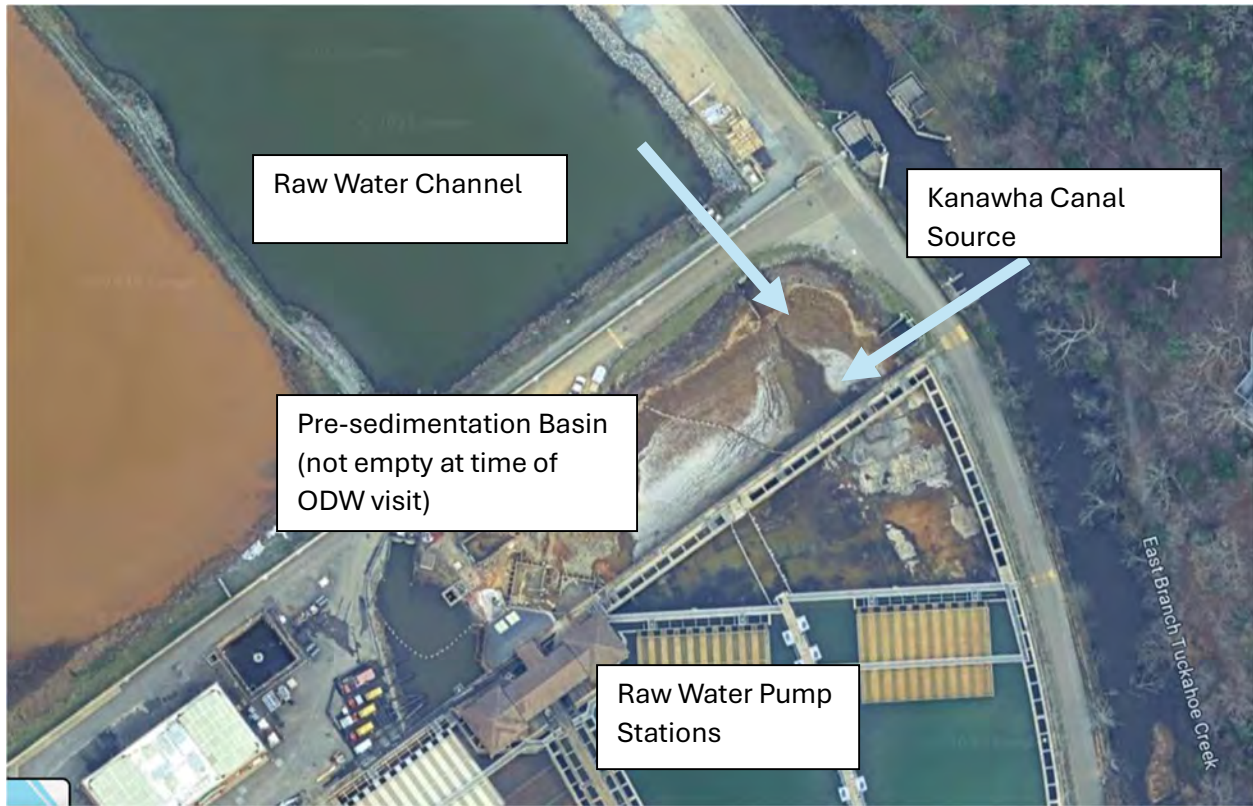
Figure 2. Location of Kanawha Canal discharge in relation to raw water channel (VDH)

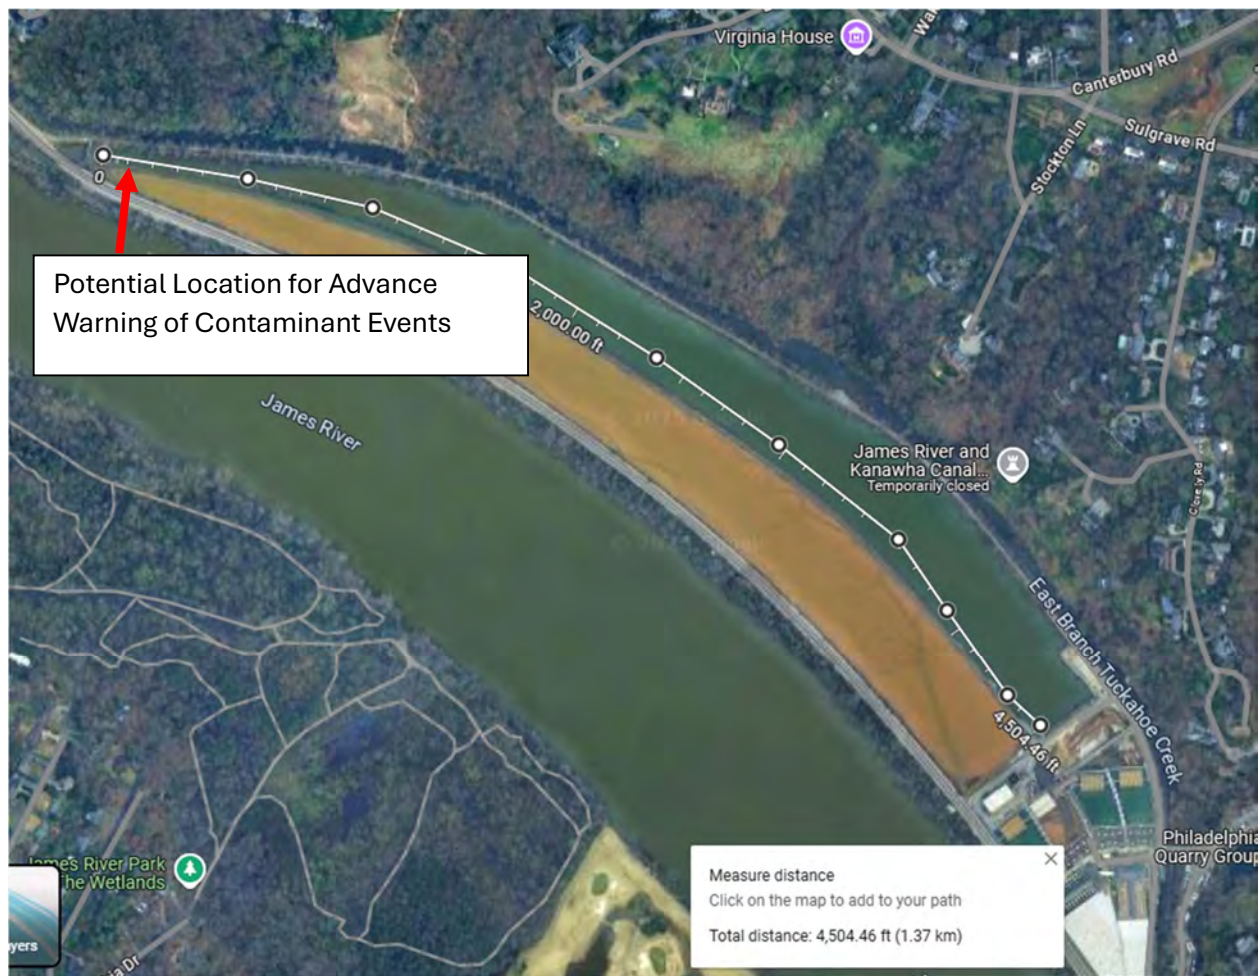
Obs. #	Category	Area of Concern	Supporting Observation	Relevant Citation	Richmond DPU Response 2025	VDH-ODW Observation 2025	Photograph (Appendix A)
						maintain capacity in the basin.	
<b>AOC-5</b>	Raw Water Quality Monitoring	Raw water quality testing analytes and frequency is minimal for early detection issues that could affect treatment.	The System analyzes for pH, turbidity, and alkalinity in the raw water. The System does not conduct any other periodic monitoring of raw water to test for potential contaminants.	“Recommended Standards for Water Works” (2018 Edition) Part 2.19.h. – “Real time water quality monitoring with continuous recording and alarms should be considered at key locations to provide early warning for possible contamination events.”	Water quality monitoring equipment is being incorporated into the pre-sedimentation basin dredging project. The City will seek approval from VDH as needed for equipment / design. Raw water is also monitored and reported with online instrumentation.	<p>No change.</p> <p>Waterworks measures raw water for pH, turbidity, and alkalinity.</p> <p>Additional potential parameters include algal counts/HAB measurements, DO, turbidity, conductivity. Measurements would be recommended at the head of the feeder channel, near the dam intake and upstream of the WTP to give advanced warning of possible contamination. These parameters are not required in the current regulations at the locations described.</p>	Figure 3

Figure 3. Advance detection testing location (VDH)

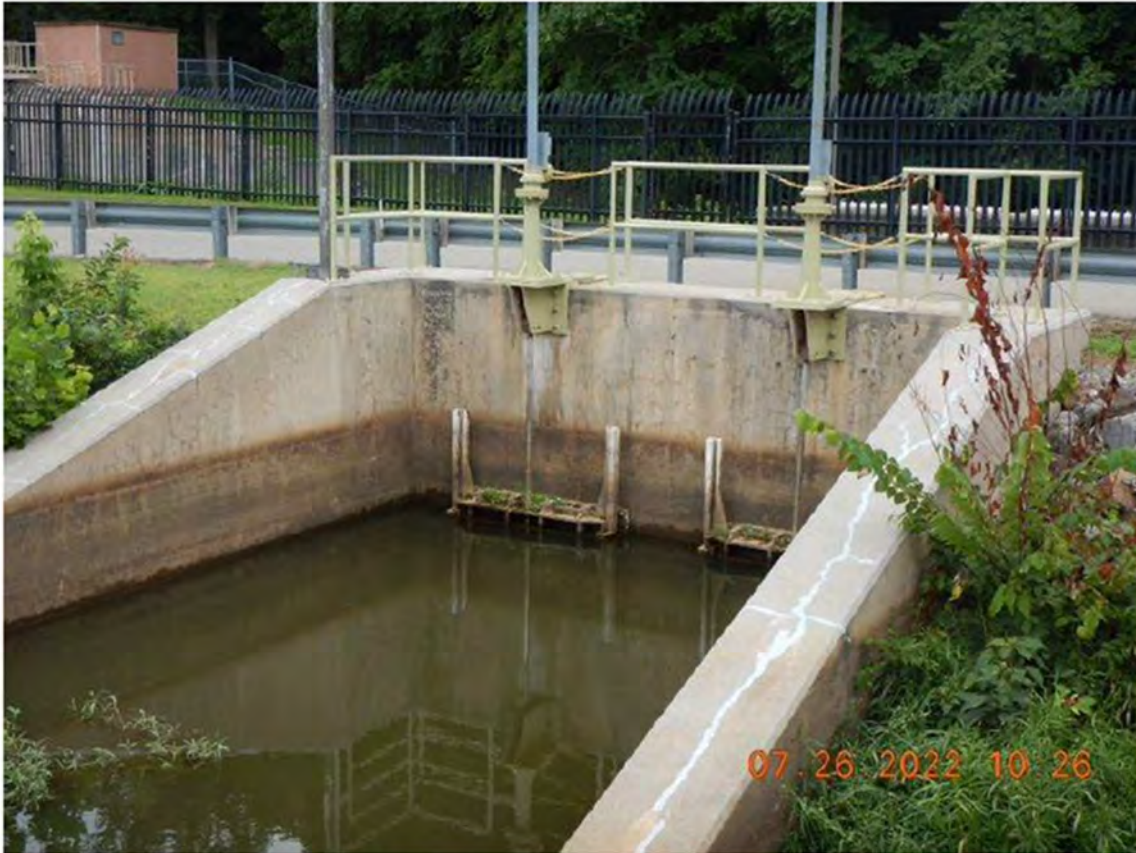
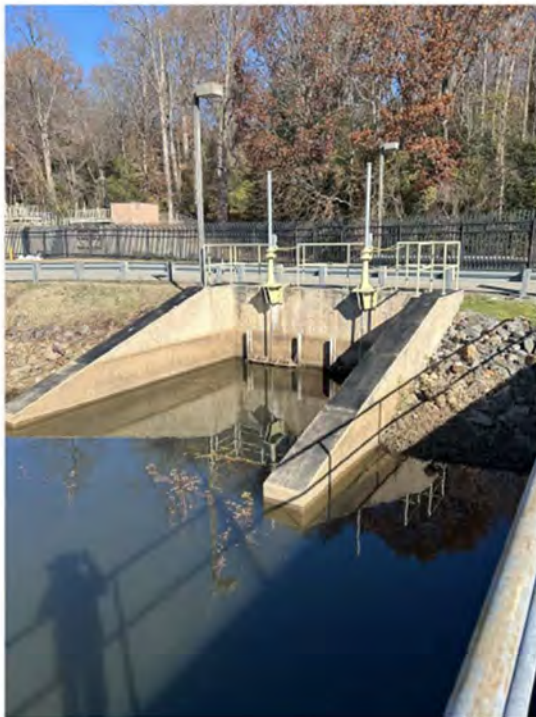
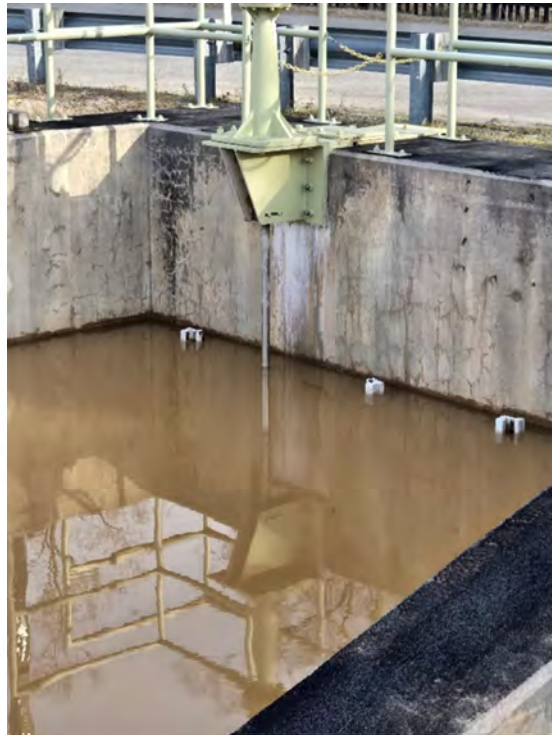
<b>AOC-6</b>	Kanawha Canal	There is a lack of flow monitoring of water from the Kanawha Canal, which could	Canal water flows by gravity without flow measurements. System Reps	“Recommended Standards for Water Works” (2018 Edition) Part 2.13 states, “All	There is currently no flow monitoring infrastructure associated with any of the canal crossover gates. Flow is controlled from the	<p>No change.</p> <p>No means to monitor flow currently. Gates did not appear to be</p>	Figure 4

Figure 4. Kanawha Canal gate closed, no flow observed (Top-EPA, Lower Left- COR, Lower Right- VDH)

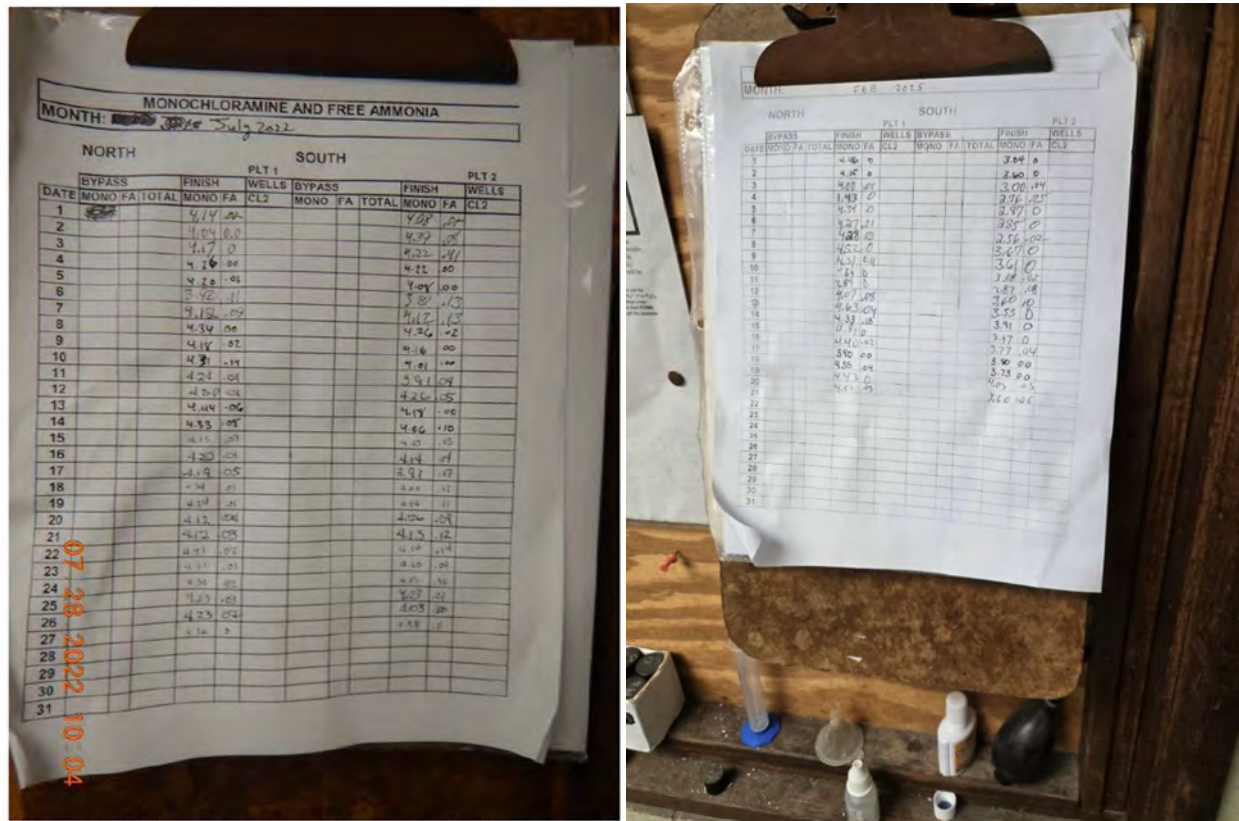
<b>AOC-7</b>	Finished Water Quality	Free ammonia concentrations exceed 0.1 mg/L when entering distribution.	July 2022 data sheets reflected several instances where free ammonia exceeds 0.1 mg/L, with a maximum of 0.41 mg/L.	12VAC5-590-1002 states, “Control should be sufficient to limit free ammonia leaving the chloramination facility to no more	The City acknowledges this observation and Operators are currently adjusting the dosage when free ammonia reaches 0.1 mg/L. Staff has been trained accordingly.	No change.  ODW reviewed February 2025 data sheets and observed 3 instances out of 40	Figure 5

Figure 5. Free ammonia readings (Left-EPA, Right- VDH)

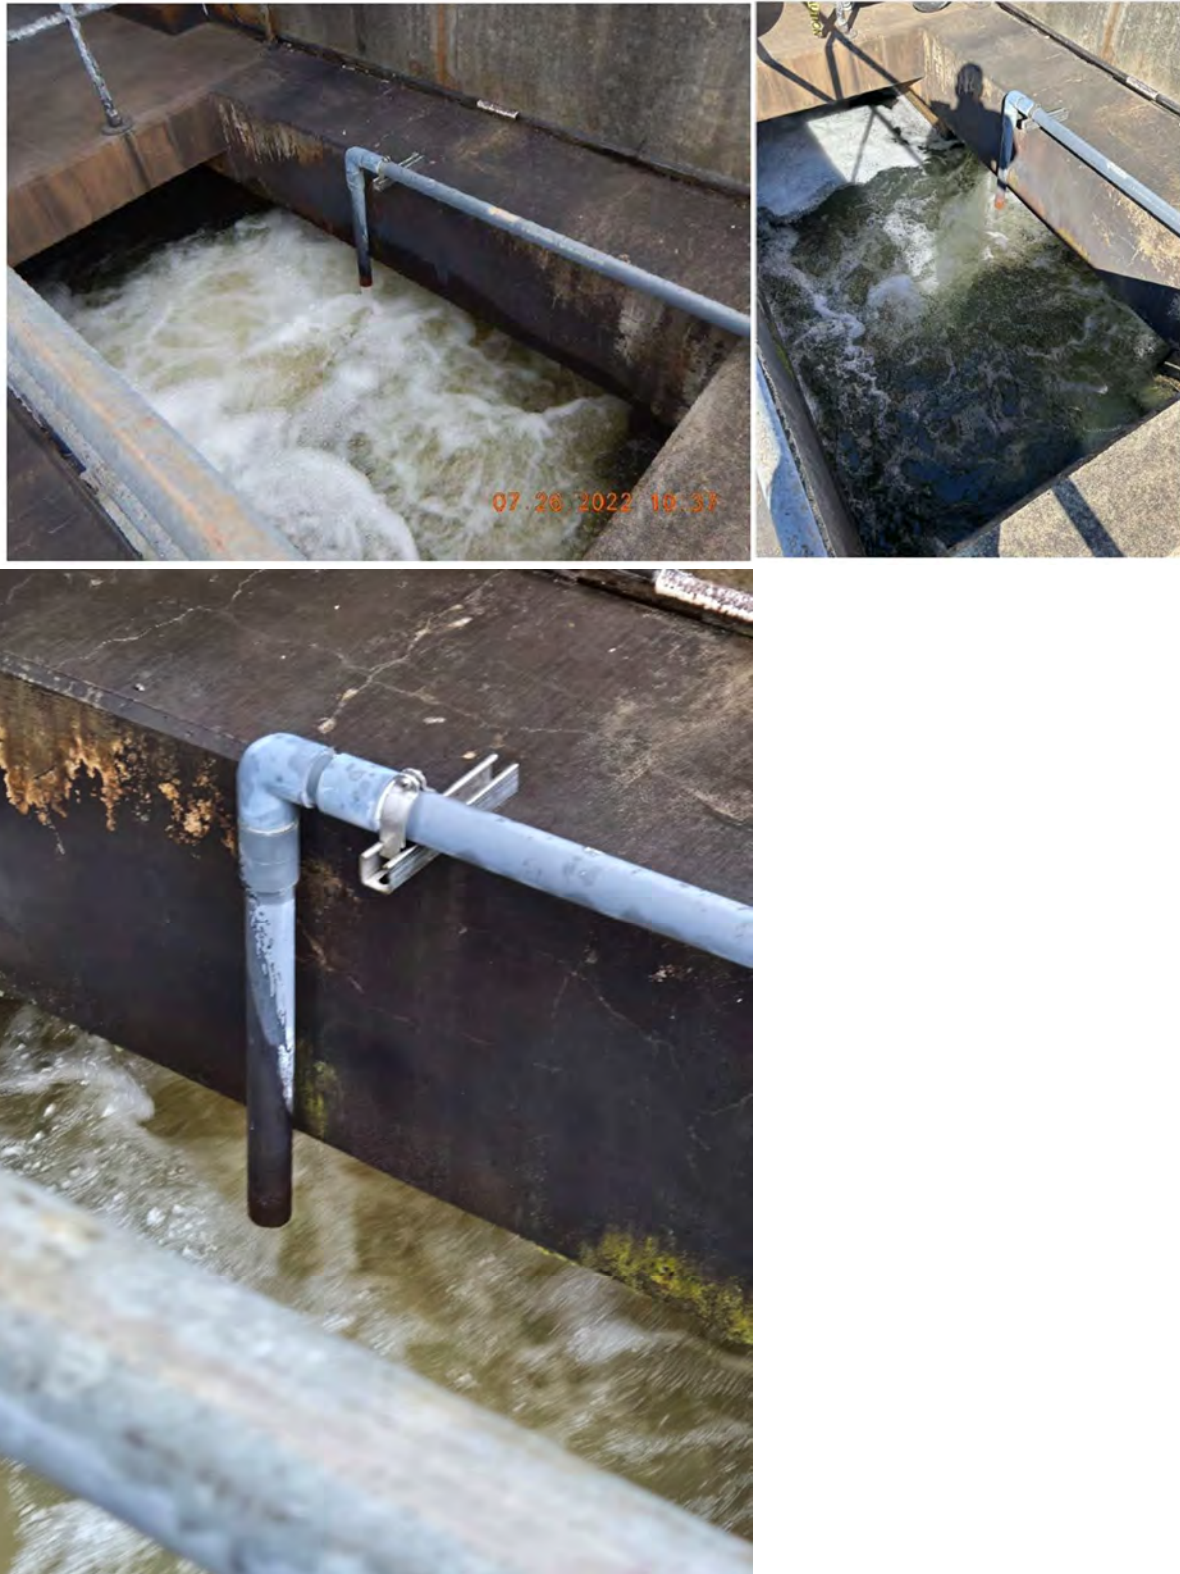
Obs. #	Category	Area of Concern	Supporting Observation	Relevant Citation	Richmond DPU Response 2025	VDH-ODW Observation 2025	Photograph (Appendix A)
				shall be promptly implemented to protect public health.” System risks exceeding turbidity standards described in 40 CFR §141.173(a)(1).			
<b>AOC-10</b>	Raw water coagulation channel	Potassium permanganate treatment out of service.	The System intended for potassium permanganate treatment based on seasonal needs, however, the treatment was out of service on two separate checks during the inspection due to an instrumentation failure. Potassium permanganate residuals are not tested in treated water to confirm proper dosage.	12VAC5-590-360.A states, in part, “The owner shall provide and maintain conditions throughout the entirety of the waterworks in a manner that will assure a high degree of capability and reliability to comply with Part II of this chapter.” System risks exceeding turbidity standards described in 40 CFR §141.173(a)(1).	The permanganate system was repaired by WTP Maintenance and is working as designed.	<p>VDH-ODW will follow-up in summer 2025</p> <p>Permanganate not being fed at the time of inspection due to seasonality of feed (not fed in winter). The WTP still does not have the ability to check permanganate residuals.</p> <p>To measure permanganate residuals, the WTP can use free chlorine DPD methods and 0.45-micron filters. This assumes no chlorine introduced to the raw water at the point of sample collection.</p> <p>1. Filter raw water</p>	Figure 8

Figure 8. Potassium permanganate feed (Top left- EPA, Top right- COR, Bottom- VDH (not used in winter))

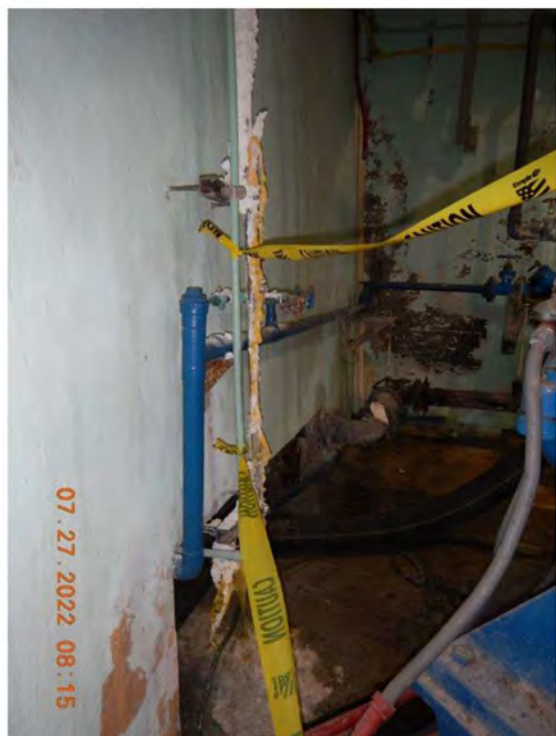
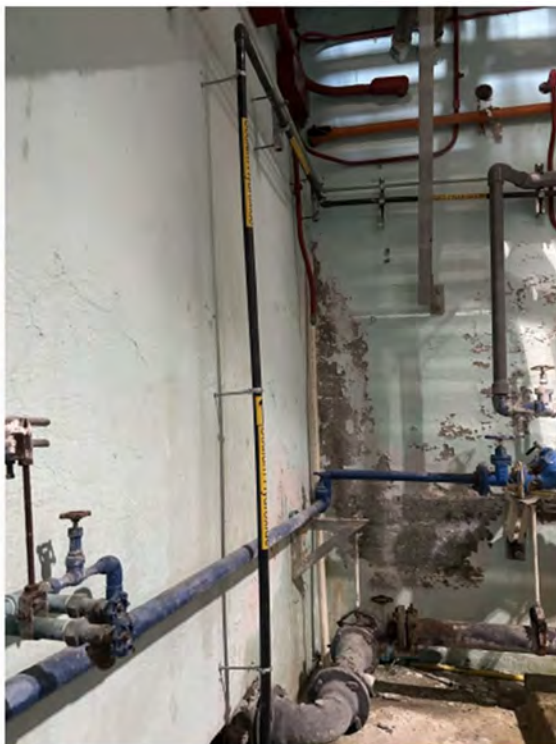
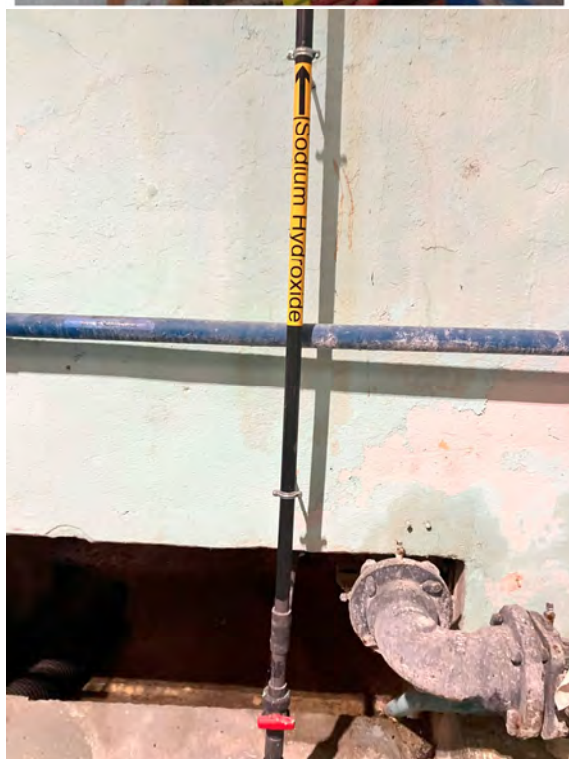
Figure 9. Caustic leak in Korah 1 Pump Station (Top left- EPA, Top right-COR, Bottom- VDH)

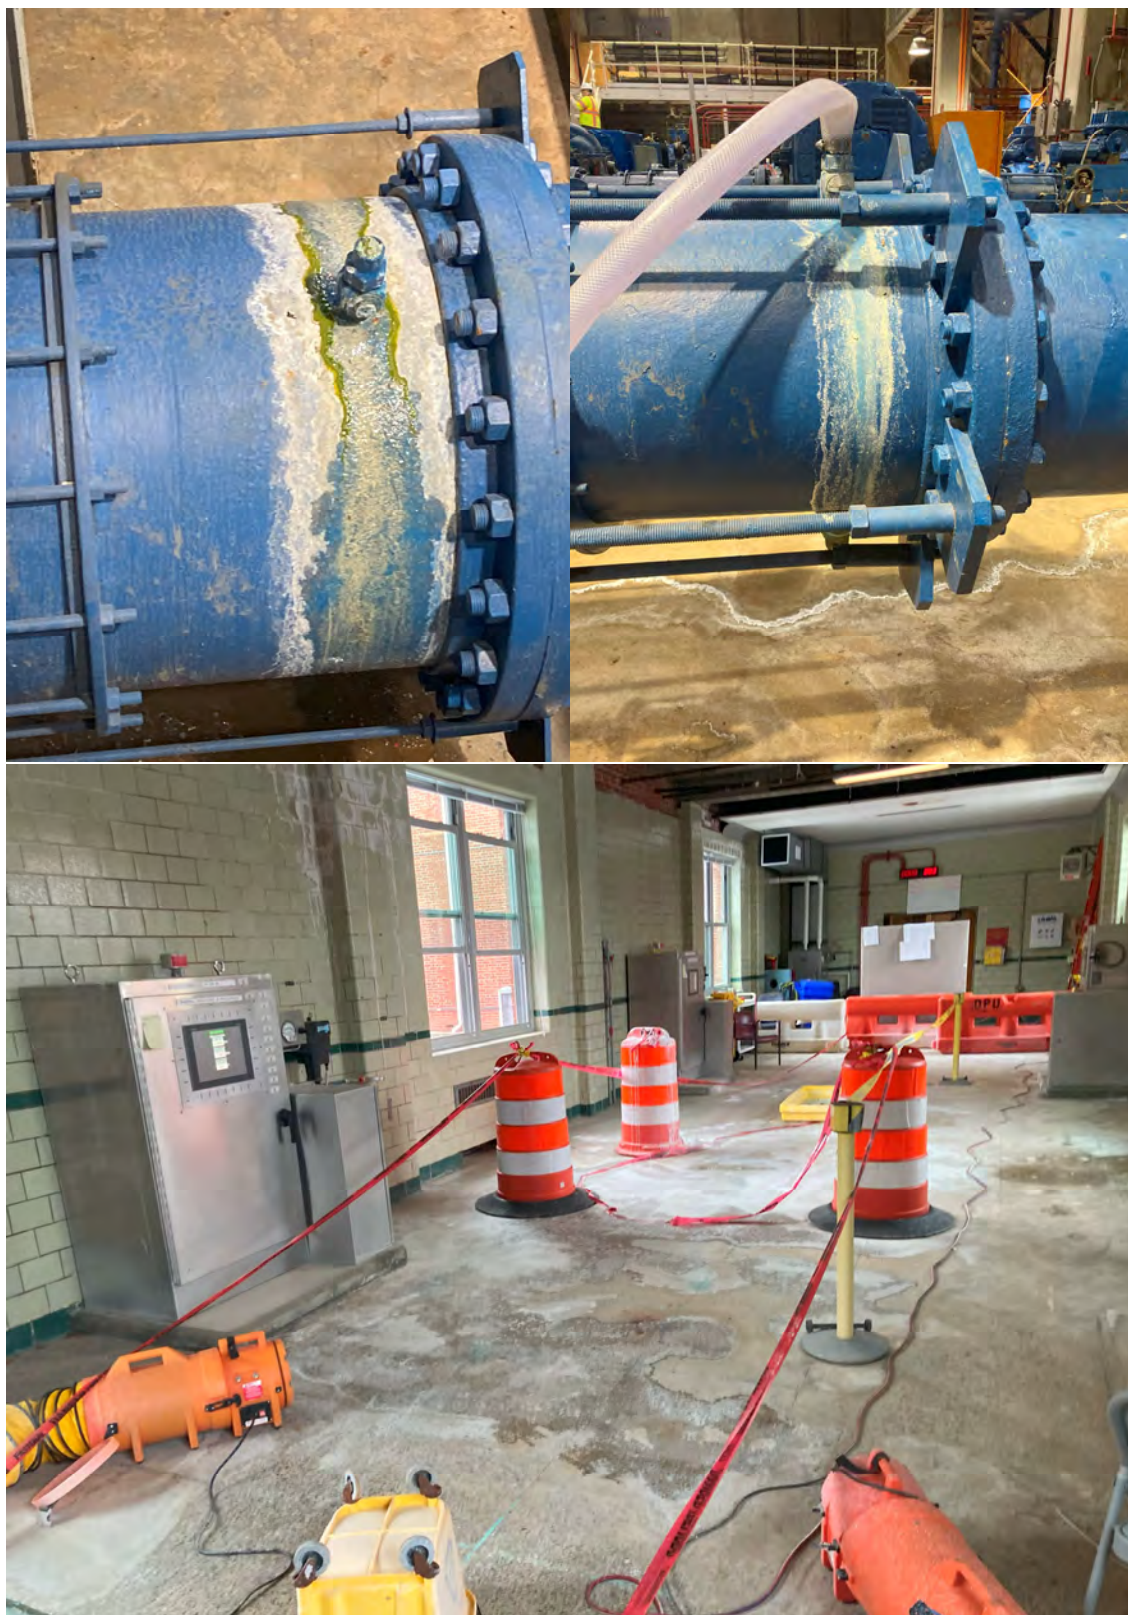
Figure 10. Chemical leaks observed (VDH)

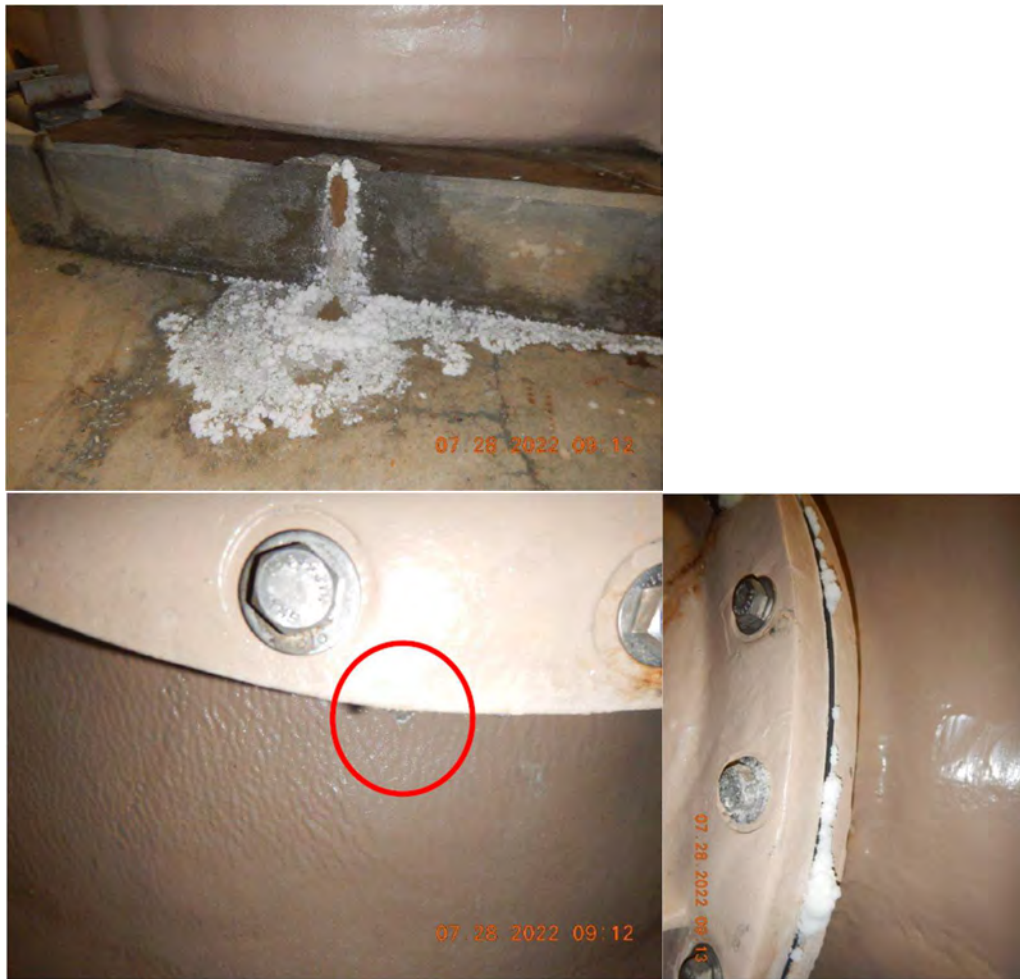
VDH-ODW's follow-up observed some progress in addressing several areas of concern EPA identified, and long-term projects were either in planning or in process. COR did not appear to implement any significant changes to processes, procedures, and work culture at the time of the VDH-ODW visits. Most of the items addressed were immediate fixes, but more long-term areas of concern remain. Some of COR's immediate fixes discussed in their response did not appear to address the cause of the issues identified by EPA or put in place routine checks on the issues. VDH-ODW observed the issues again, including controlling free ammonia concentrations, various chemical leaks, leaking valves, and standing water (Example-Figure 11, Figure 12, Figure 13).

Figure 11. Leaks observed in sodium hypochlorite tanks (EPA)

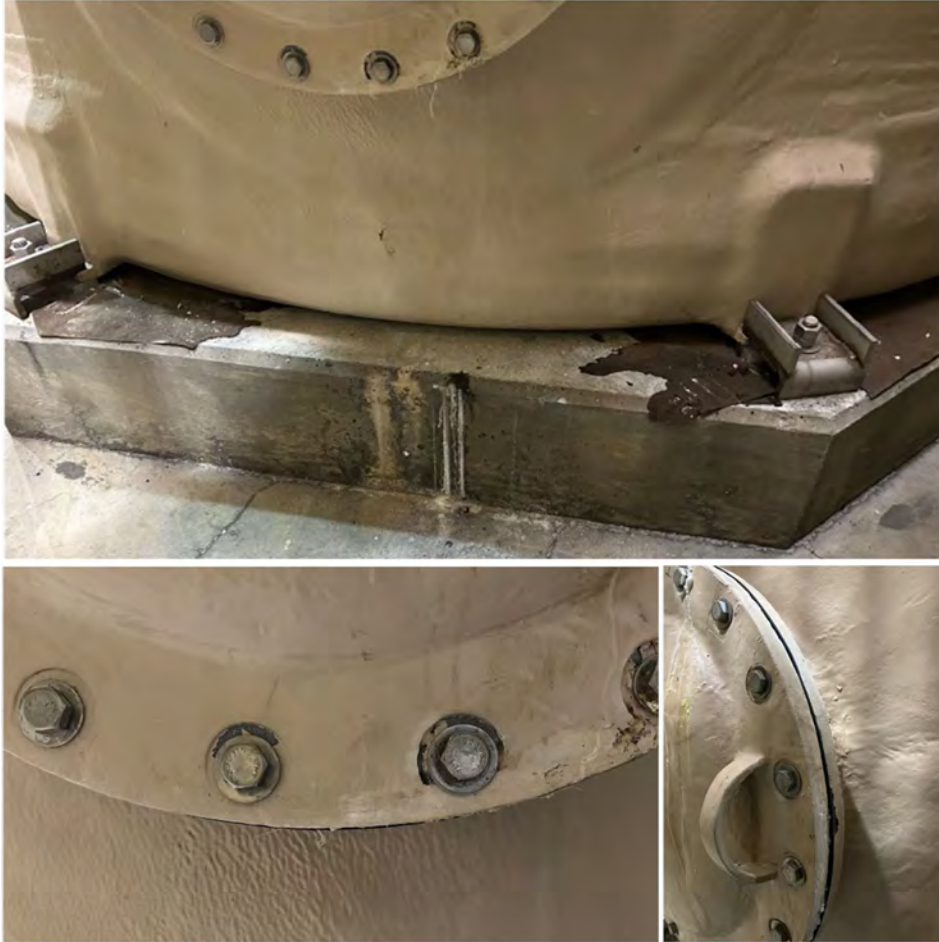
*Figure 12. Leaks in sodium hypochlorite tanks (COR)*

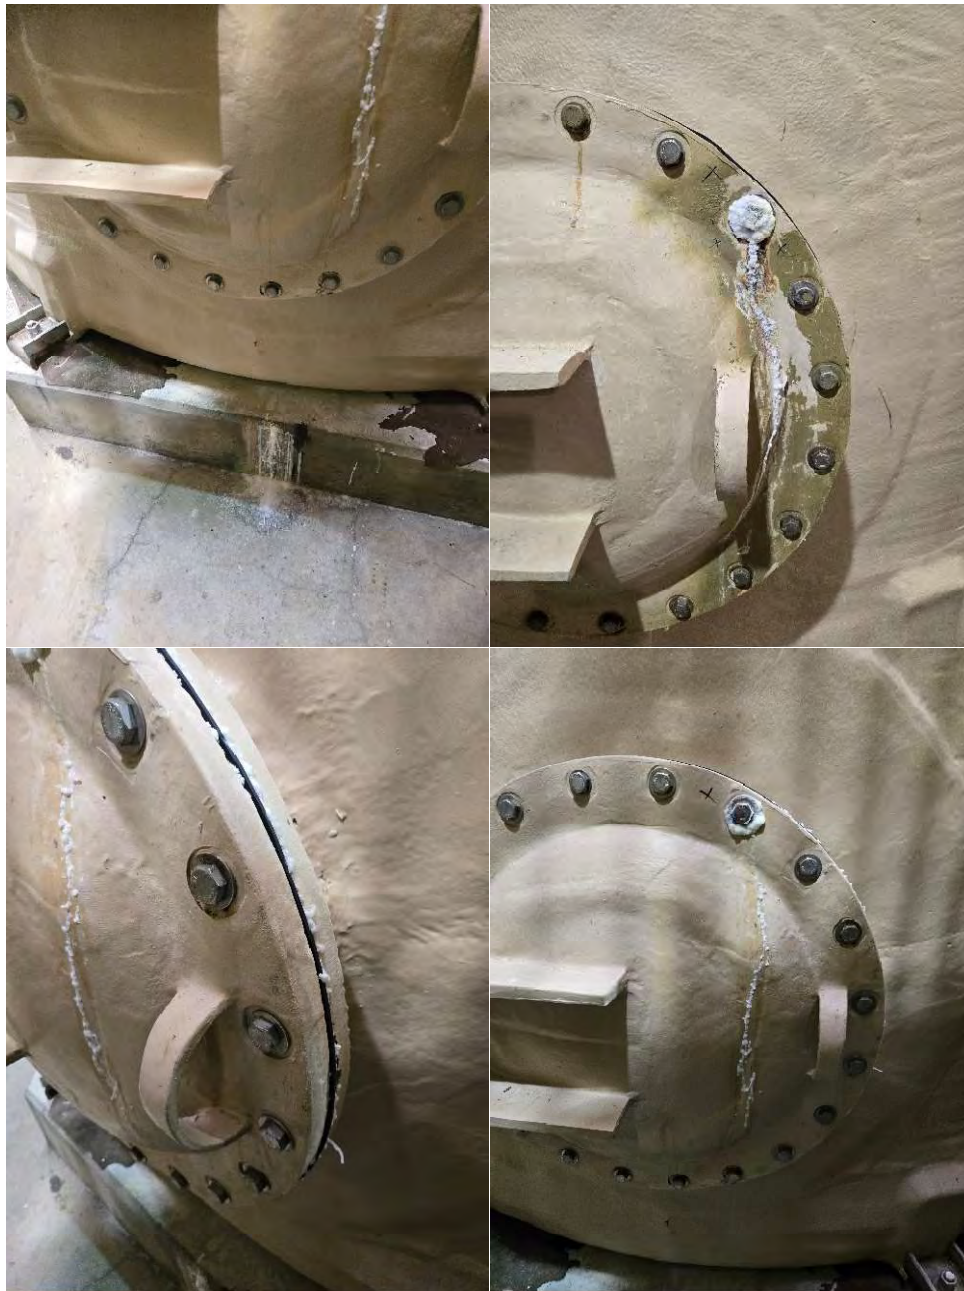
*Figure 13. Leaks observed in sodium hypochlorite tanks (VDH)*

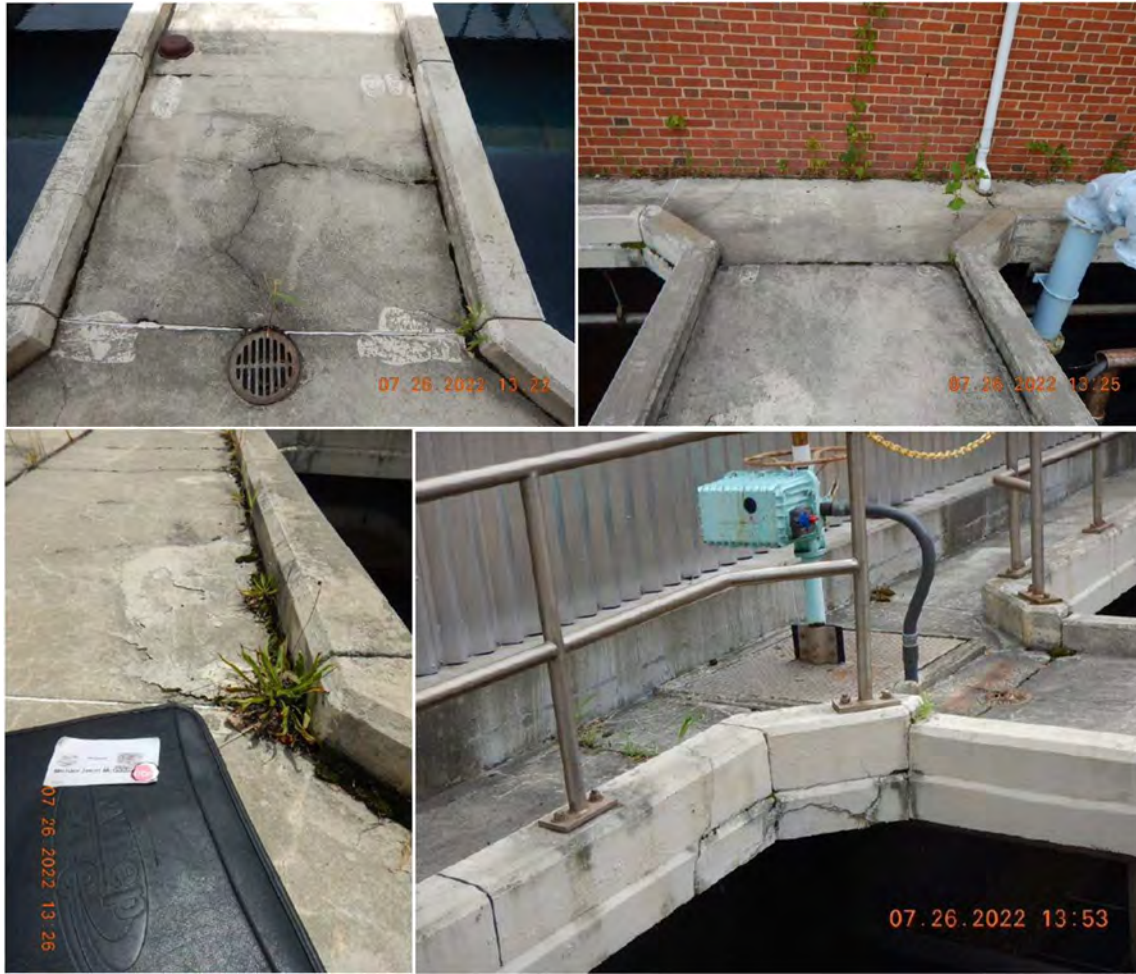
Figure 14. Filter 2 concrete (EPA)

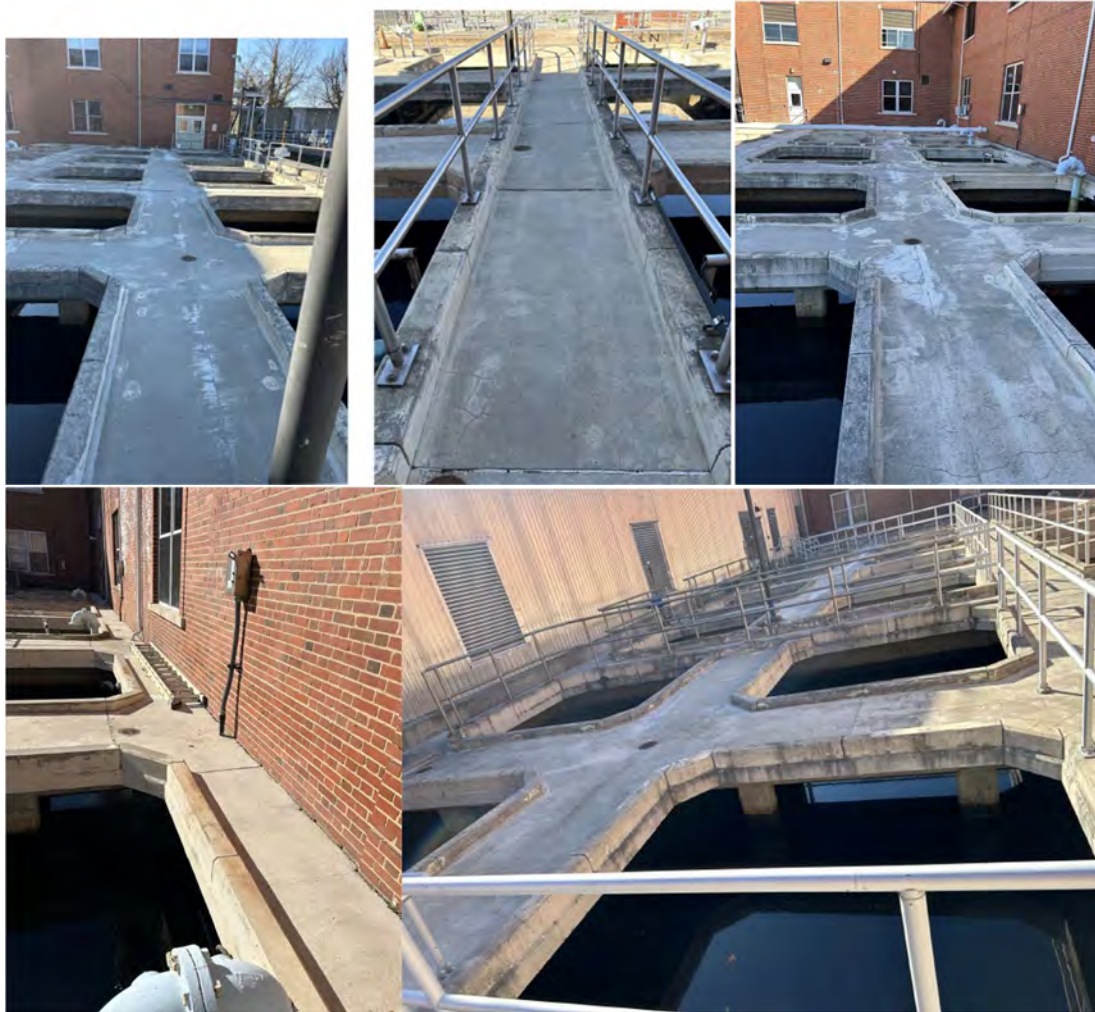
Figure 15. Plant 2 concrete (COR)

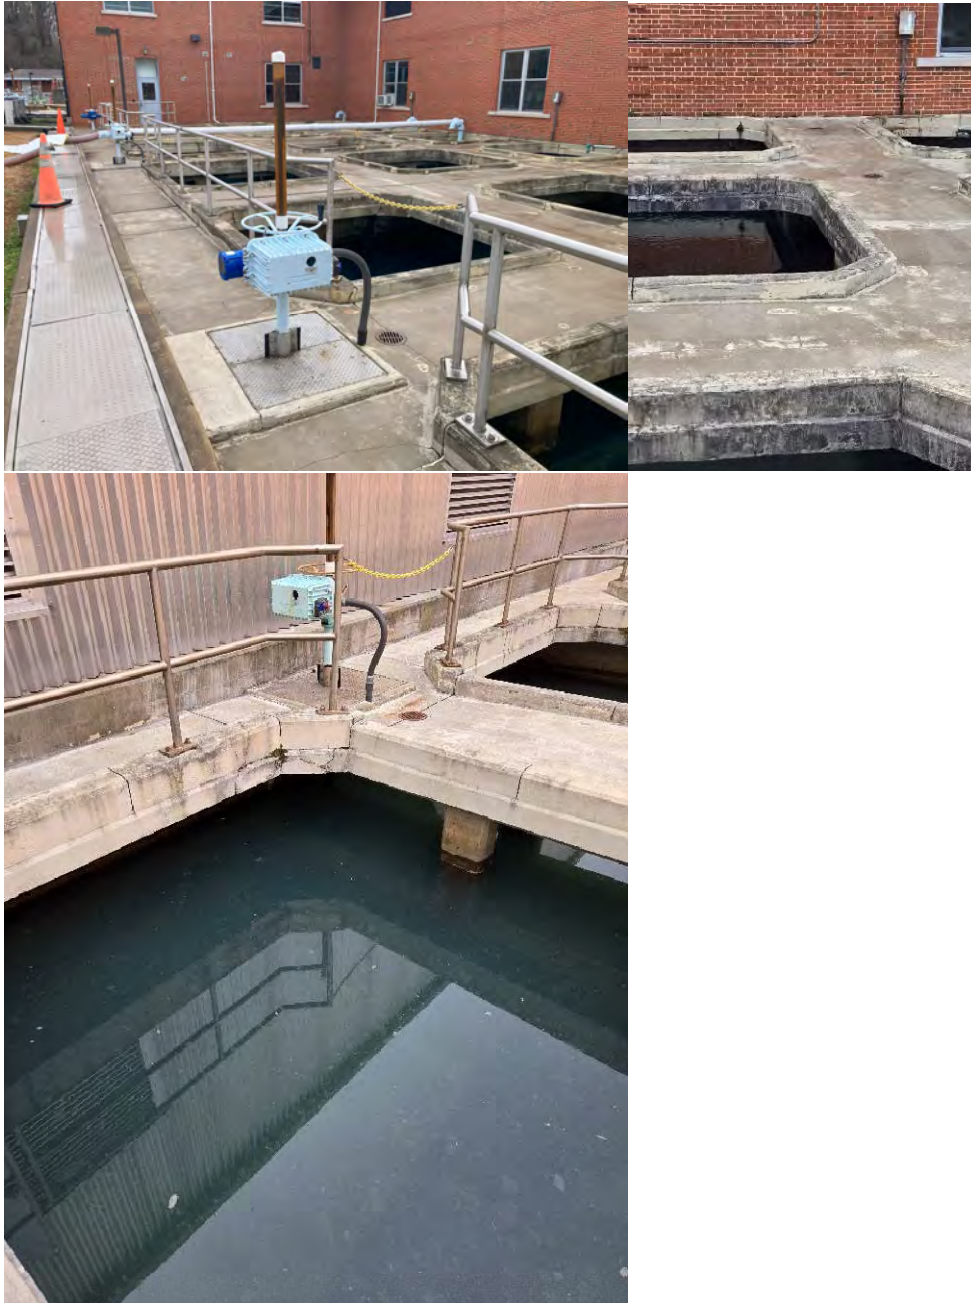
Figure 16. Plant 2 filters concrete (VDH)

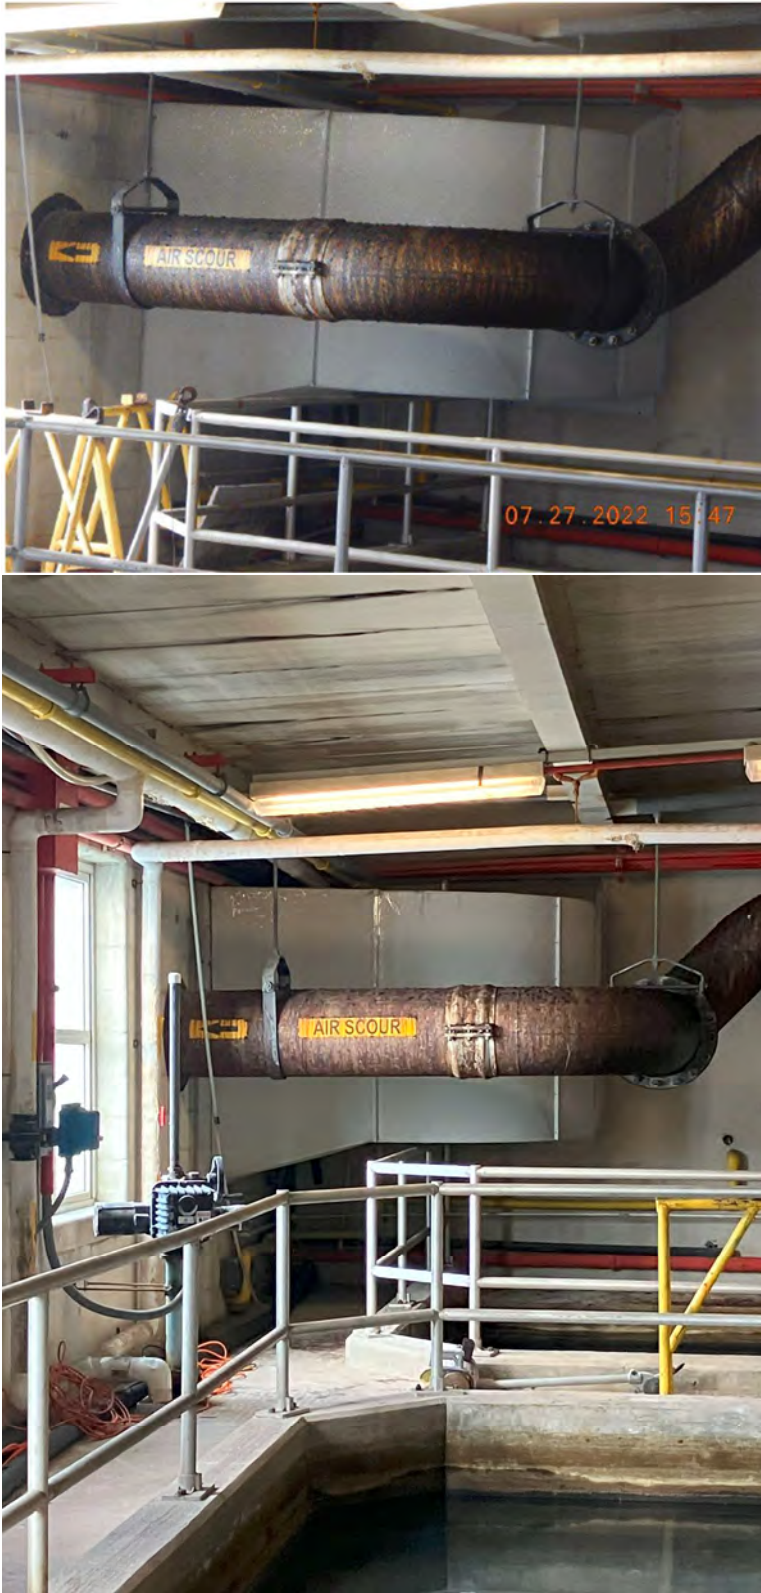
Obs. #	Category	Area of Concern	Supporting Observation	Relevant Citation	Richmond DPU Response 2025	VDH-ODW Observation 2025	Photograph (Appendix A)
				risks exceeding turbidity standards described in 40 CFR §141.173(a)(1).			
<b>AOC-18</b>	Plant 1 Filters	The air scour pipes above the filters were significantly corroded on the exterior. Failure of the air scour process could impair the filter performance.	The filter beds are contained in an enclosed structure subject to the humidity and chlorine from the filter bed water; the exposed unpainted air scour piping had severe rust and corrosion damage.		The overall solution is being evaluated through a larger CIP project, which has been highlighted above in observation #17.	No change.  Air scour pipes still showing significant signs of corrosion. As VDH-ODW observed a backwash inside the enclosed structure, chlorine levels in the air were noticeable along with a humid environment. Stainless steel may need to be replaced with another material in the future.	Figure 19

Figure 19. Plant 1 air scour piping (Top- EPA, Bottom-VDH)

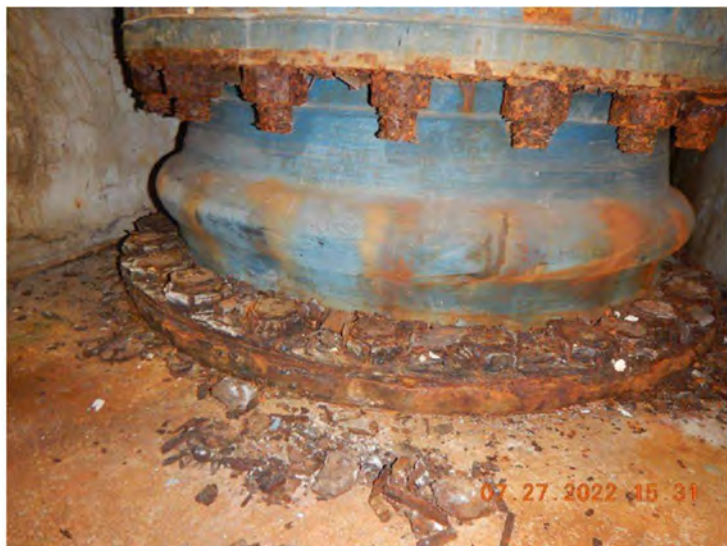
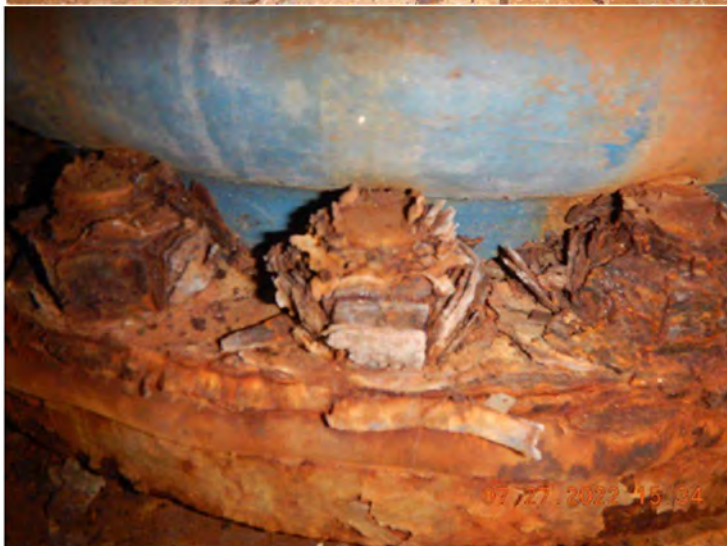
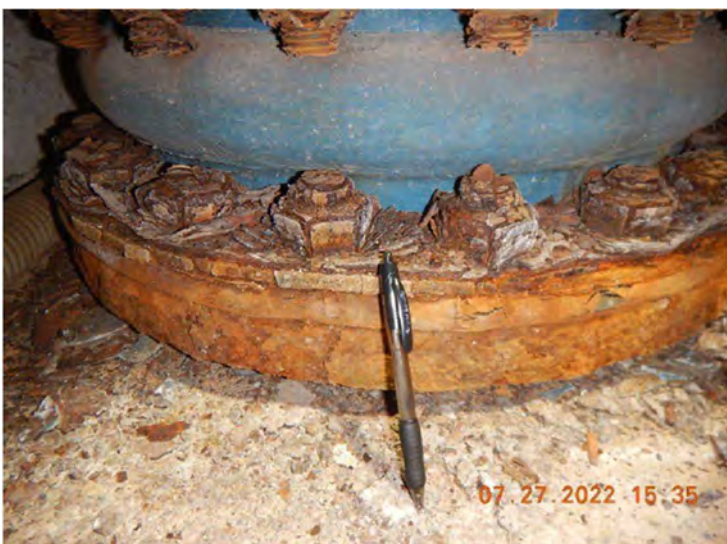
Obs. #	Category	Area of Concern	Supporting Observation	Relevant Citation	Richmond DPU Response 2025	VDH-ODW Observation 2025	Photograph (Appendix A)
						and MOR data completion software to ensure they are able to report above 2.0 NTU turbidities.	
<b>AOC-22</b>	Clearwell Pumps	Pumps are corroded and deteriorated at the base, risking a loss of capacity due to deteriorated structures	EPA observed significant corrosion at the base of Pumps 1, 2, and 3 that move water from the clearwell to the finished water basin.	12VAC5-590-360.A states, "The owner shall provide and maintain conditions throughout the entirety of the waterworks in a manner that will assure a high degree of capability and reliability to comply with Part II of this chapter. This requirement shall pertain to the source water, transmission, treatment, storage, and distribution system facilities and the operation thereof. The owner shall identify and evaluate factors with the potential for impairing the quality of the water	The City acknowledges this observation and is addressing this through an O&M project. Pump N-2 refurbishment is nearing completion (see pics 115 and 116). Pumps N-1 and N-3 refurbishment will follow accordingly.	Partially addressed. Corrosion still observed at time of site visit on several pumps in the pipe gallery area. Some pumps appear to have relatively new bolts attached to still corroded bracketing and/or base pedestals. New bolts appear to be uncoated, may accelerate rusting.	Figure 21 Figure 22 Figure 23

Figure 21. Corrosion at filtered water pumps (EPA)
