**Subject:** Environmental Protection Agency (EPA) Safe Drinking Water Act Compliance  
Inspection Report.

**Follow-Up Site Visit Conducted by Virginia Department of Health-Office of  
Drinking Water's (VDH-ODW) Richmond Field Office**

**Author:** James Reynolds, PE- Field Director Richmond Field Office

The City of Richmond (COR) owns and operates a public waterworks (PWSID 4760100). The system is served by a Class 1 surface water treatment plant with a permitted capacity of 132 million gallons per day (MGD).

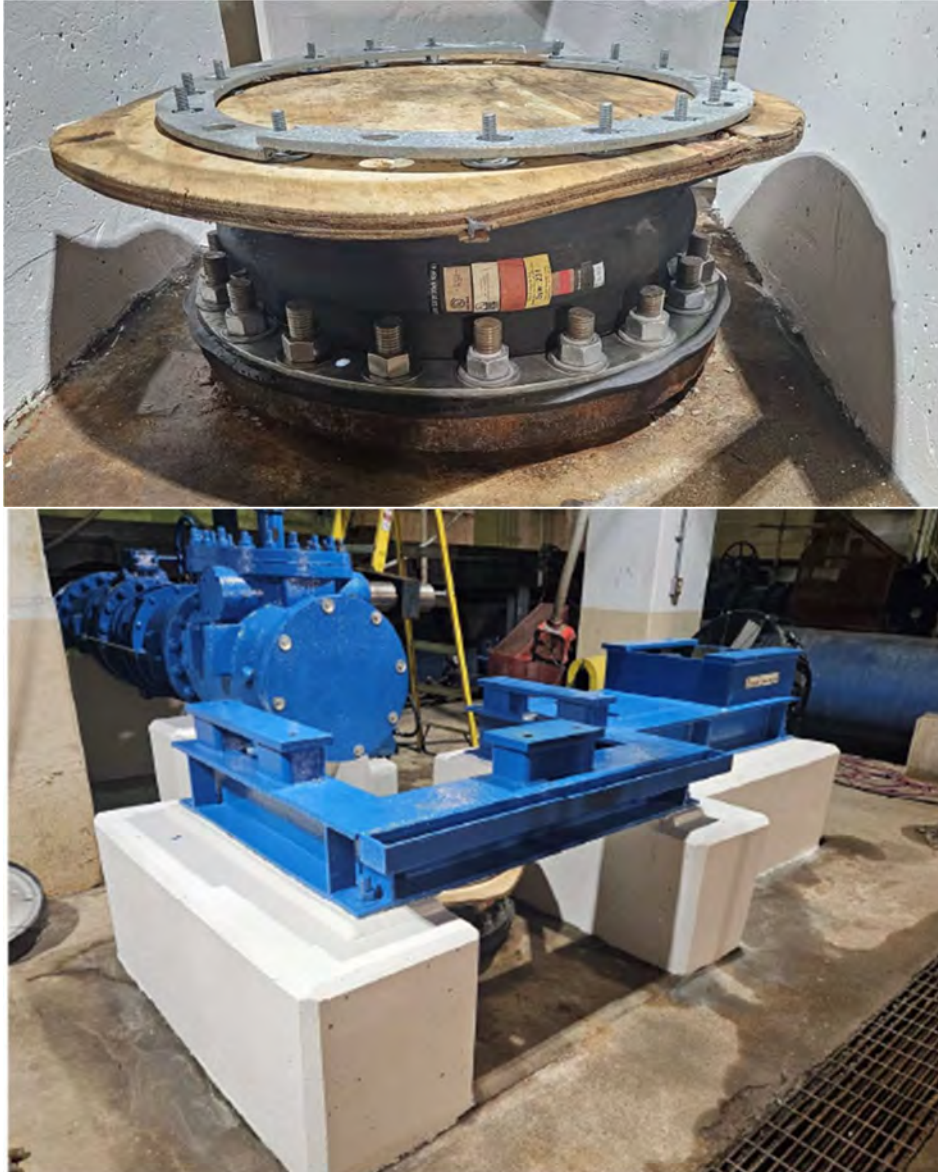
Obs. #	Category	Area of Concern	Supporting Observation	Relevant Citation	Richmond DPU Response 2025	VDH-ODW Observation 2025	Photograph (Appendix A)
						and MOR data completion software to ensure they are able to report above 2.0 NTU turbidities.	
<b>AOC-22</b>	Clearwell Pumps	Pumps are corroded and deteriorated at the base, risking a loss of capacity due to deteriorated structures	EPA observed significant corrosion at the base of Pumps 1, 2, and 3 that move water from the clearwell to the finished water basin.	12VAC5-590-360.A states, "The owner shall provide and maintain conditions throughout the entirety of the waterworks in a manner that will assure a high degree of capability and reliability to comply with Part II of this chapter. This requirement shall pertain to the source water, transmission, treatment, storage, and distribution system facilities and the operation thereof. The owner shall identify and evaluate factors with the potential for impairing the quality of the water	The City acknowledges this observation and is addressing this through an O&M project. Pump N-2 refurbishment is nearing completion (see pics 115 and 116). Pumps N-1 and N-3 refurbishment will follow accordingly.	Partially addressed. Corrosion still observed at time of site visit on several pumps in the pipe gallery area. Some pumps appear to have relatively new bolts attached to still corroded bracketing and/or base pedestals. New bolts appear to be uncoated, may accelerate rusting.	Figure 21 Figure 22 Figure 23

Figure 22. Filtered water pumps upgrades (COR)

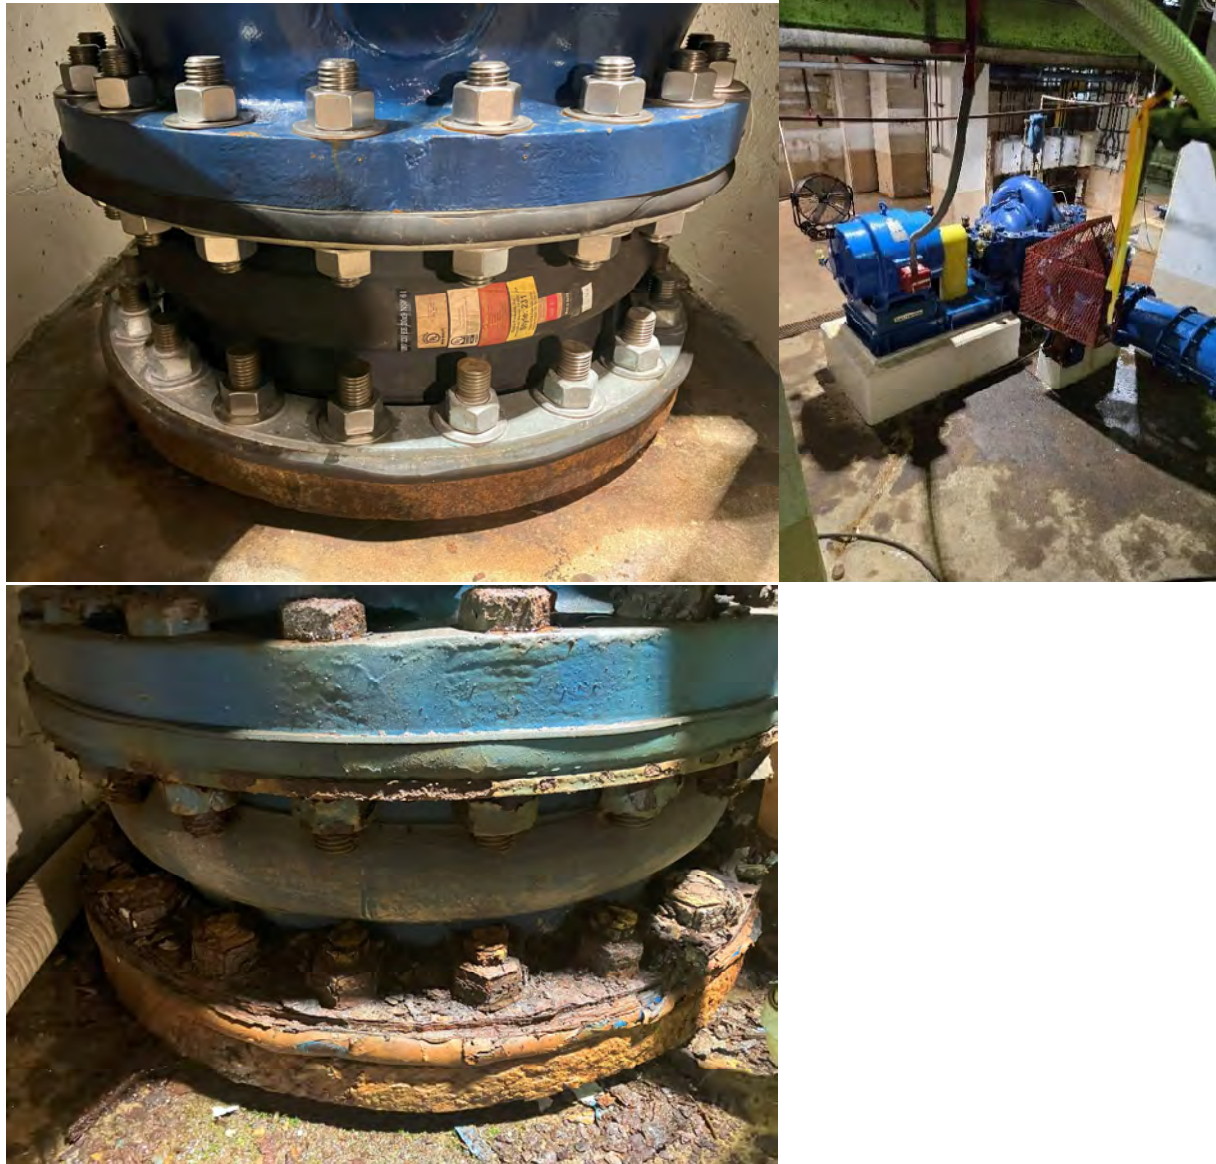
*Figure 23. Filtered water pumps mix of upgrades and old corrosion observed (VDH)*

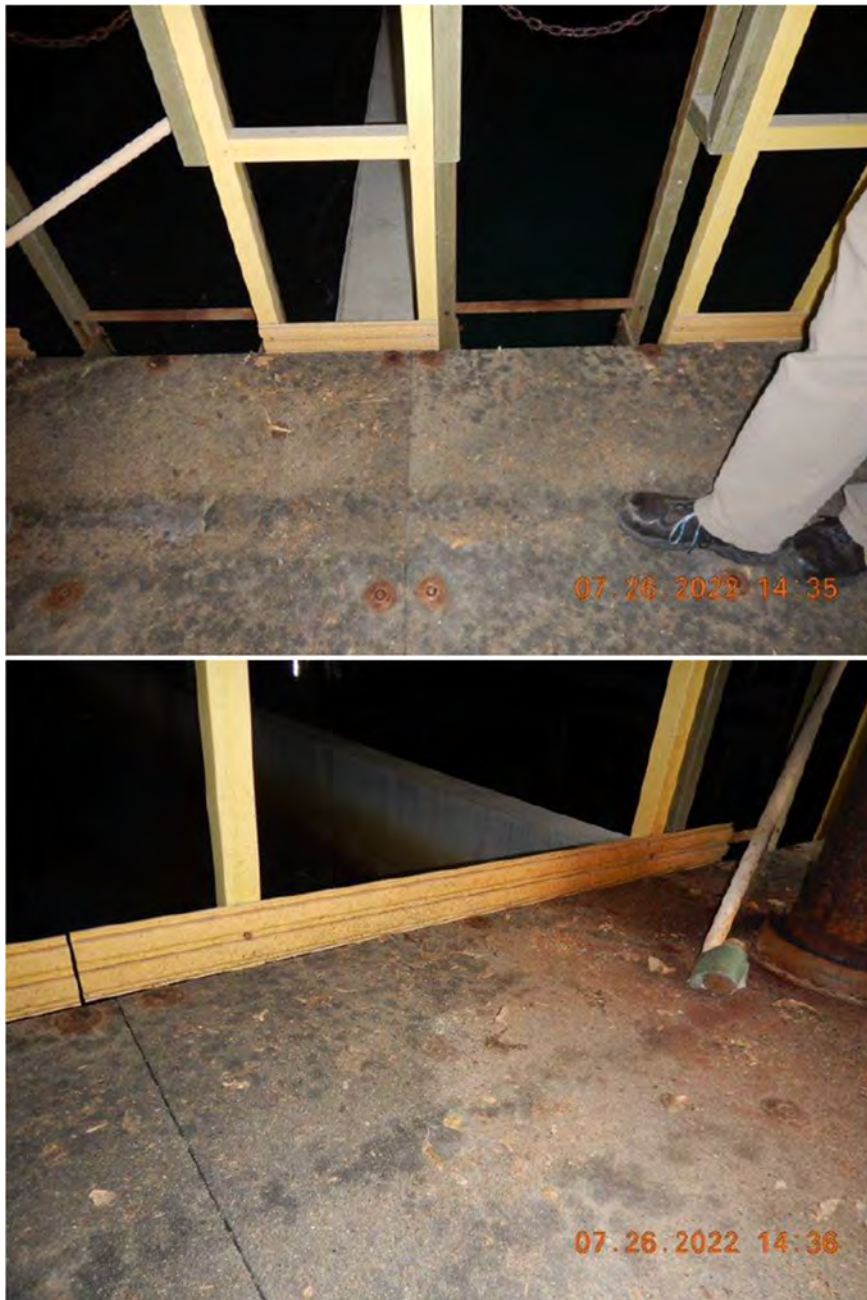
Figure 24. Finish water basins (aeration basins) (EPA)

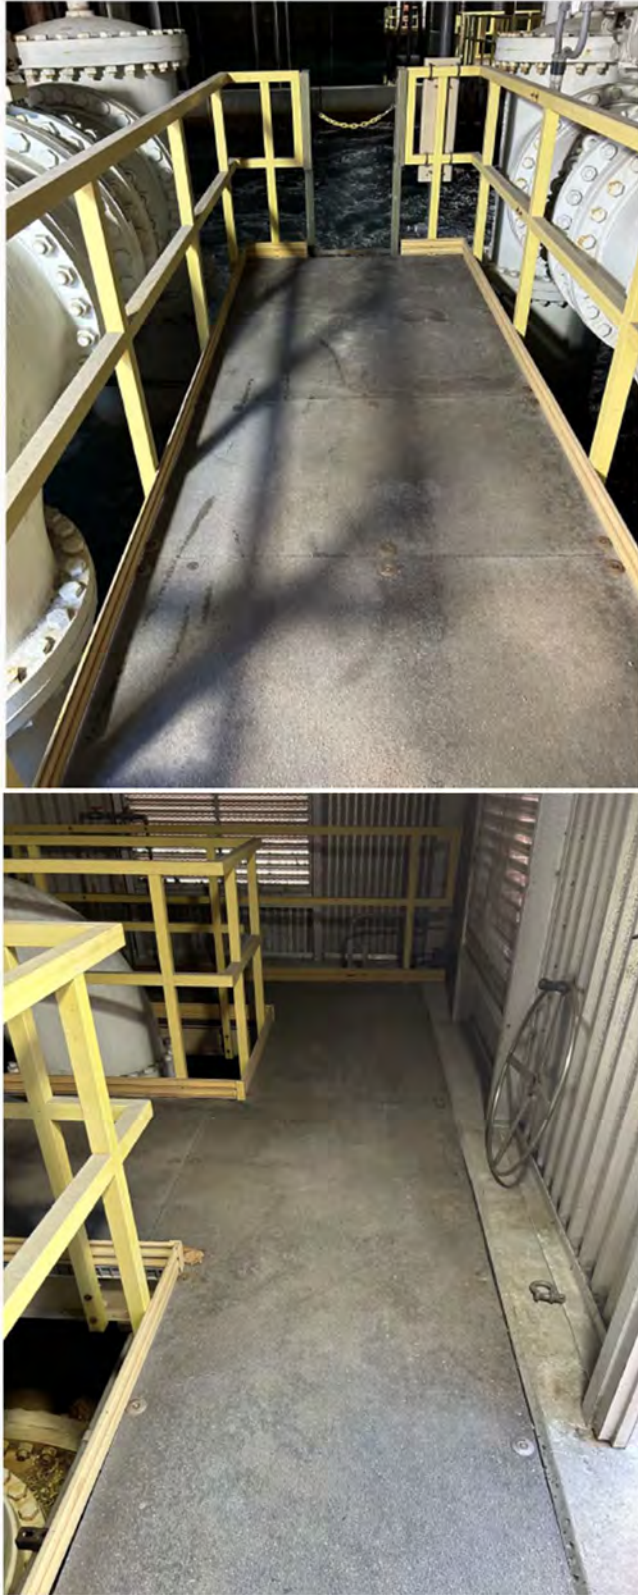
Figure 25. Finished water basins (aeration basins) (COR)

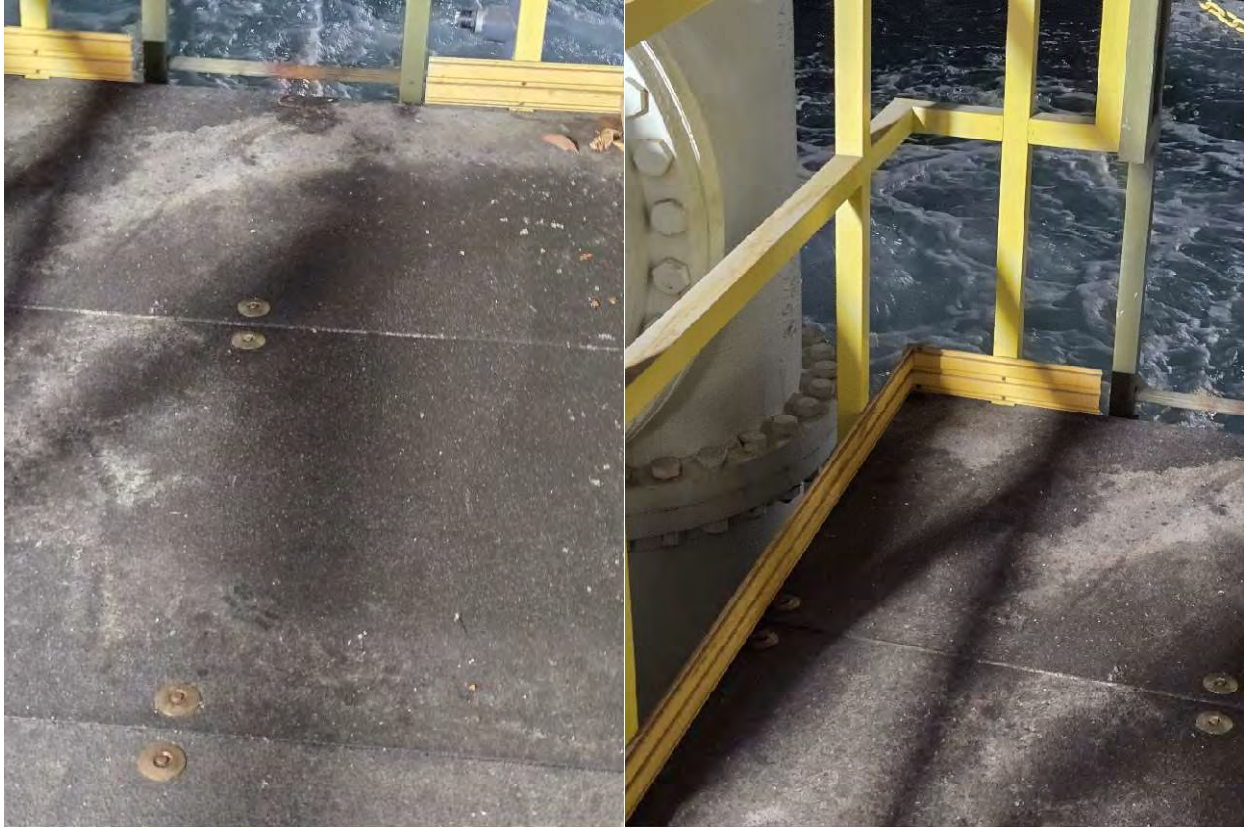
*Figure 26. Finished water basins (aeration basins) (VDH)*

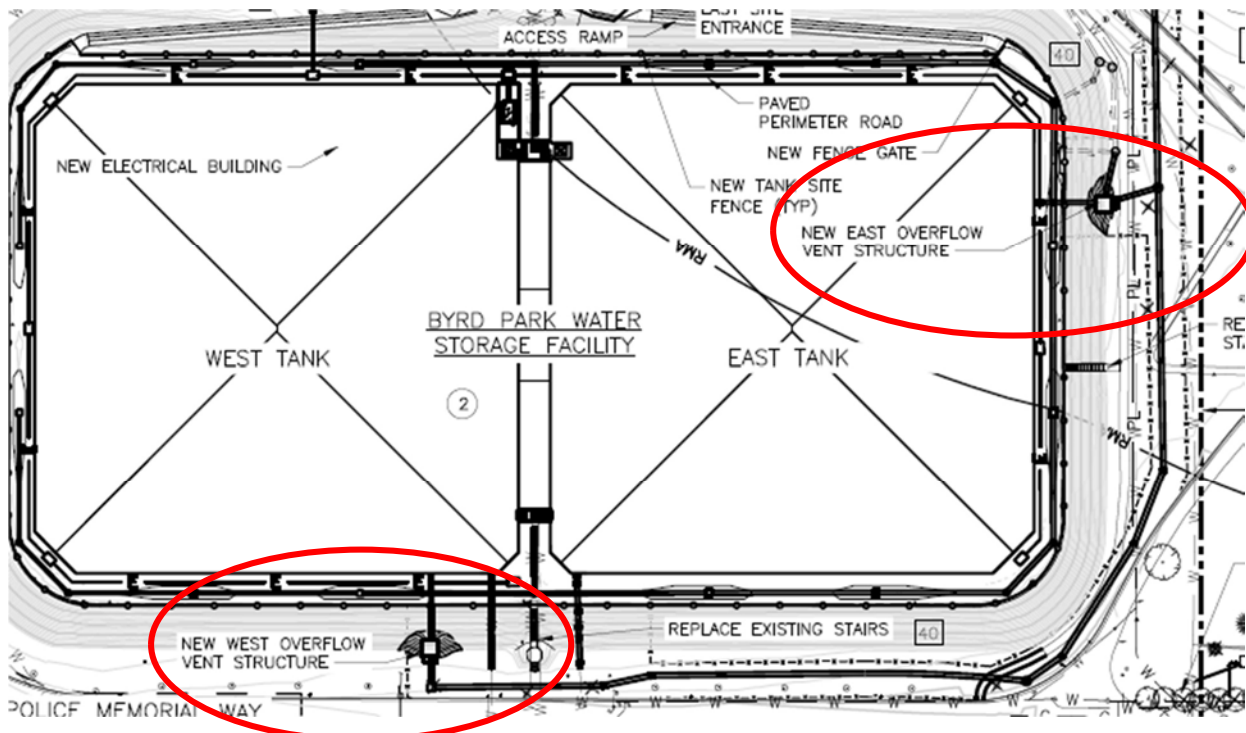
Figure 29. Byrd Park Reservoir roof replacement plans showing overflow

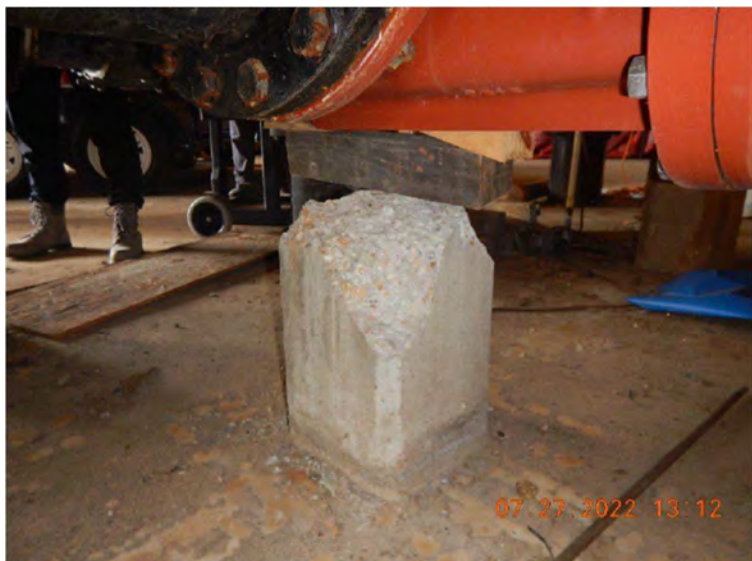
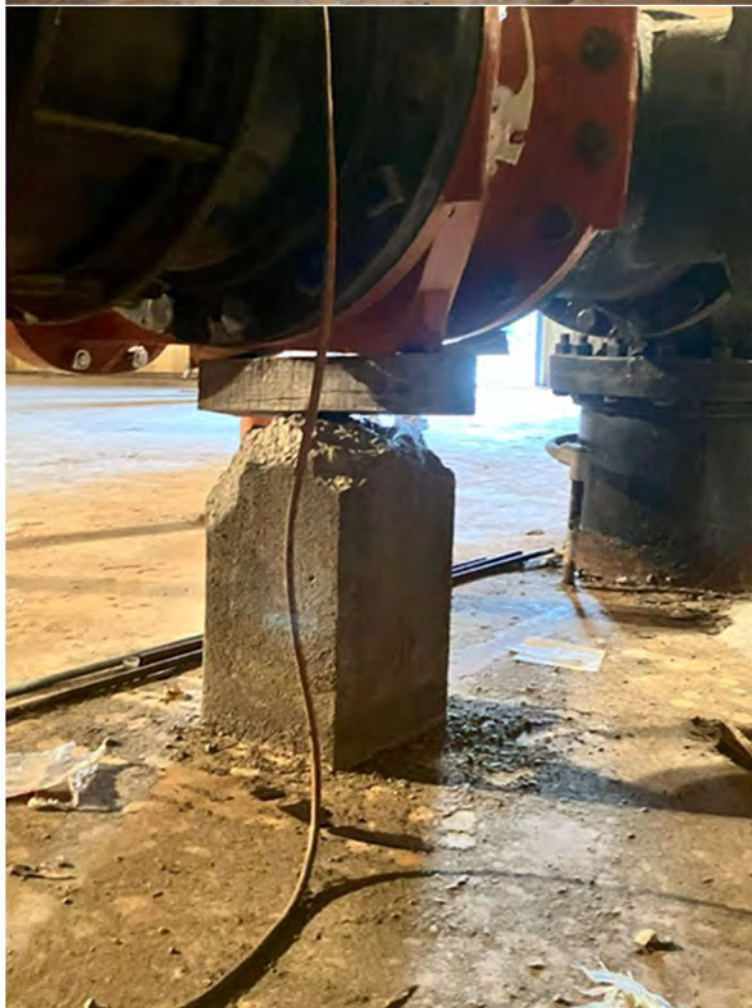
<b>AOC-27</b>	Warwick Road Tank	Lack of structural support to gate valve on the primary tank transmission main as designed to prevent failure.	Inside the tower at ground level, a 16" gate valve was installed on the tank transmission main connection above grade. EPA observed several pieces of wood stacked to create an insignificant	12VAC5-590-360.A states, in part, "The owner shall provide and maintain conditions throughout the entirety of the waterworks in a manner that will assure a high degree of capability and	The City acknowledges this observation and will determine a path forward using the framework of the June 2023 organizational changes. The Water Distribution team intends to investigate and strategize immediately following the holidays.	No change.  Wood blocks continue to be used as support.	Figure 30

Figure 30. Warwick Road Tank gate valve (Left-EPA, Right- VDH)

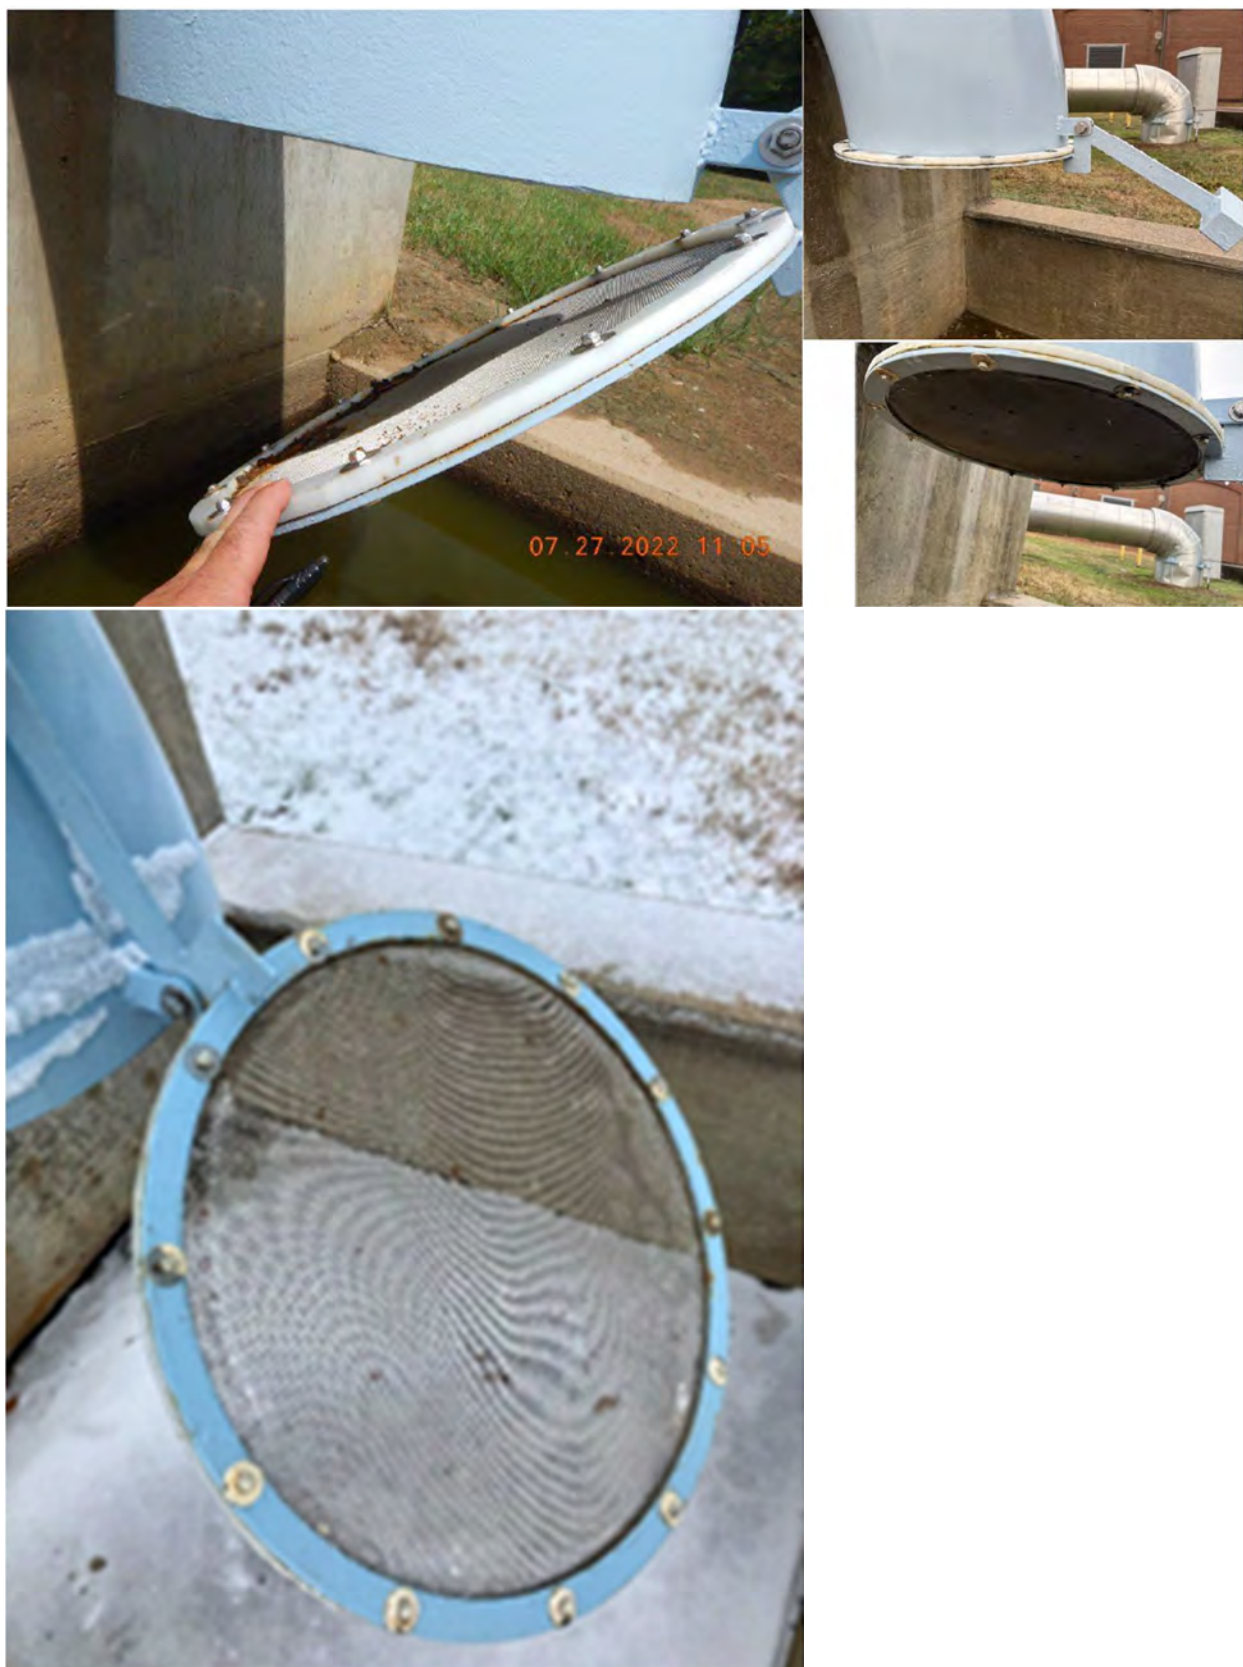
Figure 31. Cofer Road overflow screen (Top left-EPA, Top right-COR, Bottom-VDH, Fine Mesh (also has air gap of ~3 feet))

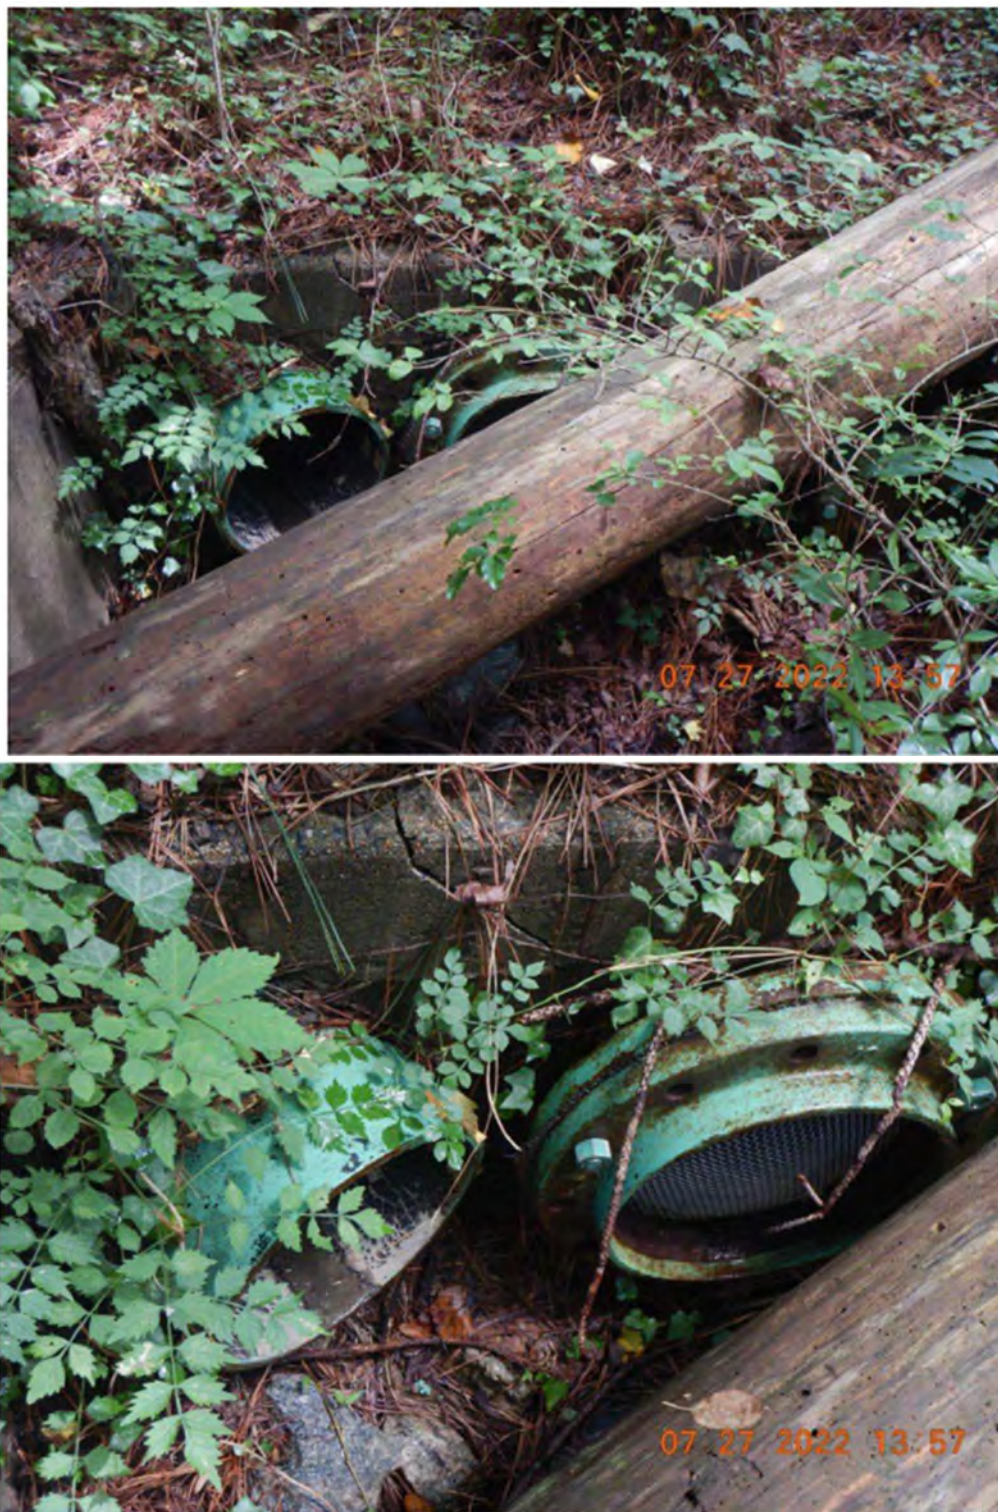
Obs. #	Category	Area of Concern	Supporting Observation	Relevant Citation	Richmond DPU Response 2025	VDH-ODW Observation 2025	Photograph (Appendix A)
			was large enough to allow pests into the finished water storage.	to prevent vandalism and entrance by animals or unauthorized persons.” “Recommended Standards for Water Works” (2018 Edition) Part 7.0.7.b. states that “[t]he overflow shall open downward and be screened with twenty-four mesh non-corrodible screen...”			
<b>AOC-30</b>	Huguenot Road Tank	The overflow pipe was not able to be identified, and the pipes were below grade in a low-lying area that was not screened or were blocked with debris.	EPA could not confirm the location of the overflow pipe. There were three potential overflow pipes; only one was screened properly but it was blocked with debris. The condition of the pipes and surrounding area indicate they are not inspected regularly.	12VAC5-590-1081.D describes overflow requirement for finished water storage structures. “Recommended Standards for Water Works” (2018 Edition) Part 7.0.7.b. states that “[t]he overflow shall open downward and be screened with twenty-four mesh non-corrodible screen...”	Immediate removal of the debris was completed via WO# C275217 (See photos #: 89 & 90). These photos also show that two of the pipes had screens at the time of inspection. Additionally, the Building & Grounds Team has kicked off an effort to perform grounds maintenance around the tank out to the fence line via PM ID 1215. WTP working with Water Distribution to confirm identity of all 3 pipes and replace existing pipe screens via WO# C277116 & C276953 respectively.	Addressed.  Overflow pipe clear of debris and screened.	Figure 33 Figure 34 Figure 35

Figure 33. Huguenot Road Tank overflow (EPA)

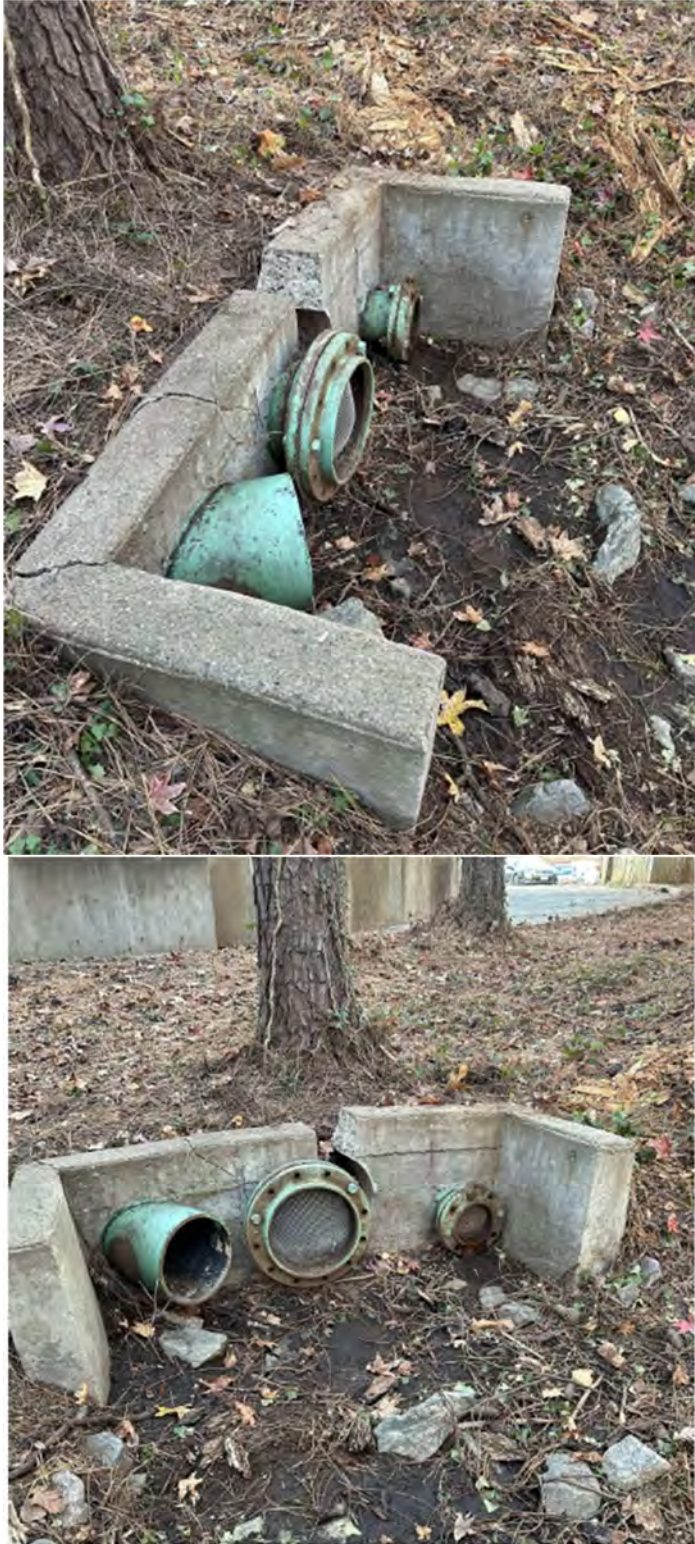
*Figure 34. Huguenot Road Tank overflow (COR)*

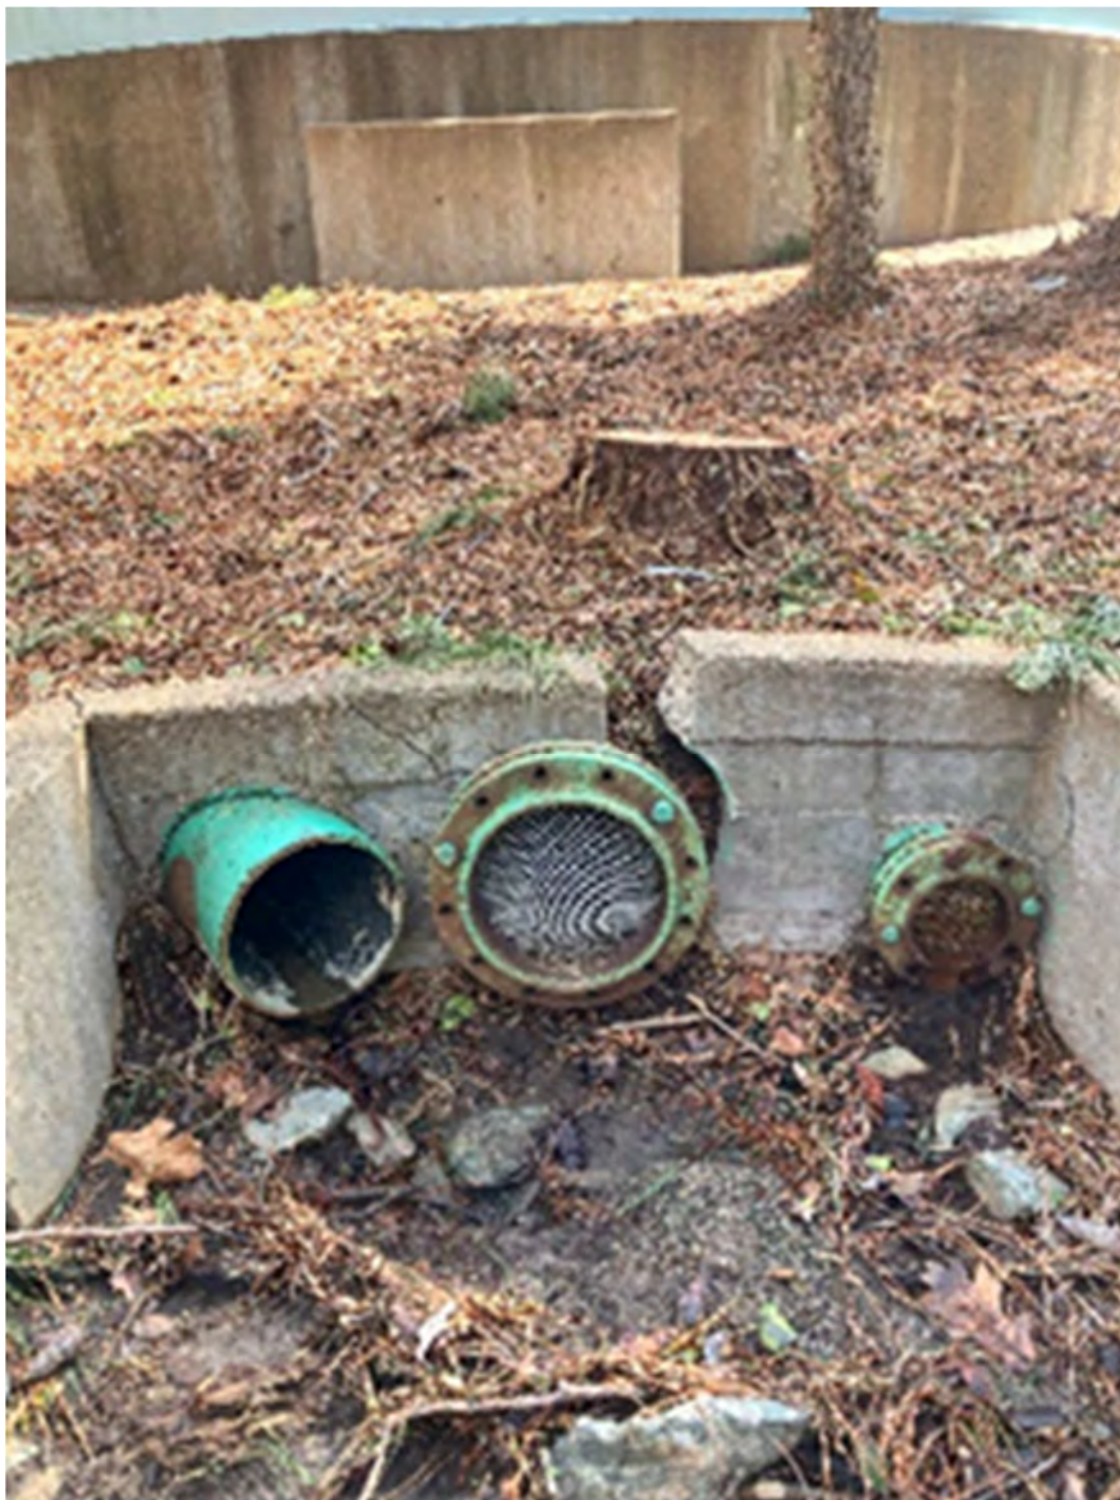
*Figure 35. Huguenot Road Tank overflow (VDH)*

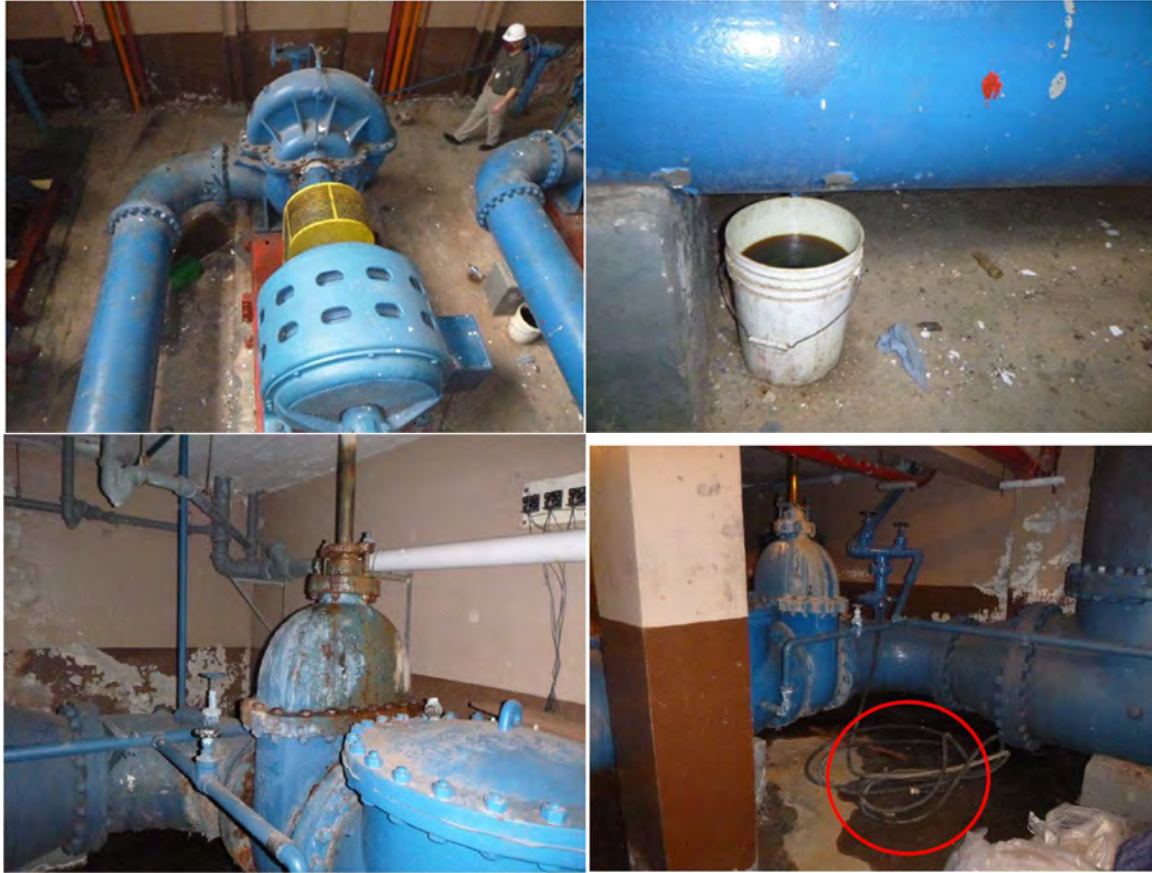
<b>AOC-32</b>	Byrd Park Main Pump Station	The pump station had debris and leaks throughout, and a hose was on the floor without a vacuum breaker presenting a high contamination risk to the finished water.	EPA observed dirt and debris across the floor from the ceiling renovation, as well as buckets of oil waste and other trash throughout the pump station. EPA also observed a hose on a threaded tap connected to a finished water line; the hose was resting in an area that was wet from other leaks in the pump station, indicating potential for contamination during pressure loss.	12VAC5-590-600 describes the cross-connection control program responsibilities for public water system owners.	Immediate repairs were made to valves (replaced glands and packing), hose was removed, vacuum breakers installed on discharge header taps / spigots and floor drain was cleared. Flow / pressure transmitter functionality was restored. 100+ year old equipment. WO #C271037 The ceiling coating will be addressed in the ongoing CIP project to significantly upgrade the pumping station. See CIP Project Name Below. Project Name; Byrd Park Main Pumping Stations Renovations (suspected end date April 2027).	Not substantially addressed.  VDH-ODW did not observe as much debris as in the EPA inspection report, but did observe areas of standing water and leaks. Significant corrosion observed on pumps. COR indicated that pumps were due to be replaced.	Figure 36 Figure 37 Figure 38

Figure 36. Byrd Park Main Pump Station debris, leaks, housekeeping, backflow prevention (EPA)

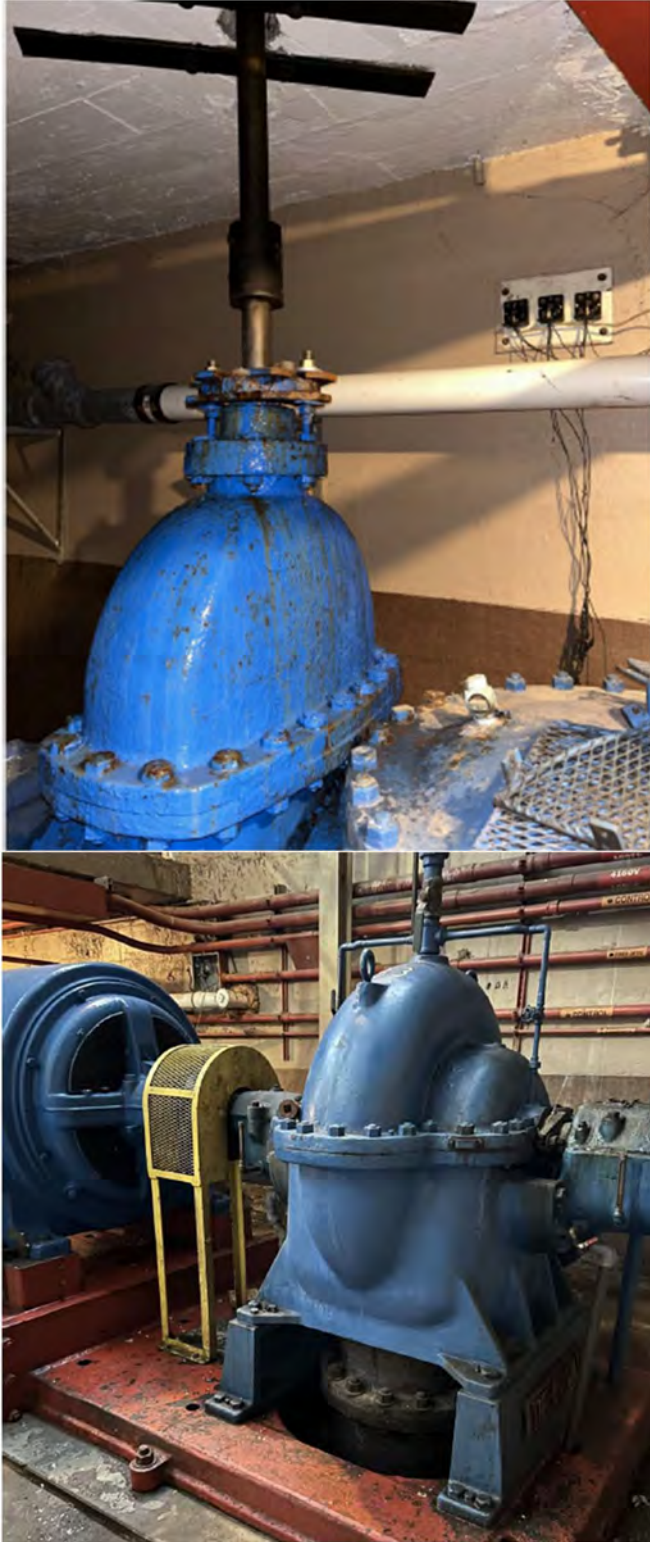
Figure 37. Byrd Park Main Pump Station (COR)

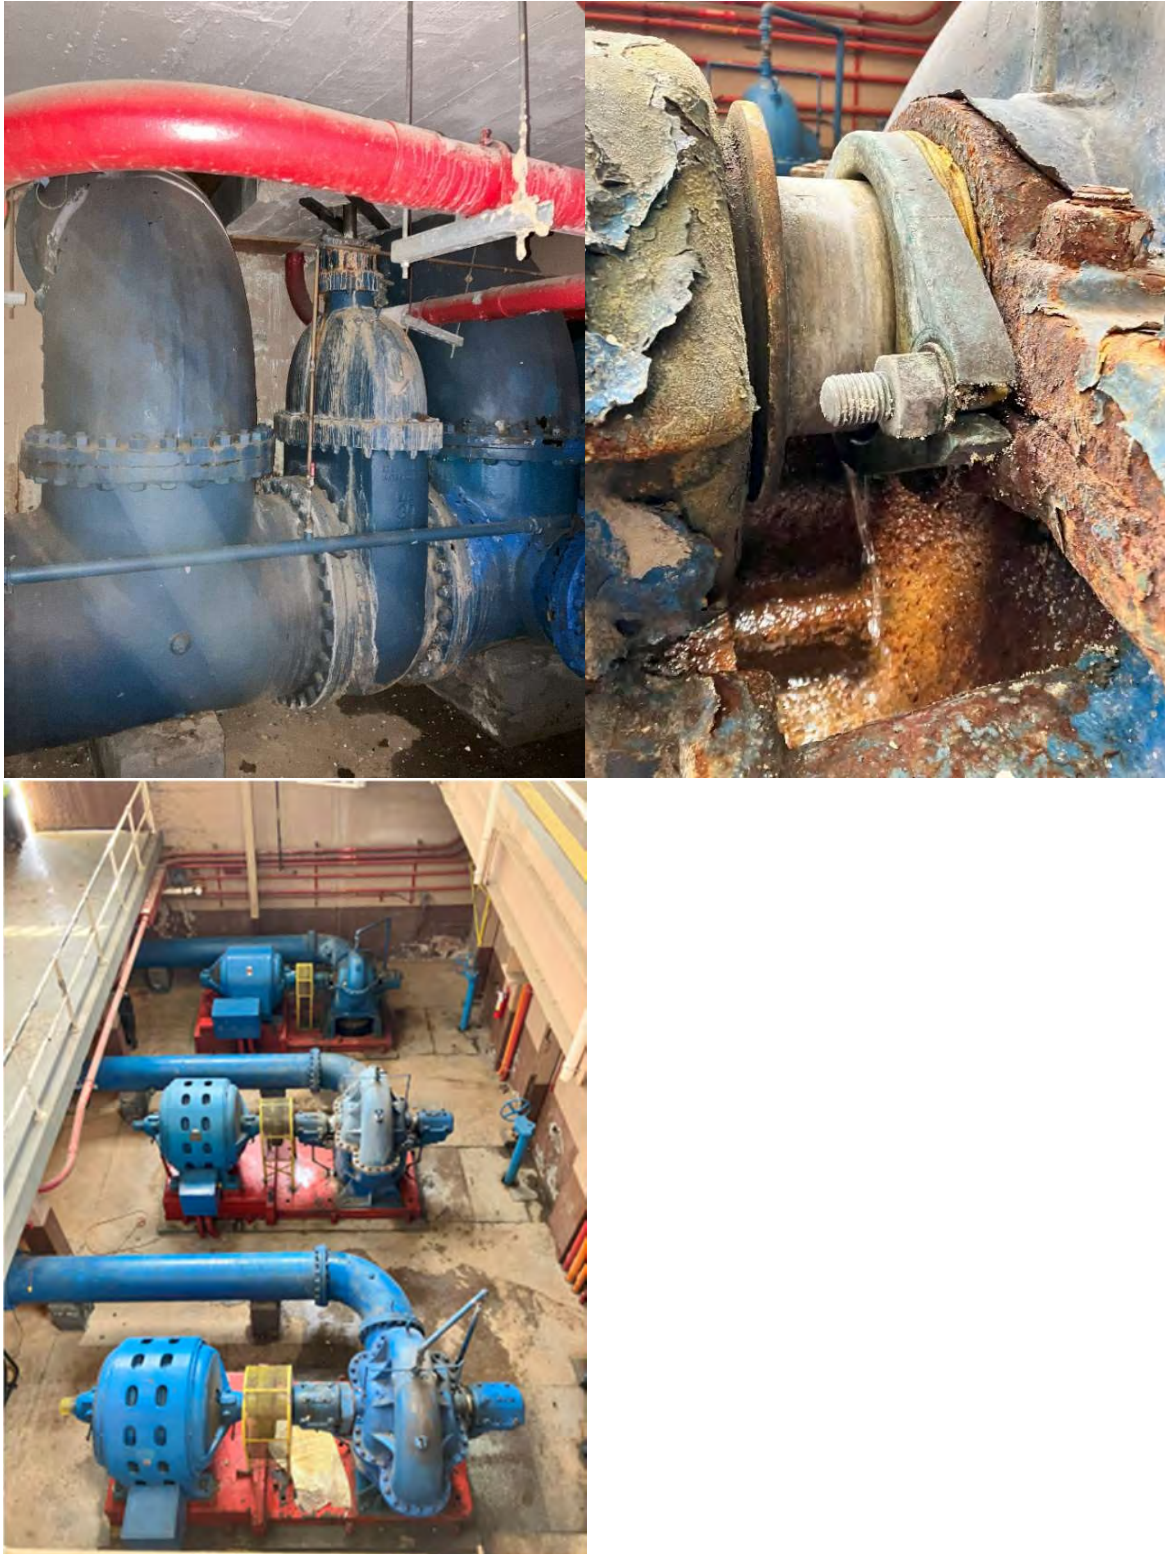
Figure 38. Byrd Park Main Pump Station (VDH)

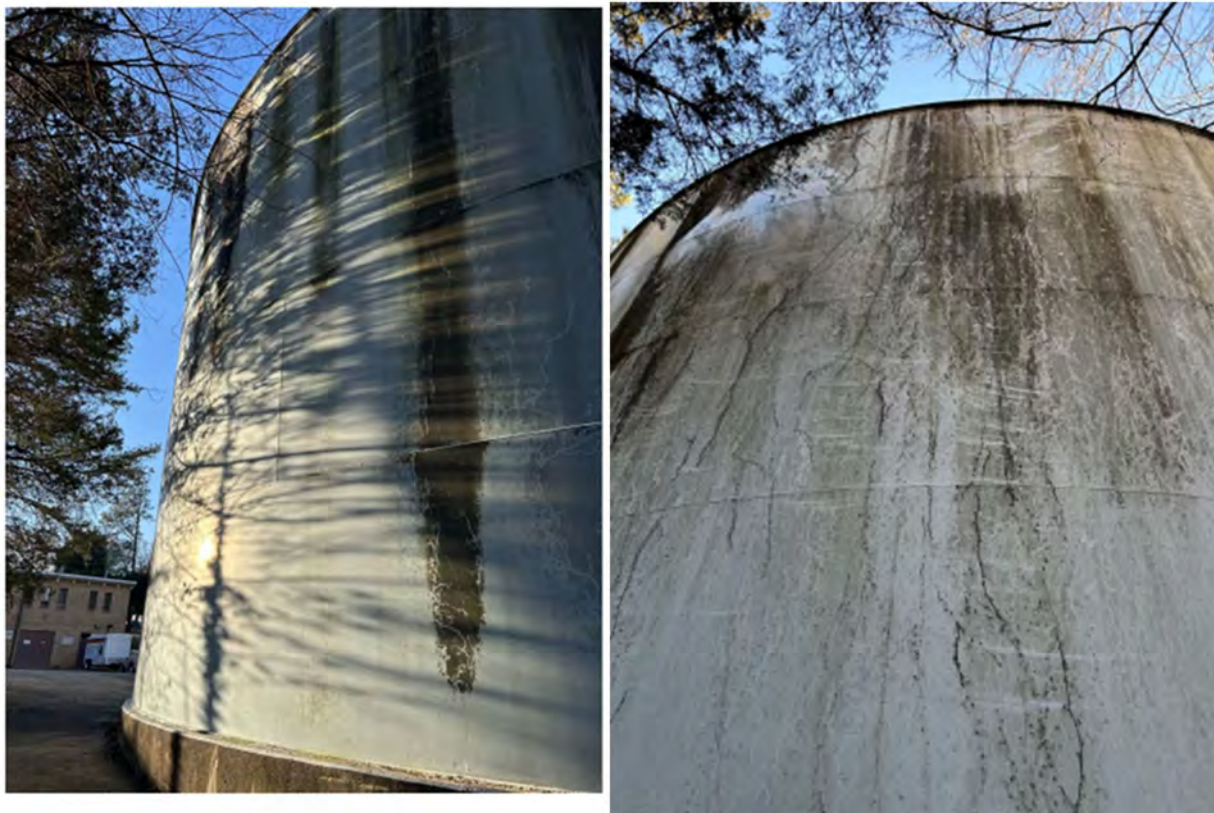
<b>AOC-34</b>	Finished Water Storage Facilities	Several tanks had overgrown vegetation within 6' and/or overhanging the	Overgrown vegetation was observed at the Jahnke Road Tank	12VAC5-590-360.A states, in part, "The owner shall identify and	Vegetation was removed shortly following the inspection. Additionally, the Building & Grounds Team has kicked off an	Addressed.  Limbs that may have been overhanging the	Figure 39 Figure 40 Figure 41

*Figure 40. Storage tank vegetation and overgrowth (COR)*

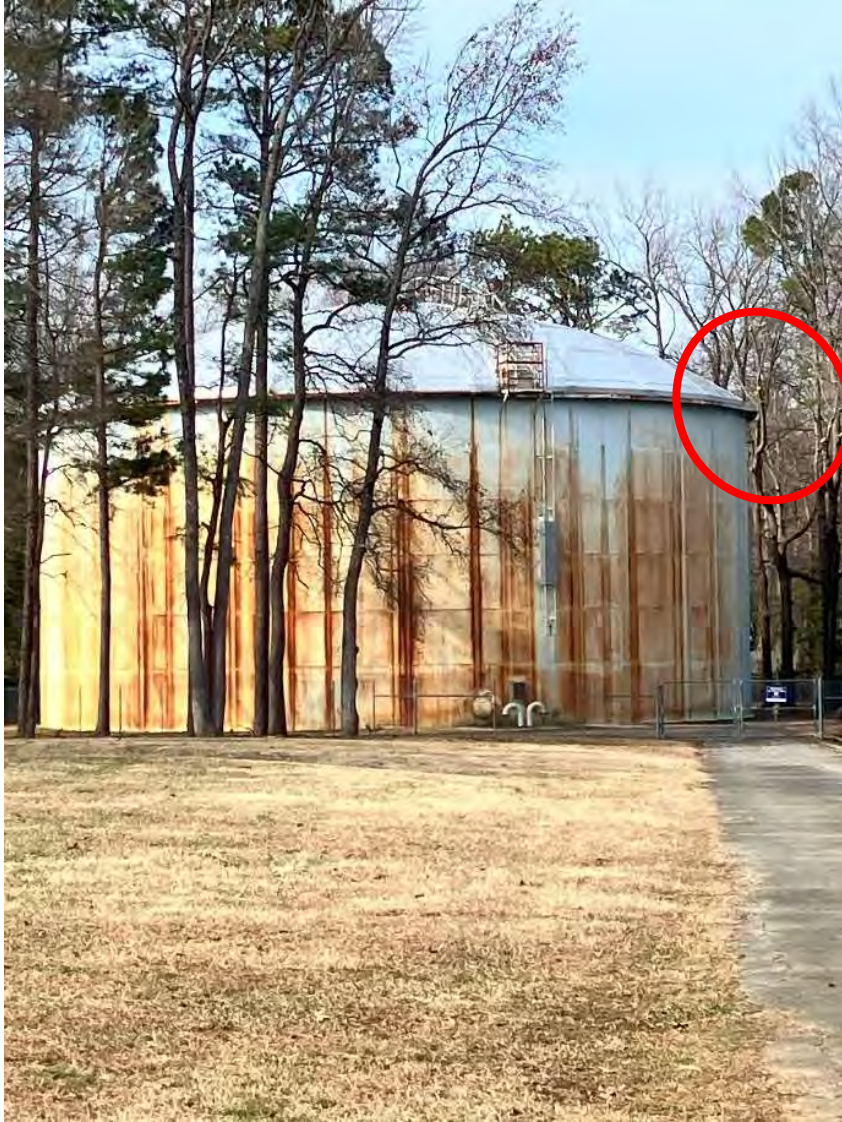
*Figure 41. Storage tank vegetation and overgrowth. Cut limbs visible (VDH)*
