**Subject:** Environmental Protection Agency (EPA) Safe Drinking Water Act Compliance  
Inspection Report.

**Follow-Up Site Visit Conducted by Virginia Department of Health-Office of  
Drinking Water's (VDH-ODW) Richmond Field Office**

**Author:** James Reynolds, PE- Field Director Richmond Field Office

The City of Richmond (COR) owns and operates a public waterworks (PWSID 4760100). The system is served by a Class 1 surface water treatment plant with a permitted capacity of 132 million gallons per day (MGD).

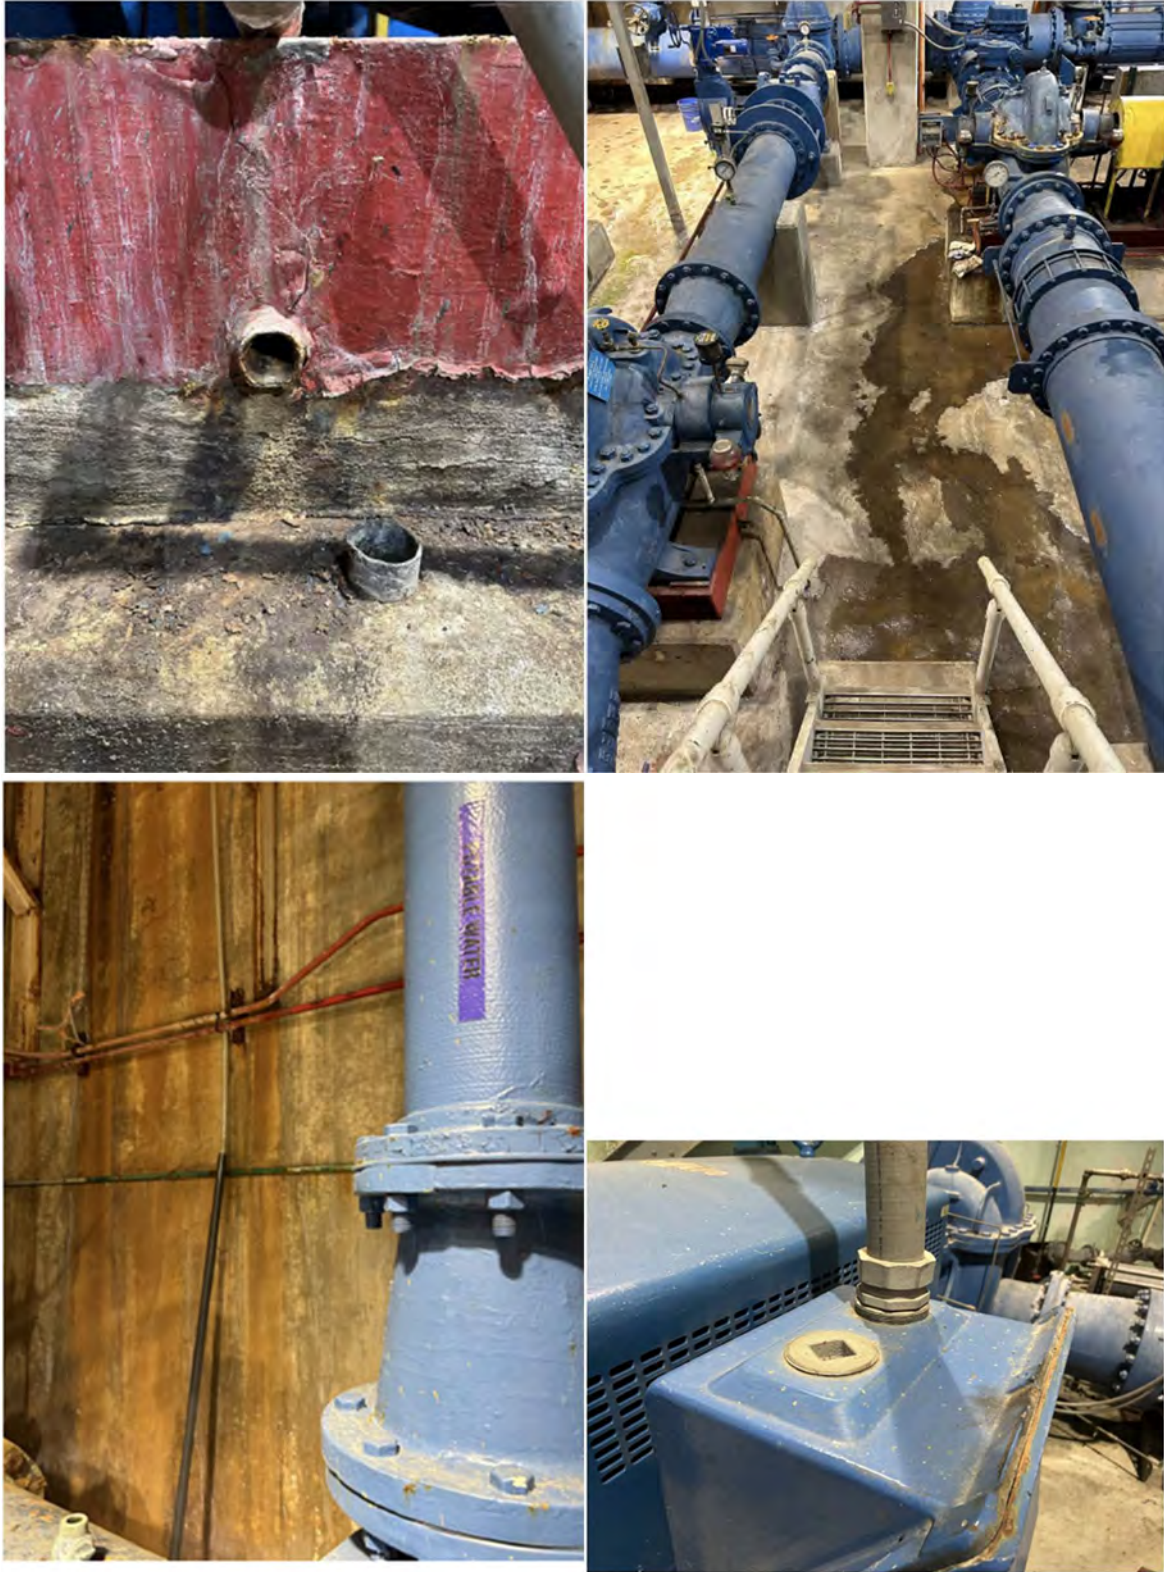
Obs. #	Category	Area of Concern	Supporting Observation	Relevant Citation	Richmond DPU Response 2025	VDH-ODW Observation 2025	Photograph (Appendix A)
					during the inspection have been resolved - Pressure / flow transmitters, leaking valve packing / glands, water on the floor, hoses removed / vacuum breakers installed, etc.		
<b>AOC-36</b>	Pump Station Maintenance	Korah Pump Stations safety concerns	The building that houses Korah Pump Station #2 and #3 had active water drainage to the floor from at least two sources. The pump for Korah 1-2 had exposed wiring.	12VAC5-590-1050.A.8. states, "A suitable outlet for drainage from pump glands shall be provided Without discharging onto the floor."	The City acknowledges this observation, and the exposed wiring was remedied through WO #C270729. The active water drainage is being managed through a short-term solution (see photo #43) (i.e., temporary PVC line). A longer-term solution is under review through WO #C276963, which is anticipated to be complete January 4, 2025.	Partially addressed.  Standing water still observed in some locations. Exposed wiring not observed.	Figure 42 Figure 43 Figure 44

Figure 43. Korah Pump Stations observations (COR)

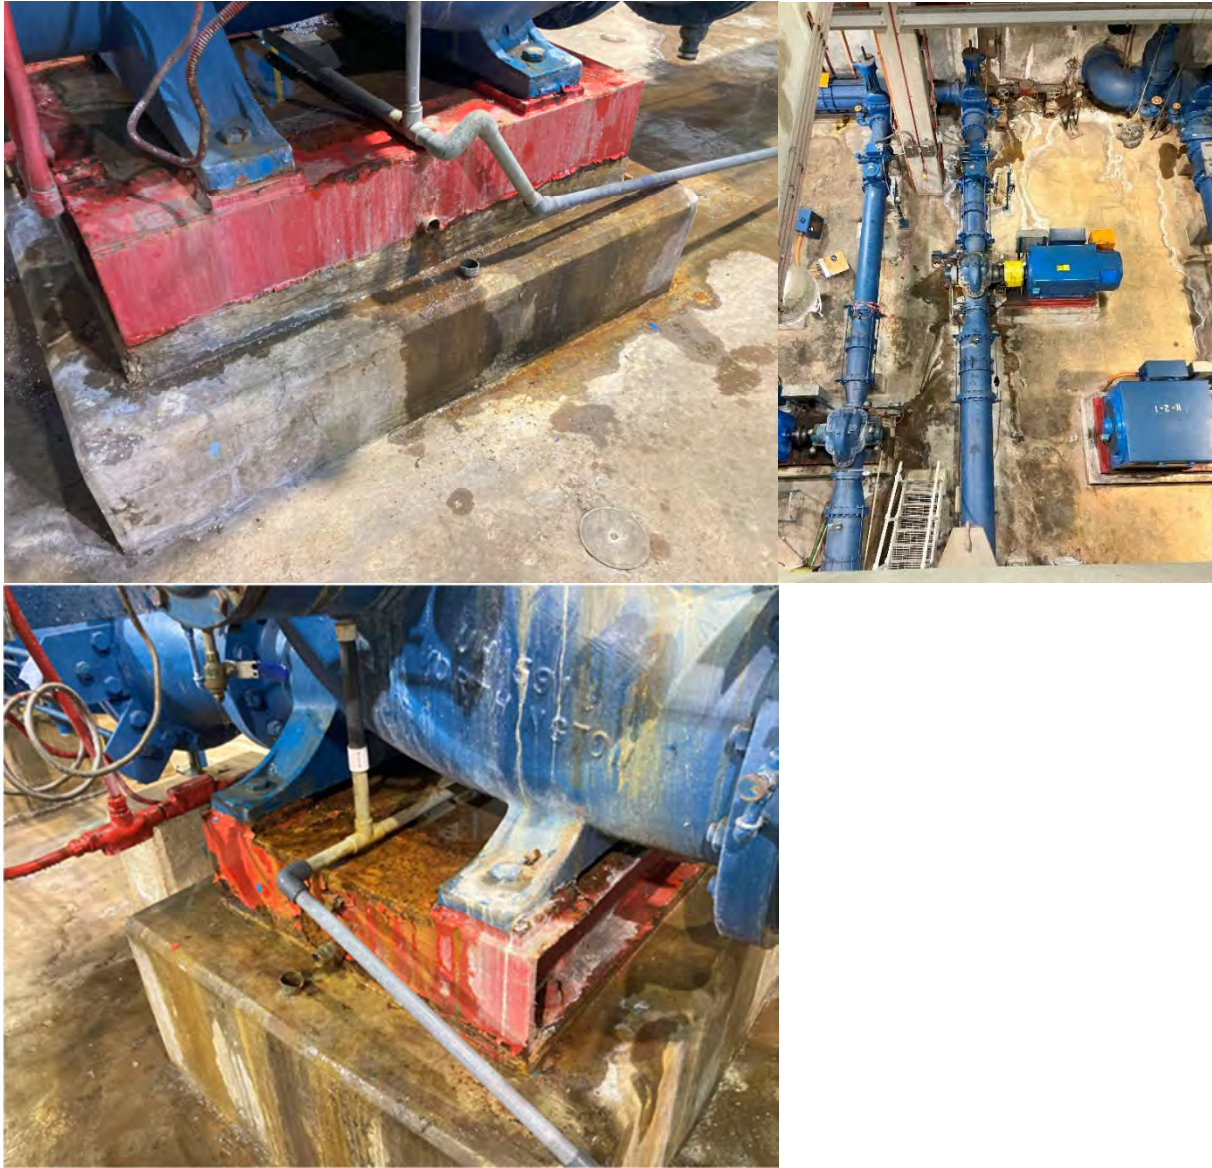
Figure 44. Korah Pump Station observation (VDH)

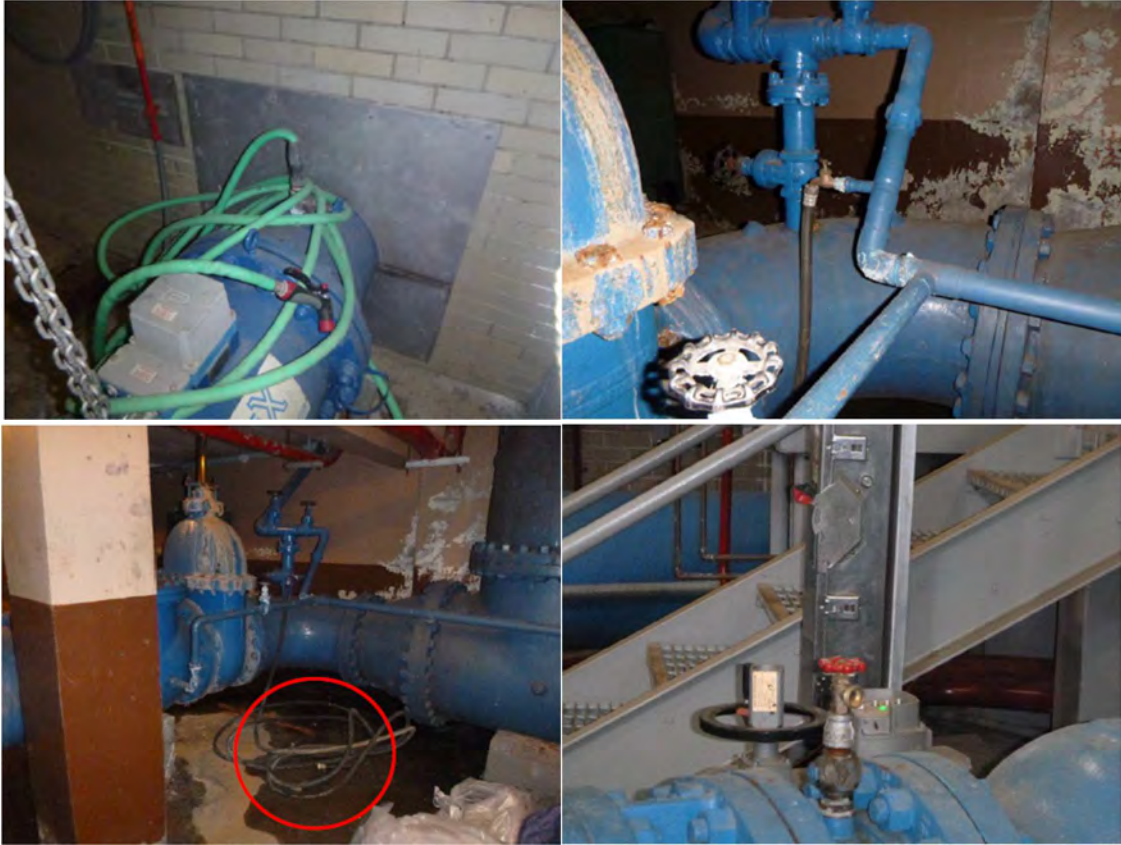
Figure 46. Threaded taps on lines without vacuum breaker (EPA)

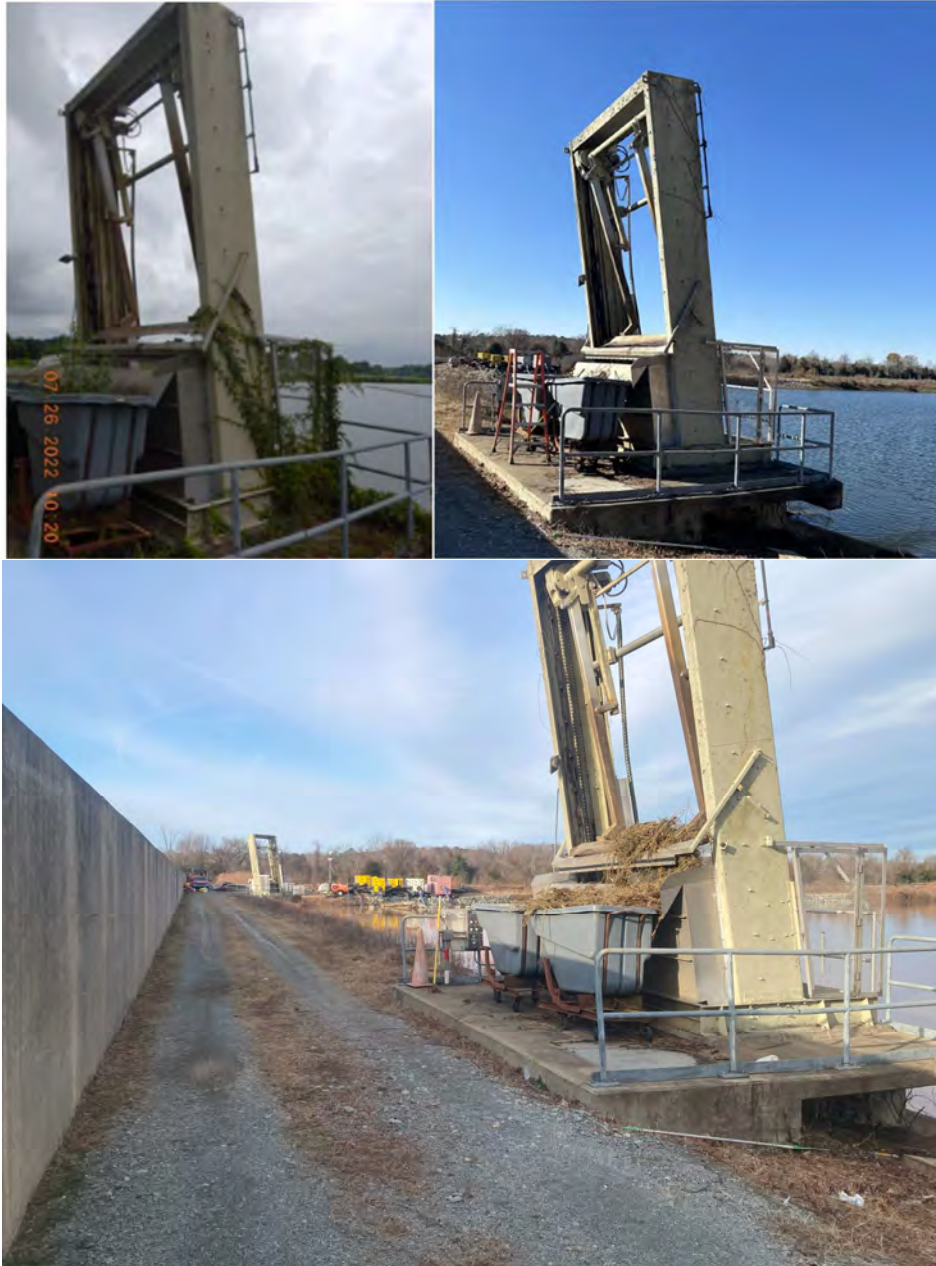
Figure 49. Raw water screens (Left-EPA, Middle- COR, Bottom-VDH)

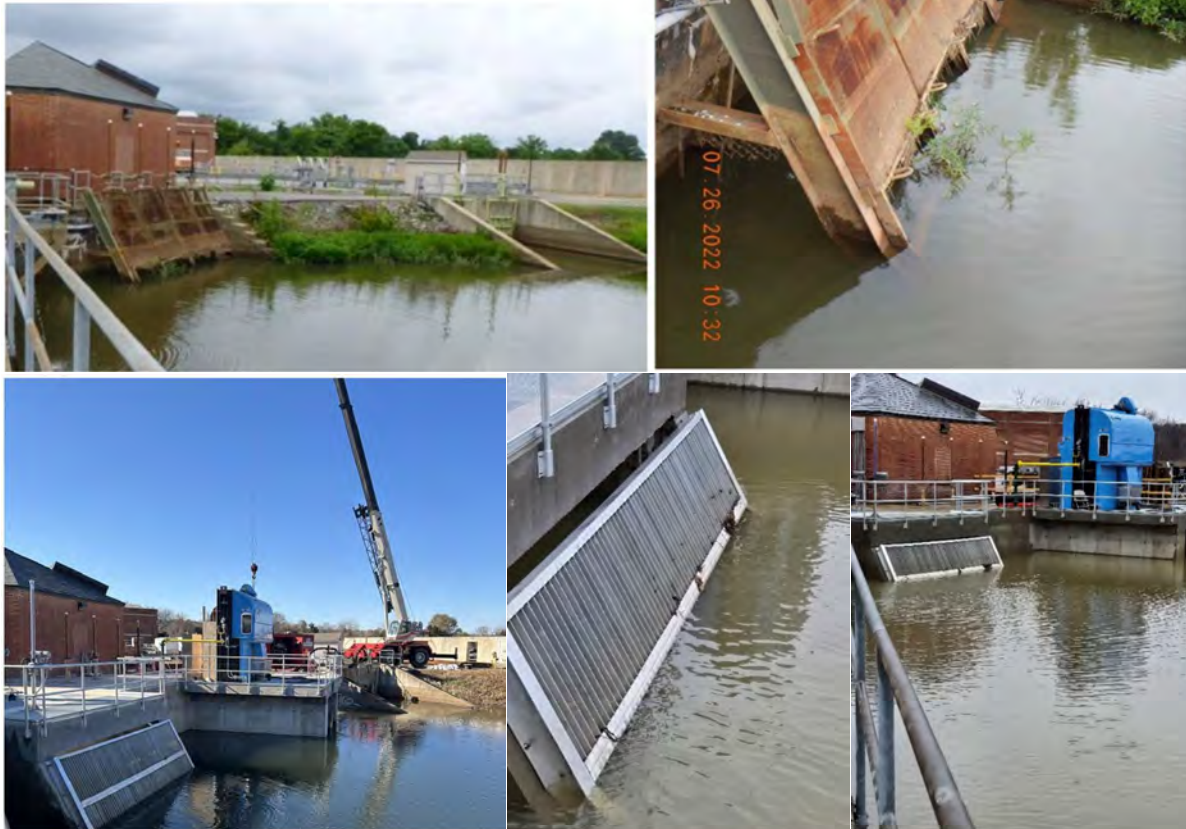
Figure 51. Pre-sed basin screens (Top-EPA, Lower Left- COR, Lower Middle and Right-VDH)

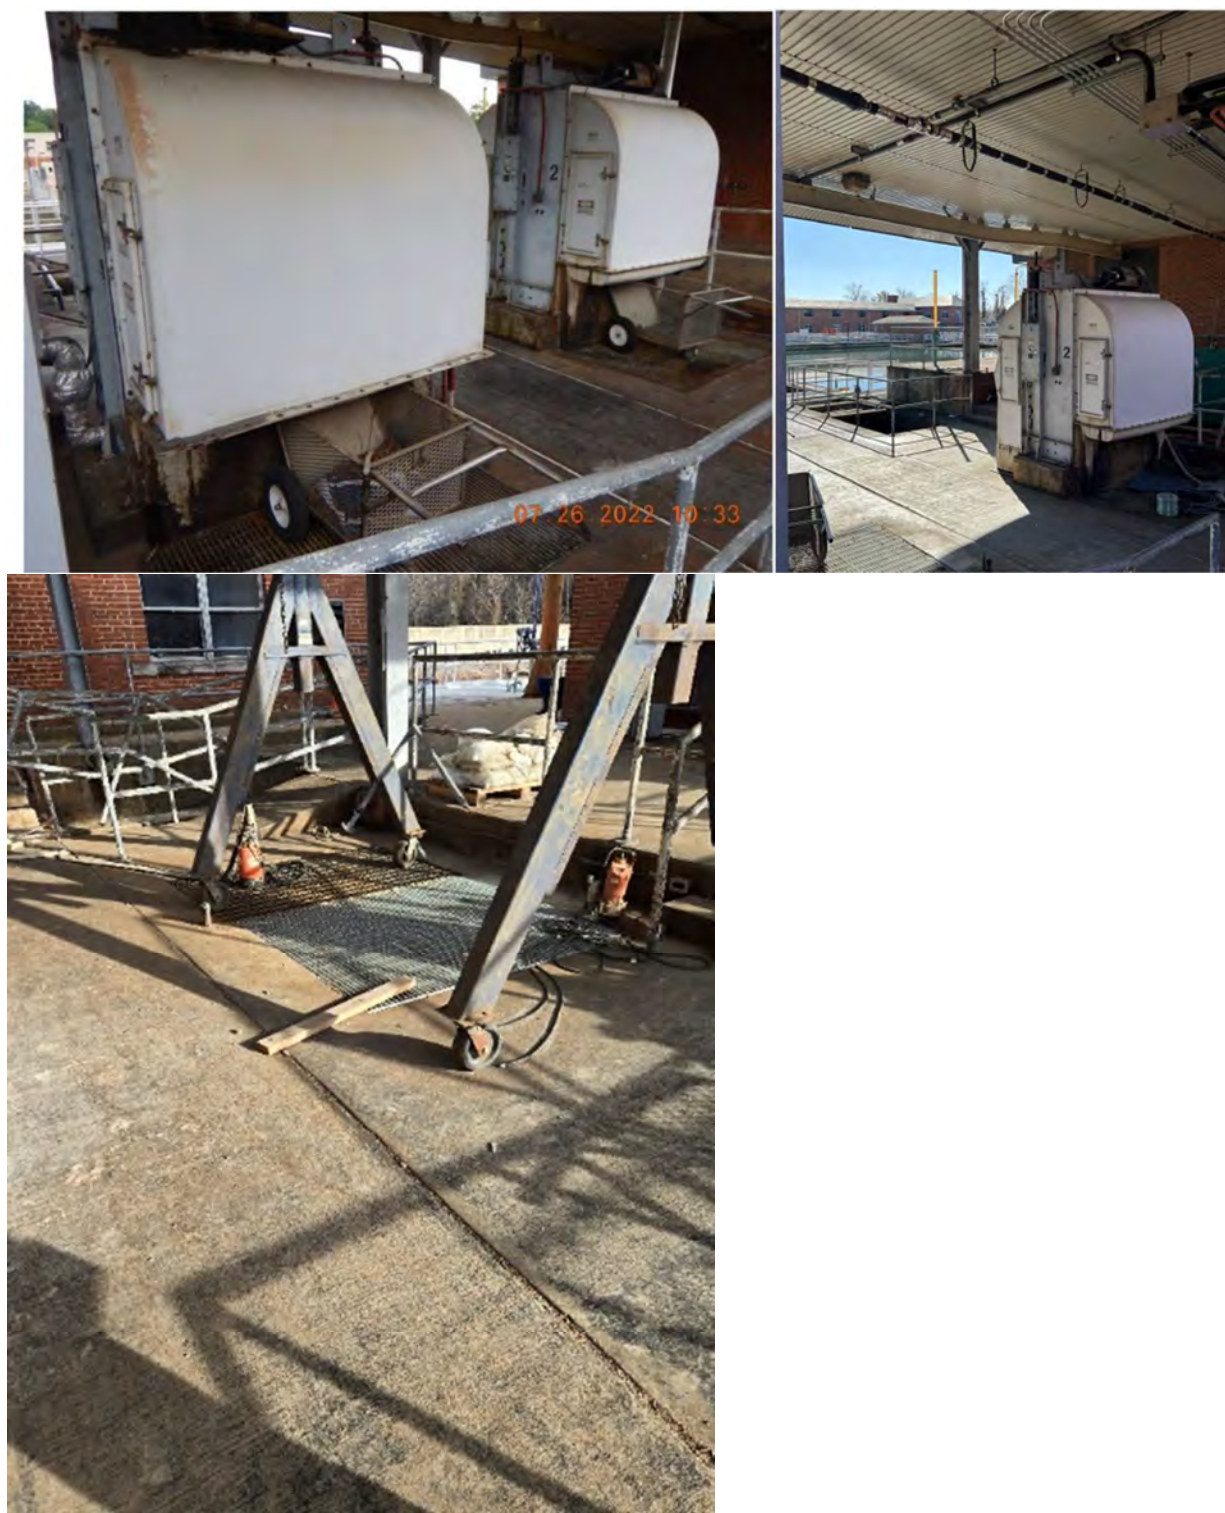
Figure 52. Traveling screens (Left-EPA, Middle-COR, Bottom-VDH)

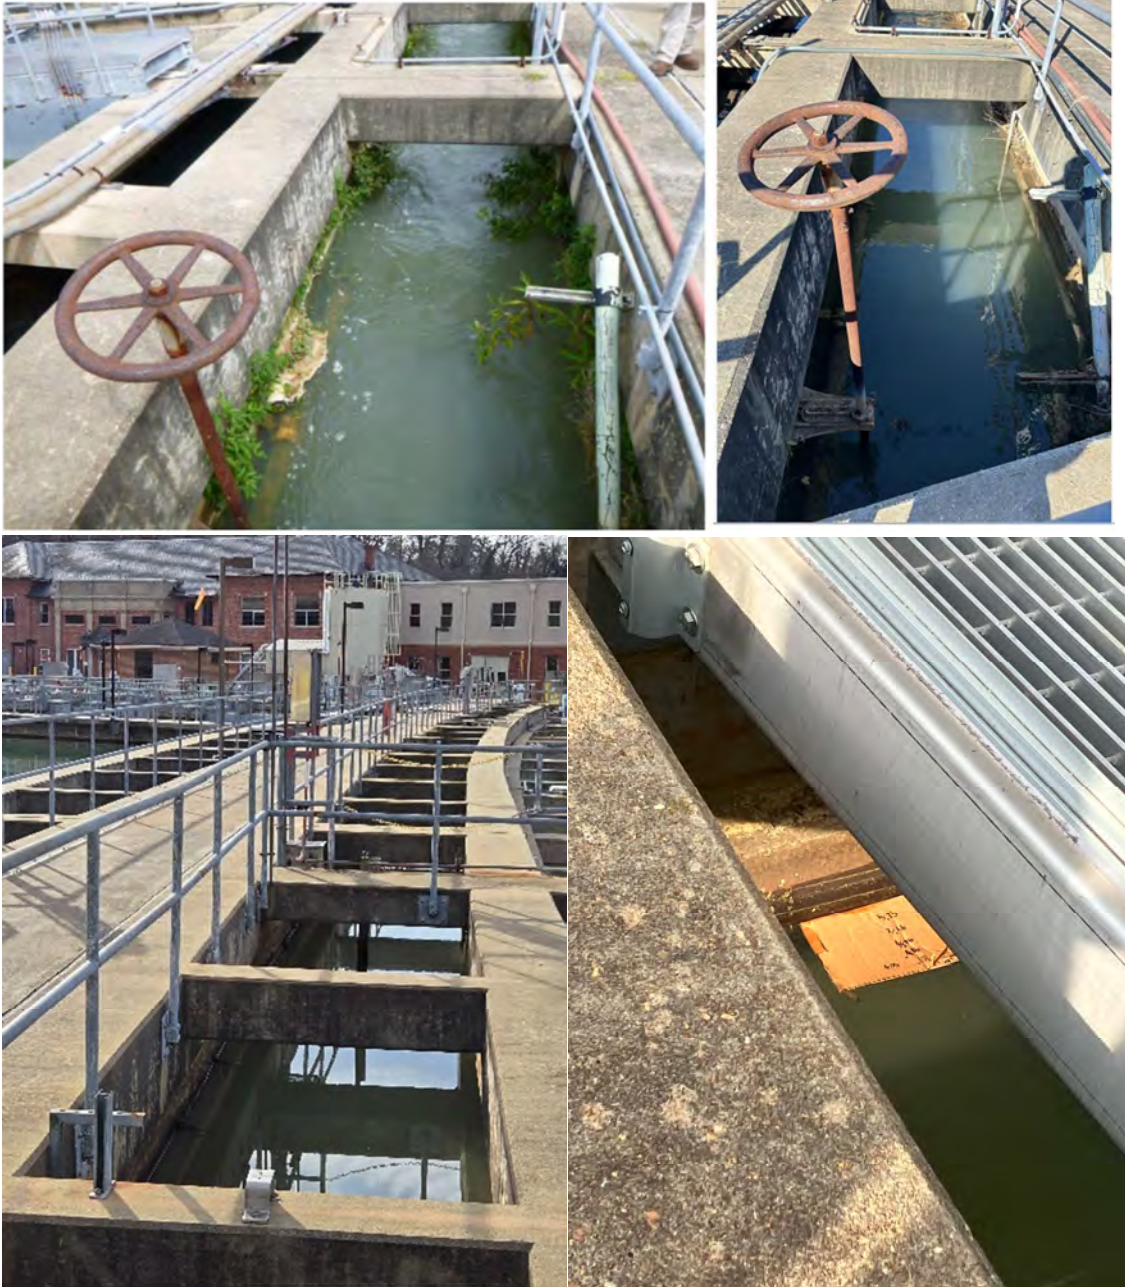
*Figure 53. Vegetation and debris raw water coagulation channel (Top Left-EPA, Top Right-COR, Bottom-VDH)*

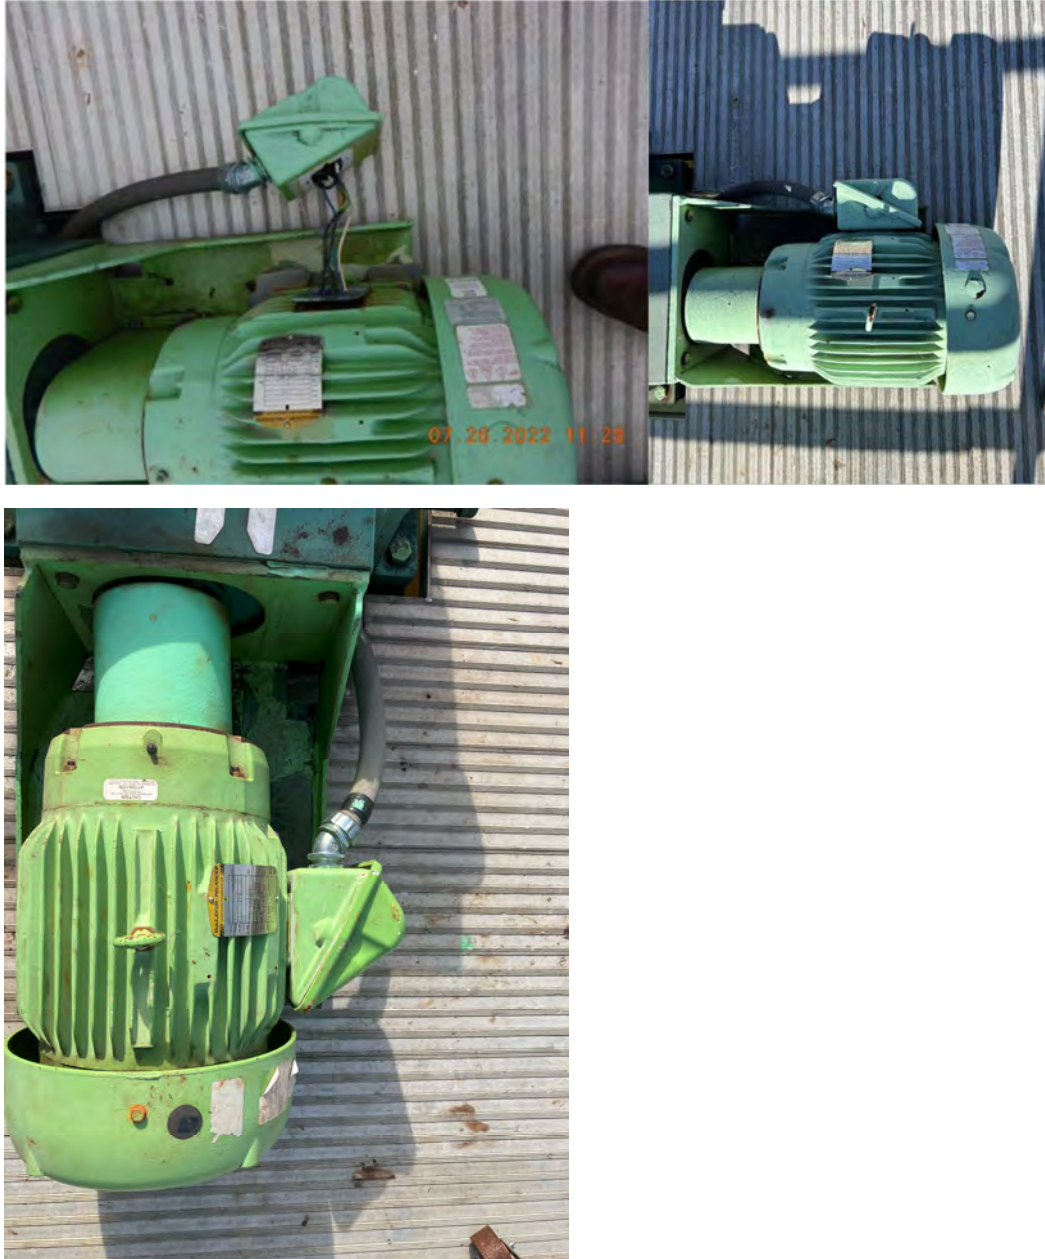
Figure 55. Exposed wiring flocculator motor (Top Left-EPA, Top Right-COR, Bottom Left- VDH)

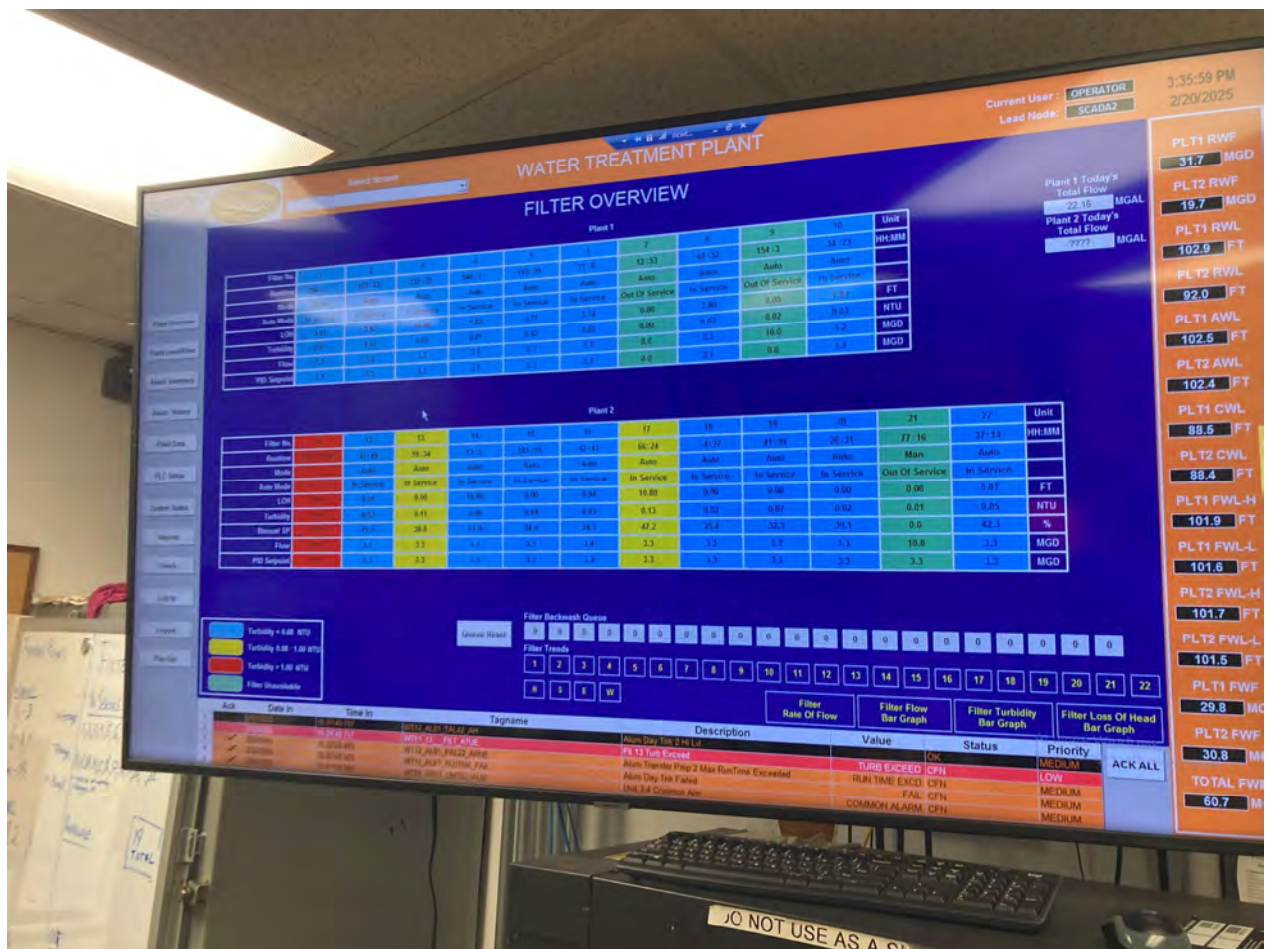
Figure 56. Filters in service/out of service (VDH)

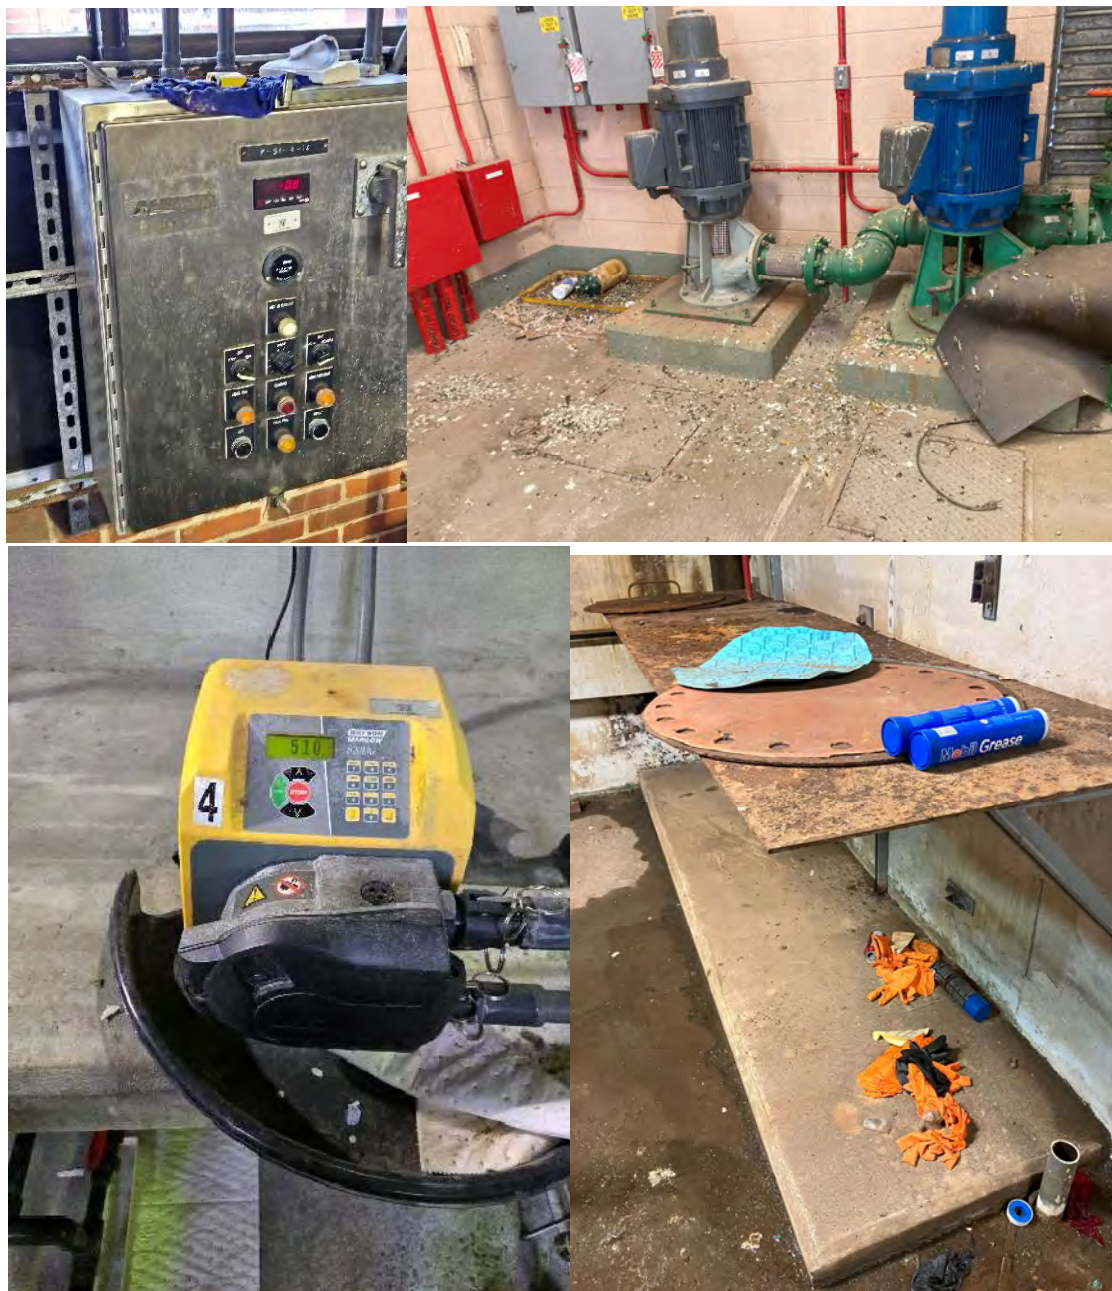
A general lack of housekeeping was observed with dust, trash, and standing areas of water throughout the water treatment plant and distribution system (Figure 59, Figure 79). As new equipment is installed and upgrades occur for infrastructure, COR must properly maintain new equipment to the end of its useful life.

Figure 59. Observations of dust, general housekeeping (VDH)

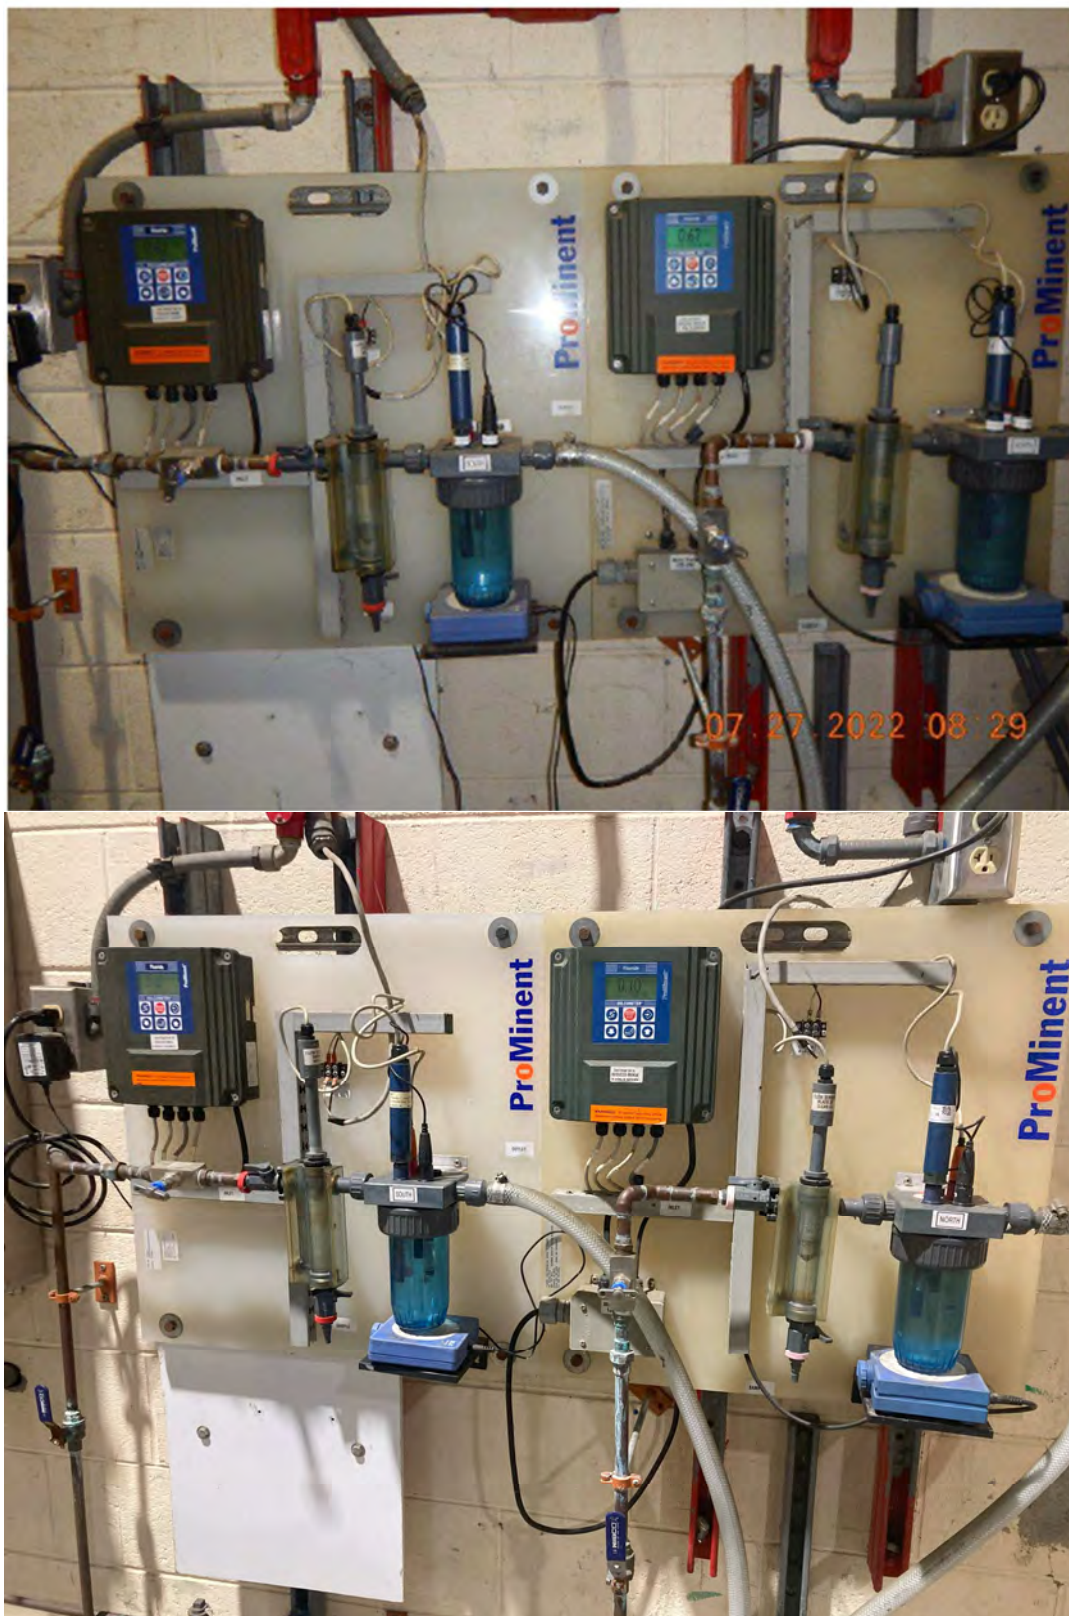
Figure 61. Instrumentation in Korah 2 and 3 pump station, no calibration stickers observed (Top-EPA, Bottom-VDH)

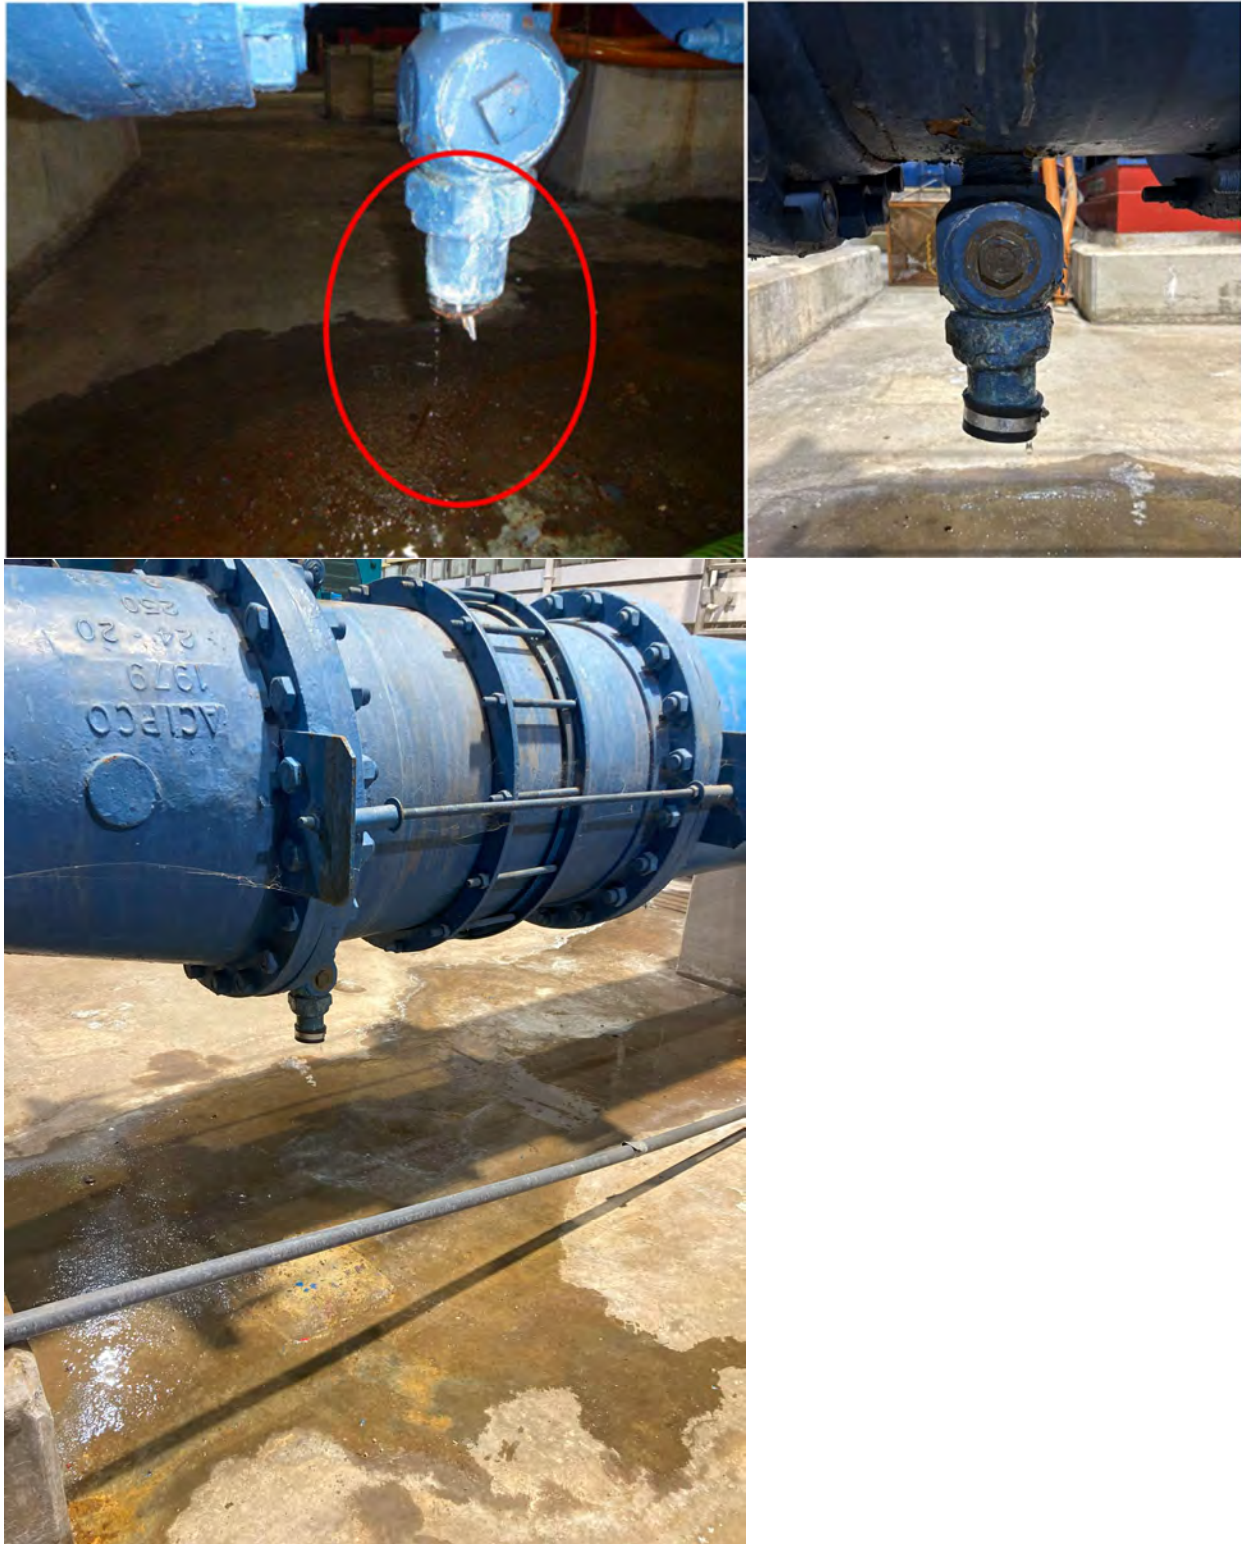
Figure 62. Corroded fitting from pipe in Korah 2 and 3 pump station (Top left- EPA, Top right- COR, Bottom- VDH)

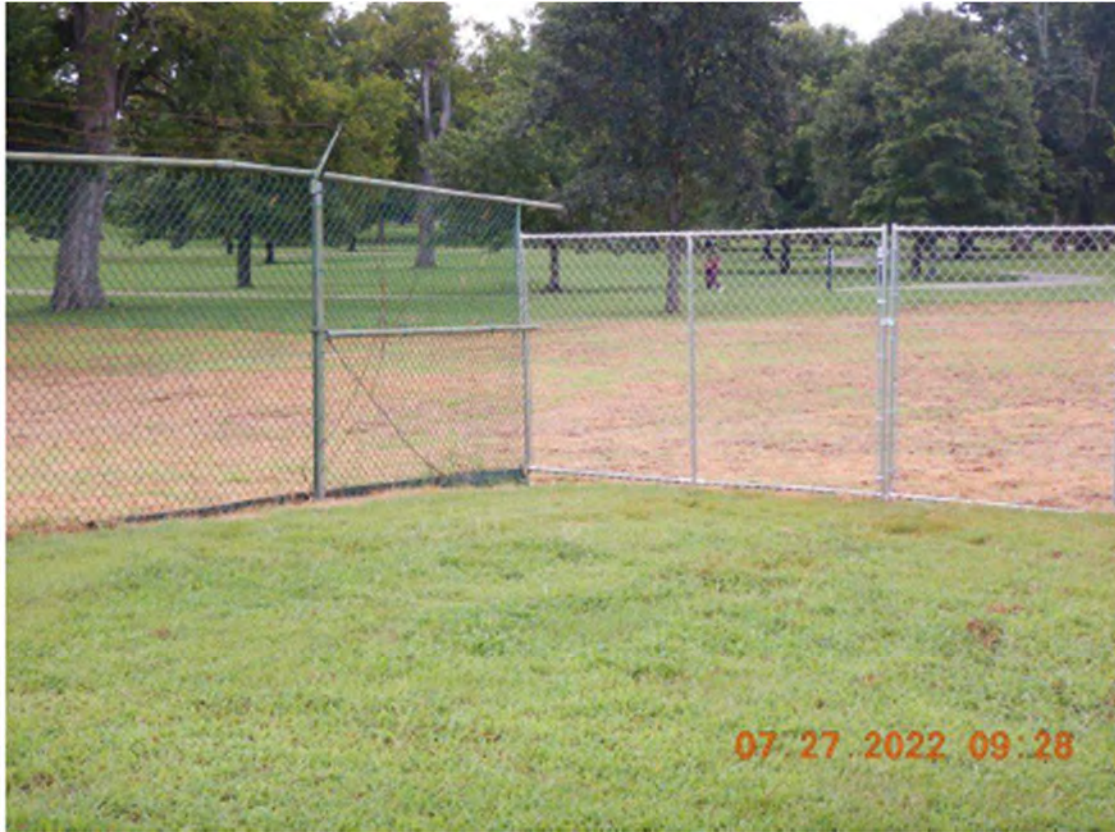
*Figure 63. Fencing at Trafford Pump Station (EPA)*

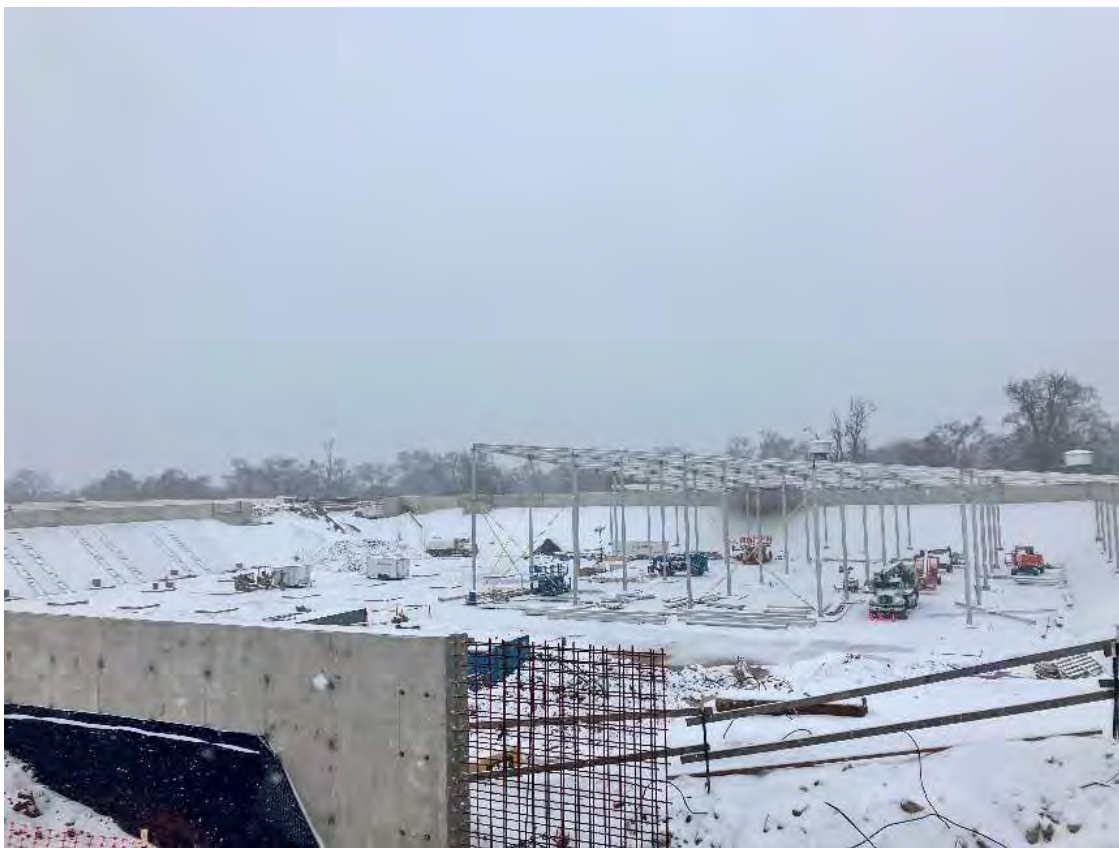
*Figure 65. Byrd Park Reservoir Construction (VDH)*

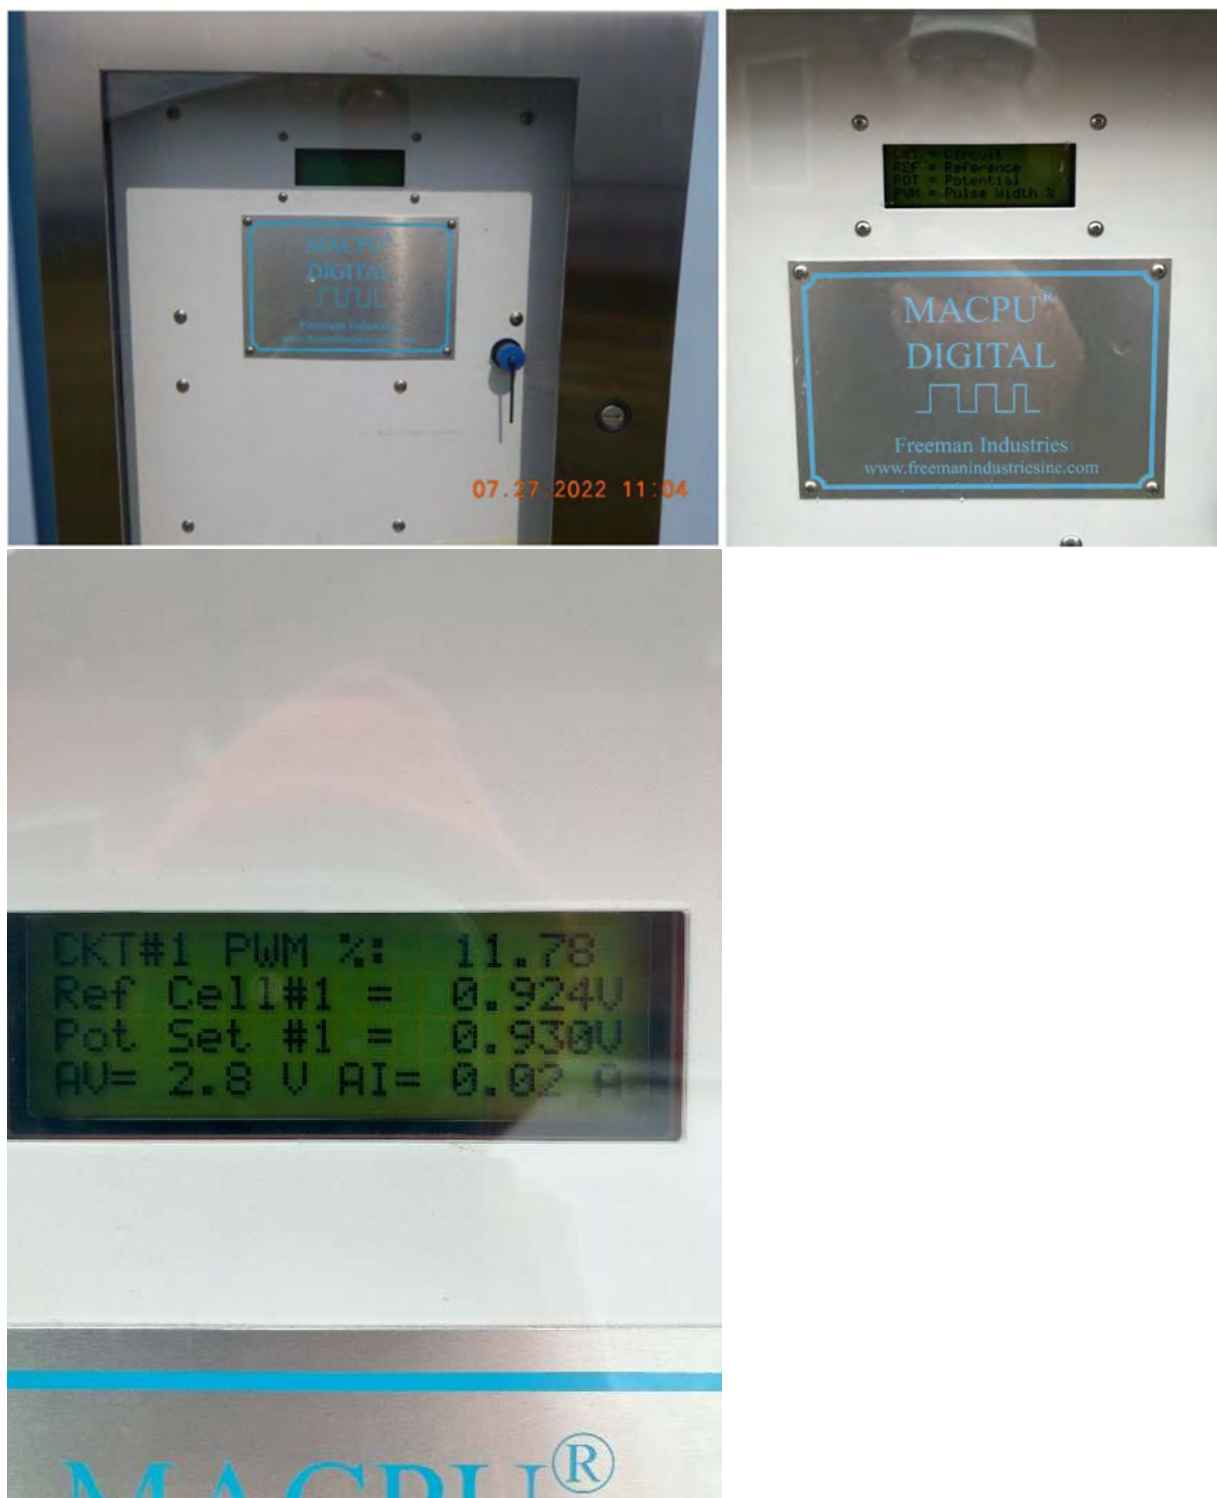
Figure 66. Cathodic Protection Unit at Cofer Road tank (Top left-EPA, Top right- COR, Bottom- VDH)

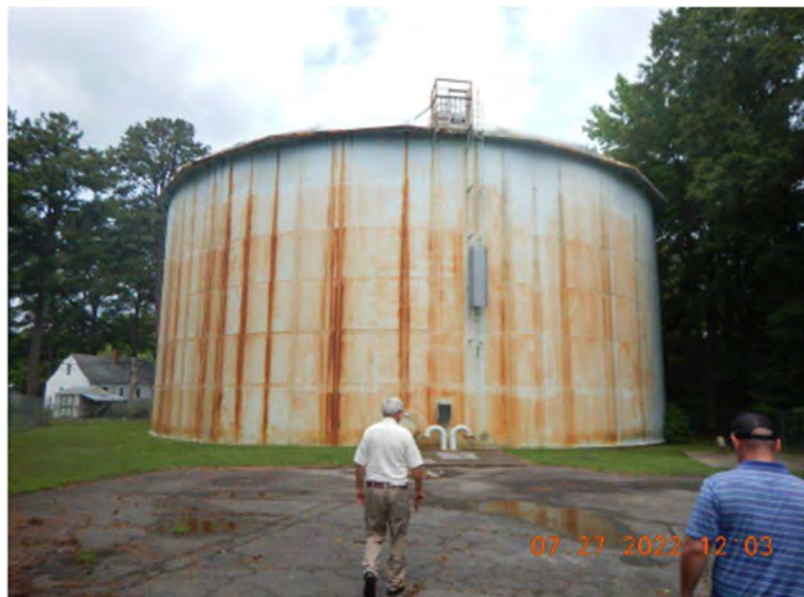
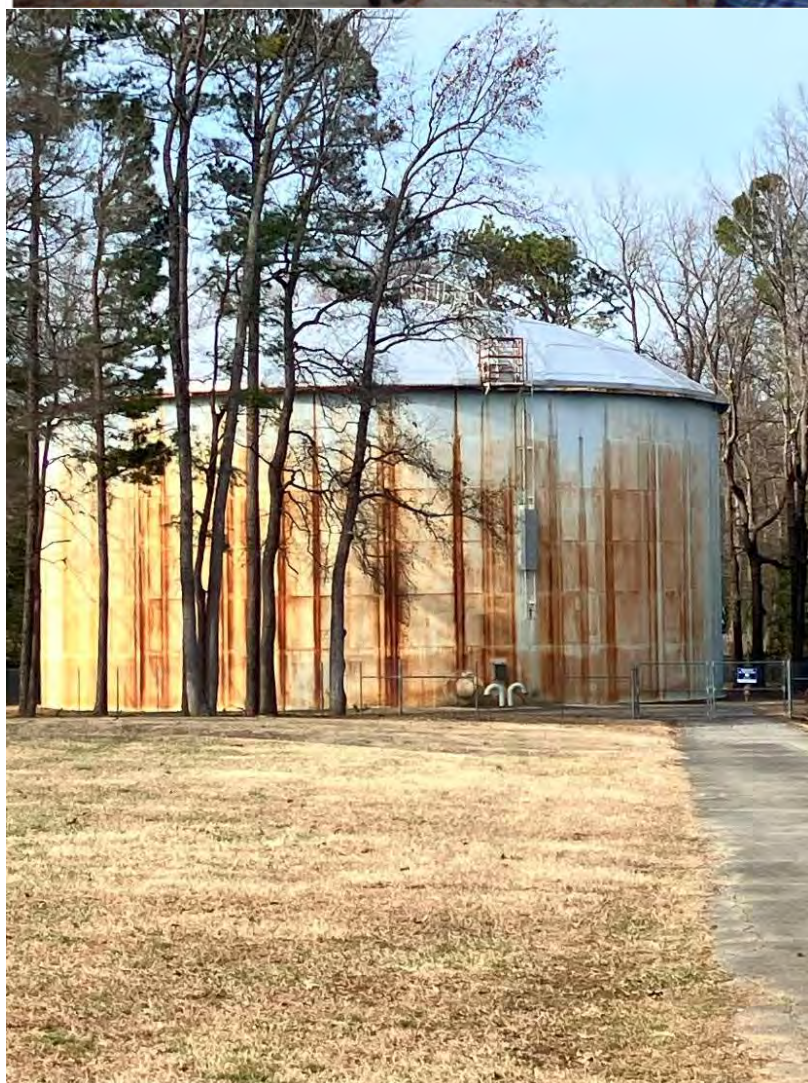
*Figure 68. Rust observed on Jahnke Road Tank (Top-EPA, Bottom-VDH)*
