**Subject:** Environmental Protection Agency (EPA) Safe Drinking Water Act Compliance  
Inspection Report.

**Follow-Up Site Visit Conducted by Virginia Department of Health-Office of  
Drinking Water's (VDH-ODW) Richmond Field Office**

**Author:** James Reynolds, PE- Field Director Richmond Field Office

The City of Richmond (COR) owns and operates a public waterworks (PWSID 4760100). The system is served by a Class 1 surface water treatment plant with a permitted capacity of 132 million gallons per day (MGD).

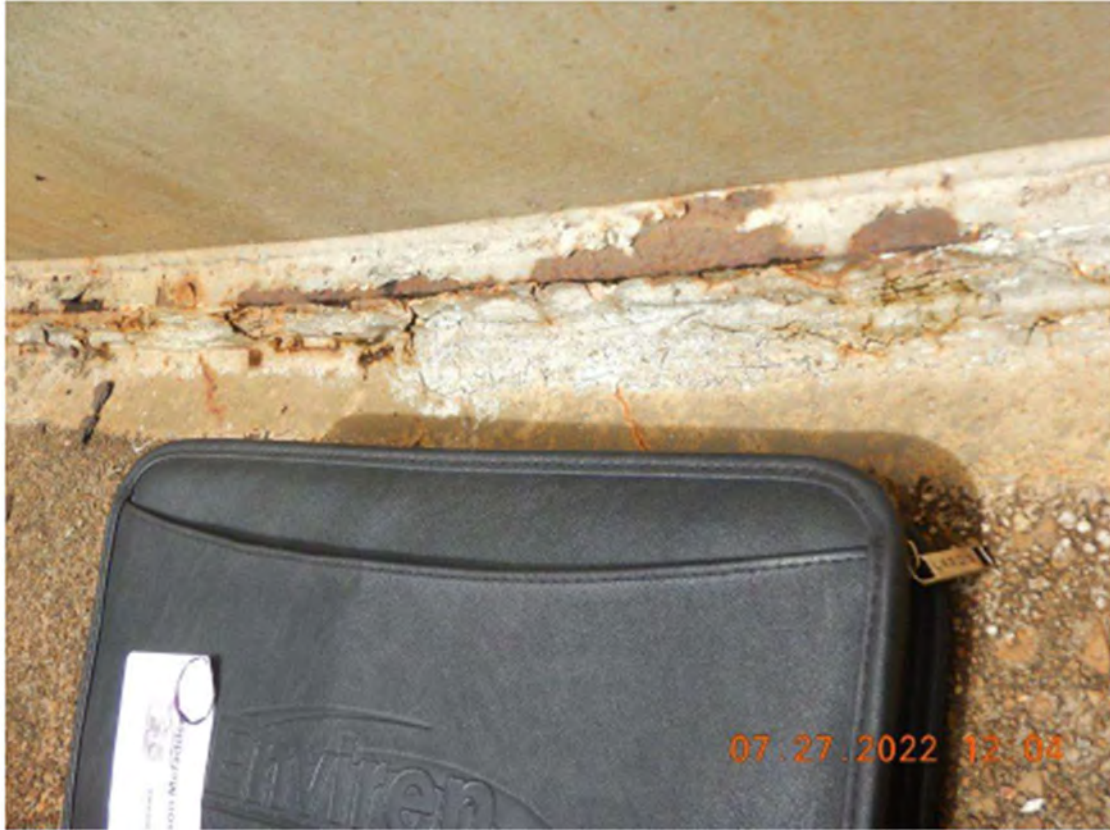
Figure 69. Corrosion and degraded seal at Jahnke Road Tank (EPA)

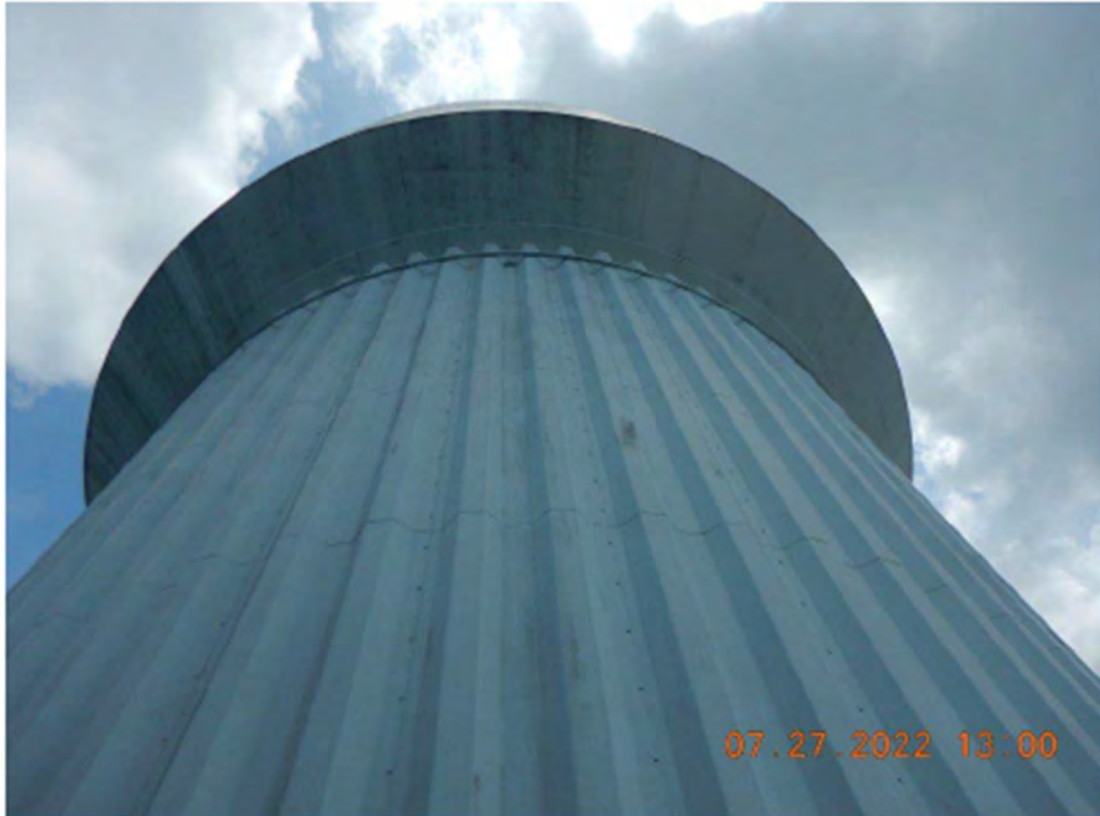
*Figure 70. Algal growth at bottom of bowl Warwick Road Tank (EPA)*

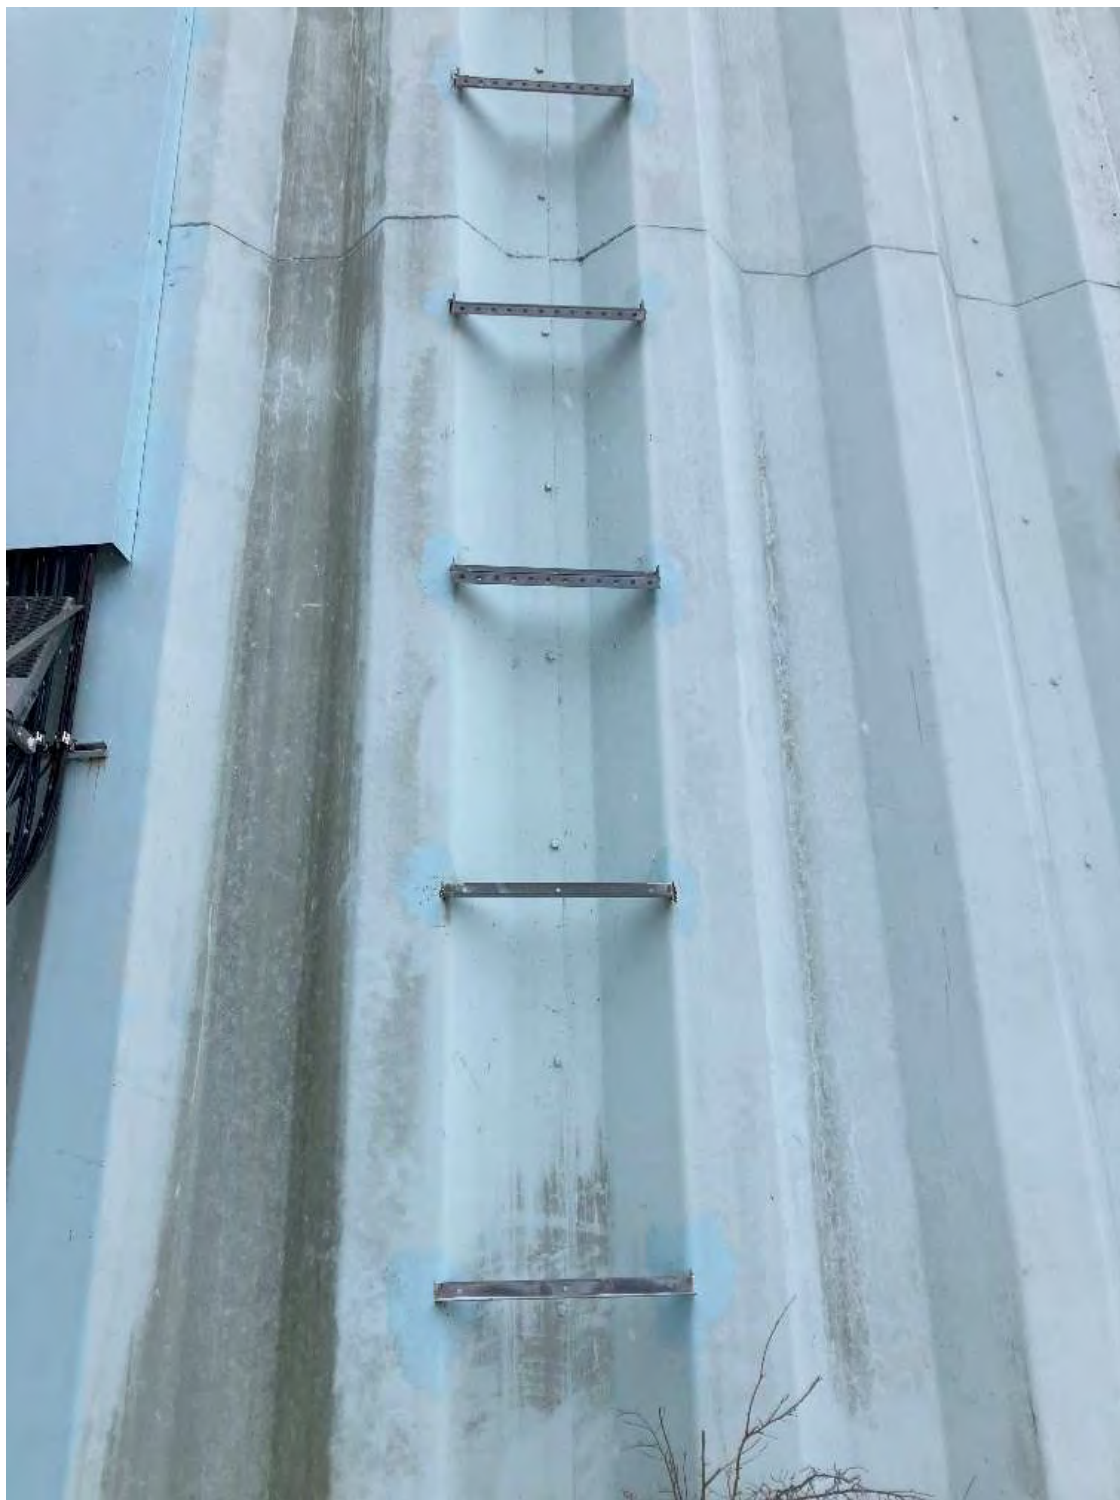
*Figure 71. Warwick Tank unprotected access to top of tank (VDH)*

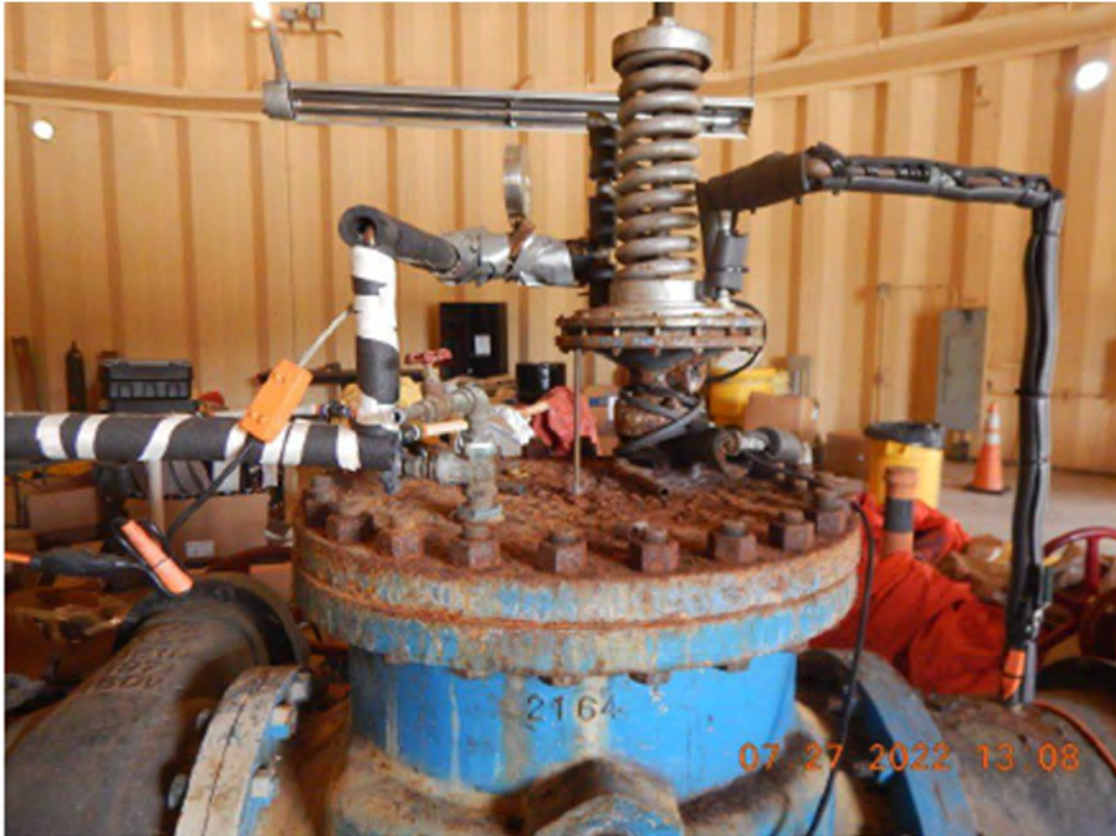
Figure 72. Corrosion on control valve in Warwick Road Tank (EPA)

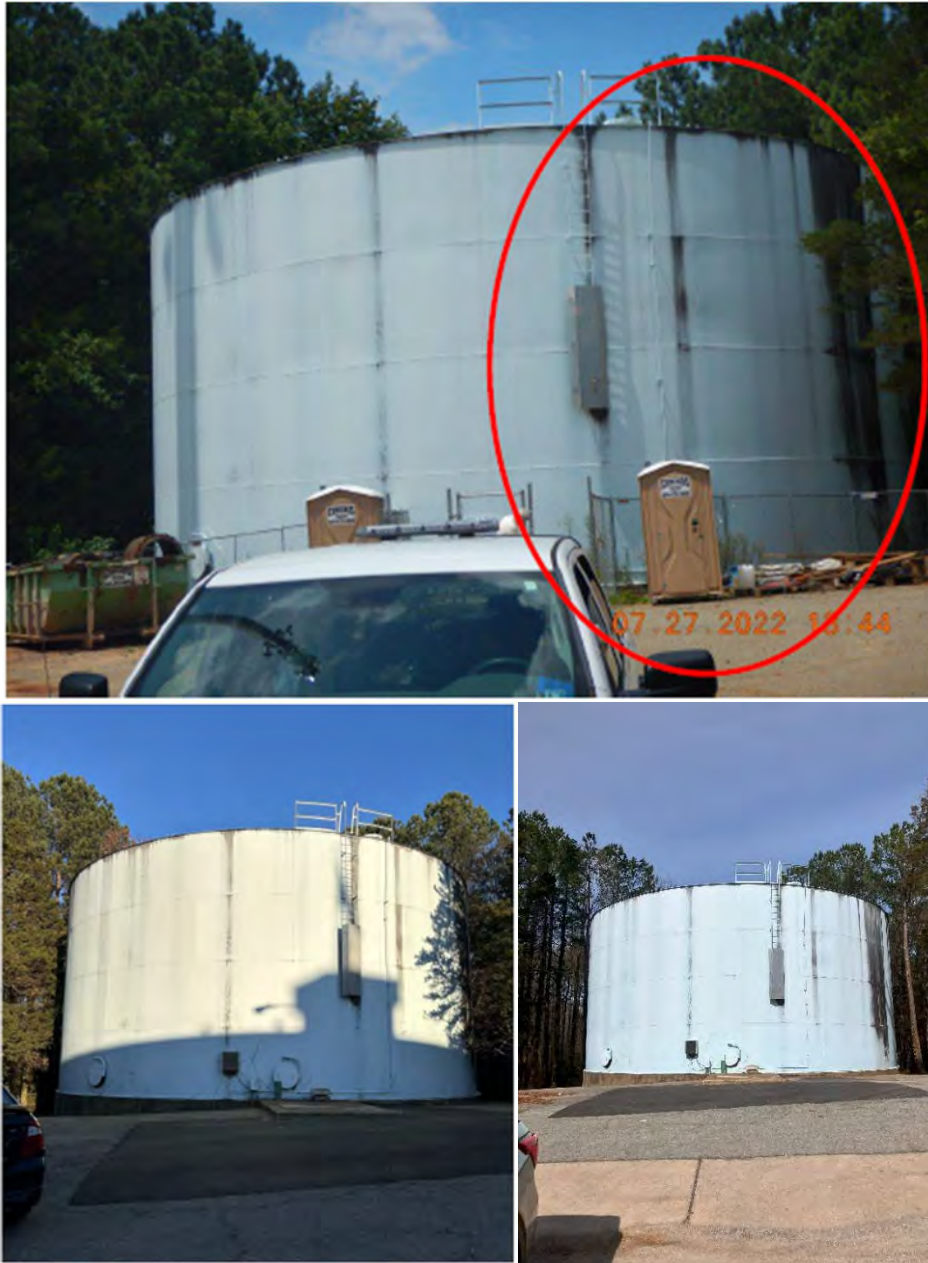
Figure 73. Huguenot Road Tank (Top- EPA, Bottom left- COR, Bottom right- VDH)

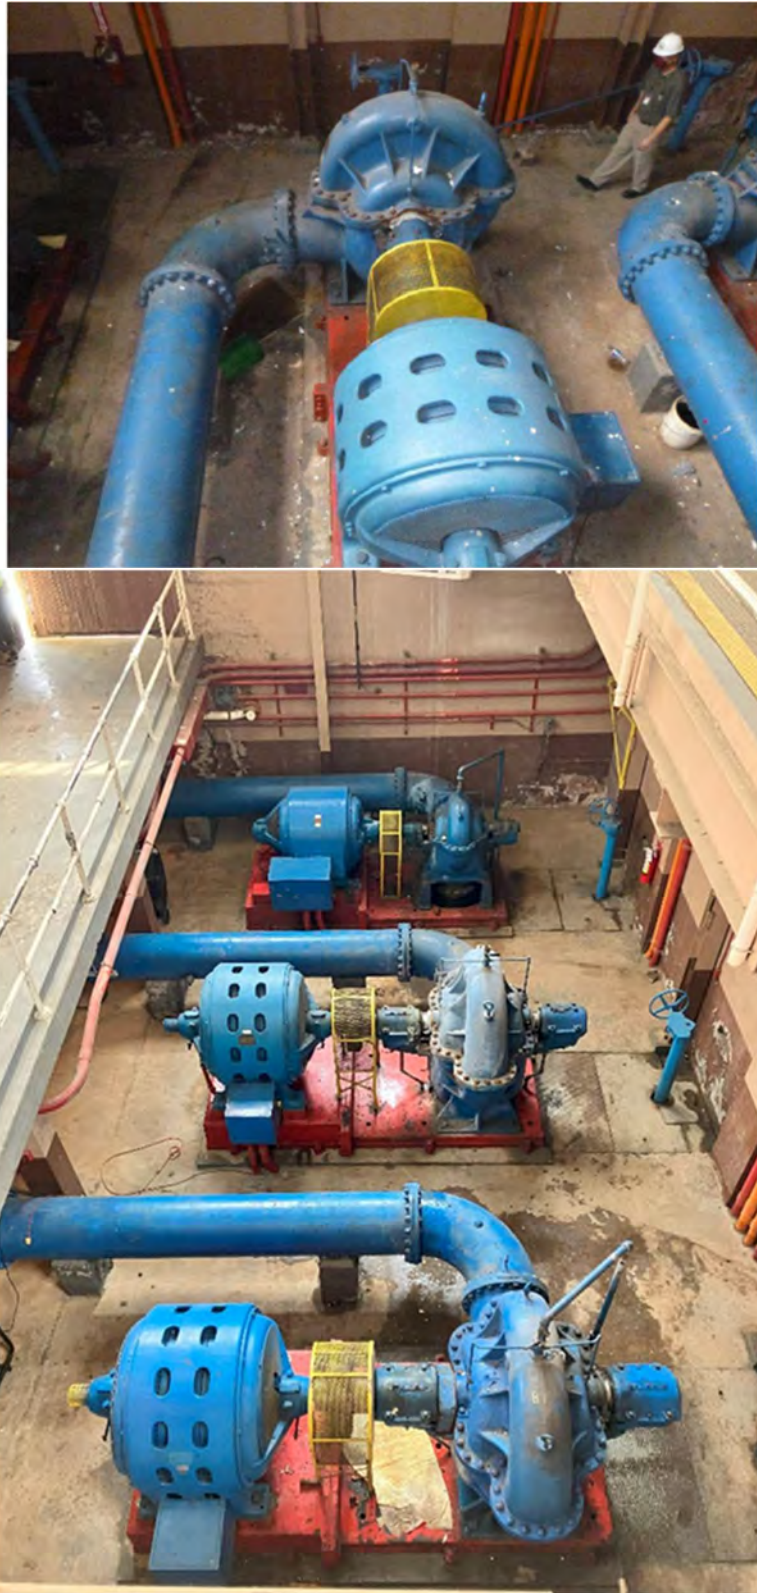
Figure 77. Debris on ground from ceiling at Byrd Park Main pump station (Top- EPA, Bottom- VDH)

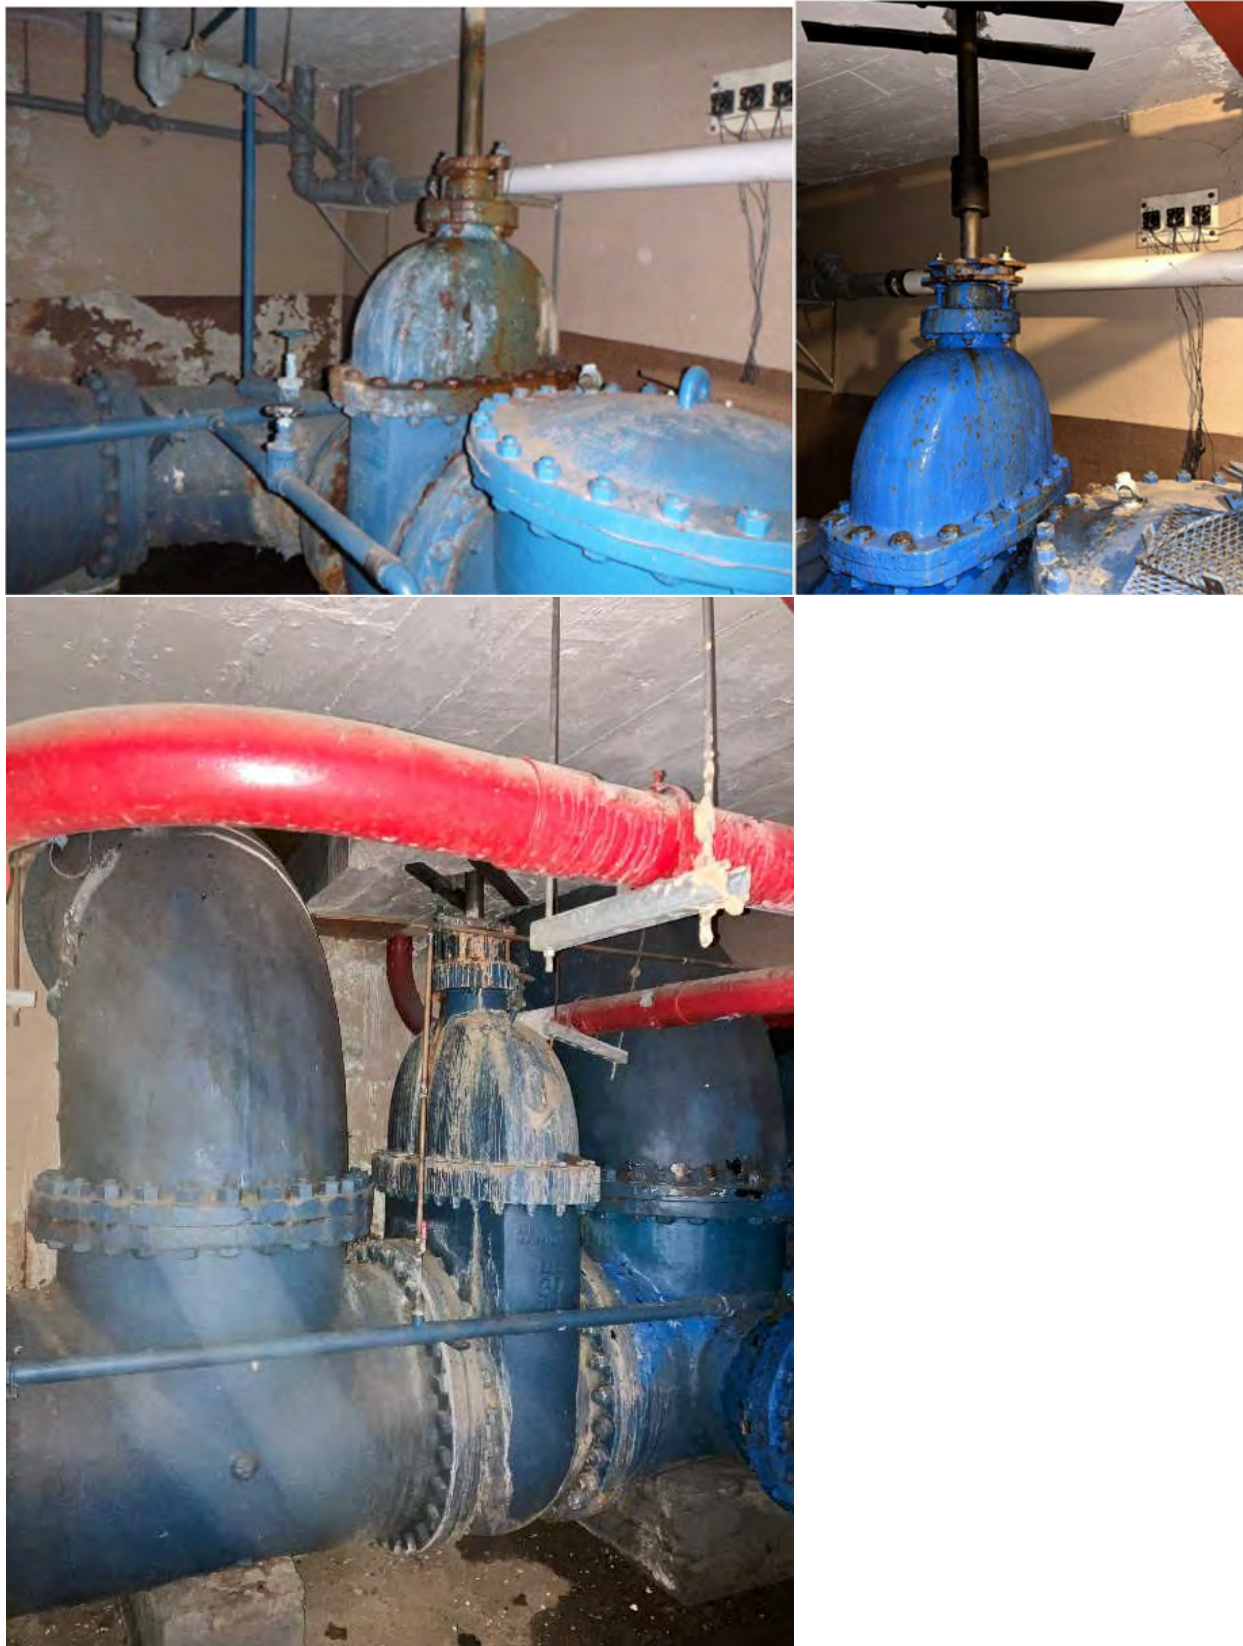
Figure 78. Leaking seals on gate valves at Byrd Park Main pump station (Top left- EPA, Top right- COR, Bottom- VDH)

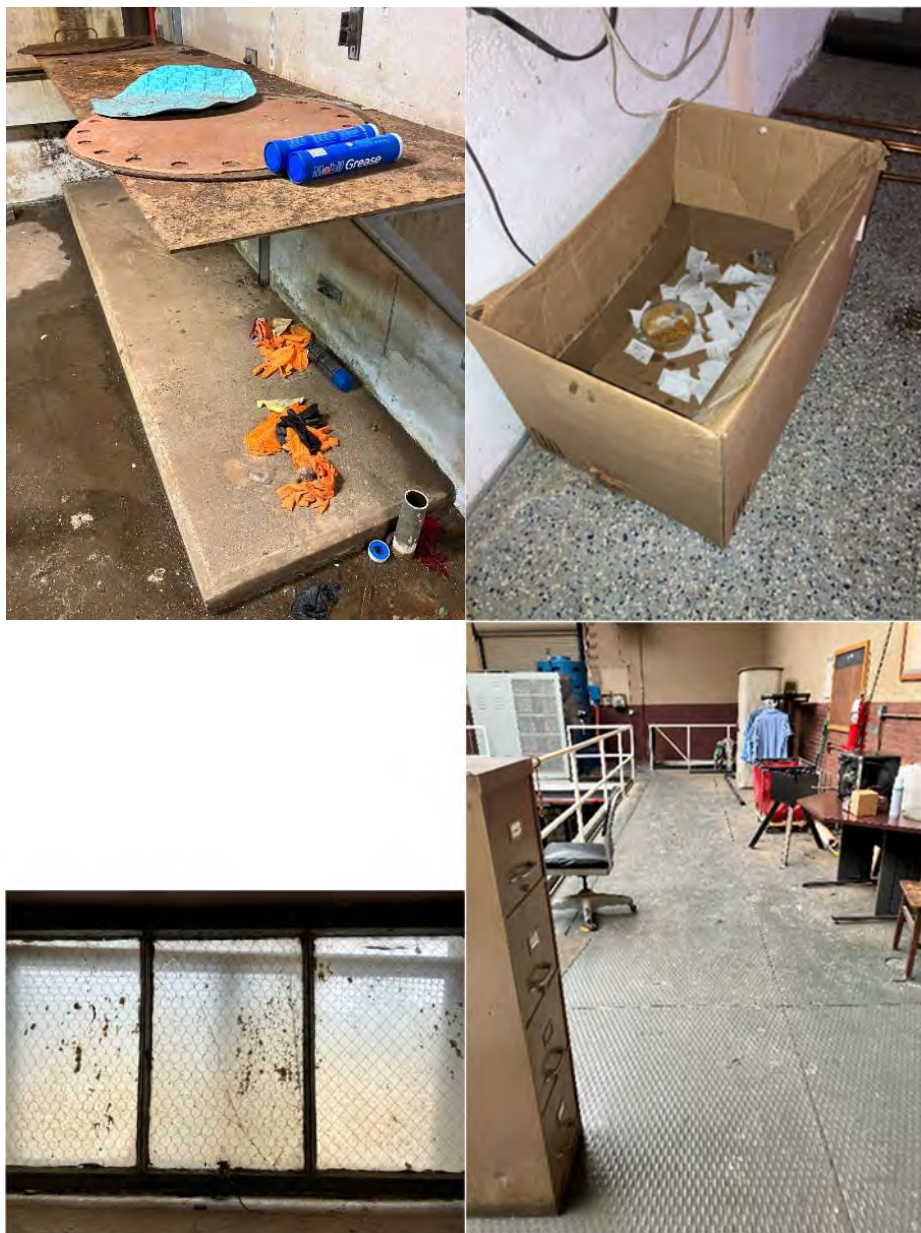
A general lack of housekeeping was observed with dust, trash, and standing areas of water throughout the water treatment plant and distribution system (Figure 59, Figure 79). As new equipment is installed and upgrades occur for infrastructure, COR must properly maintain new equipment to the end of its useful life.

Figure 79. General Housekeeping Observation (VDH)

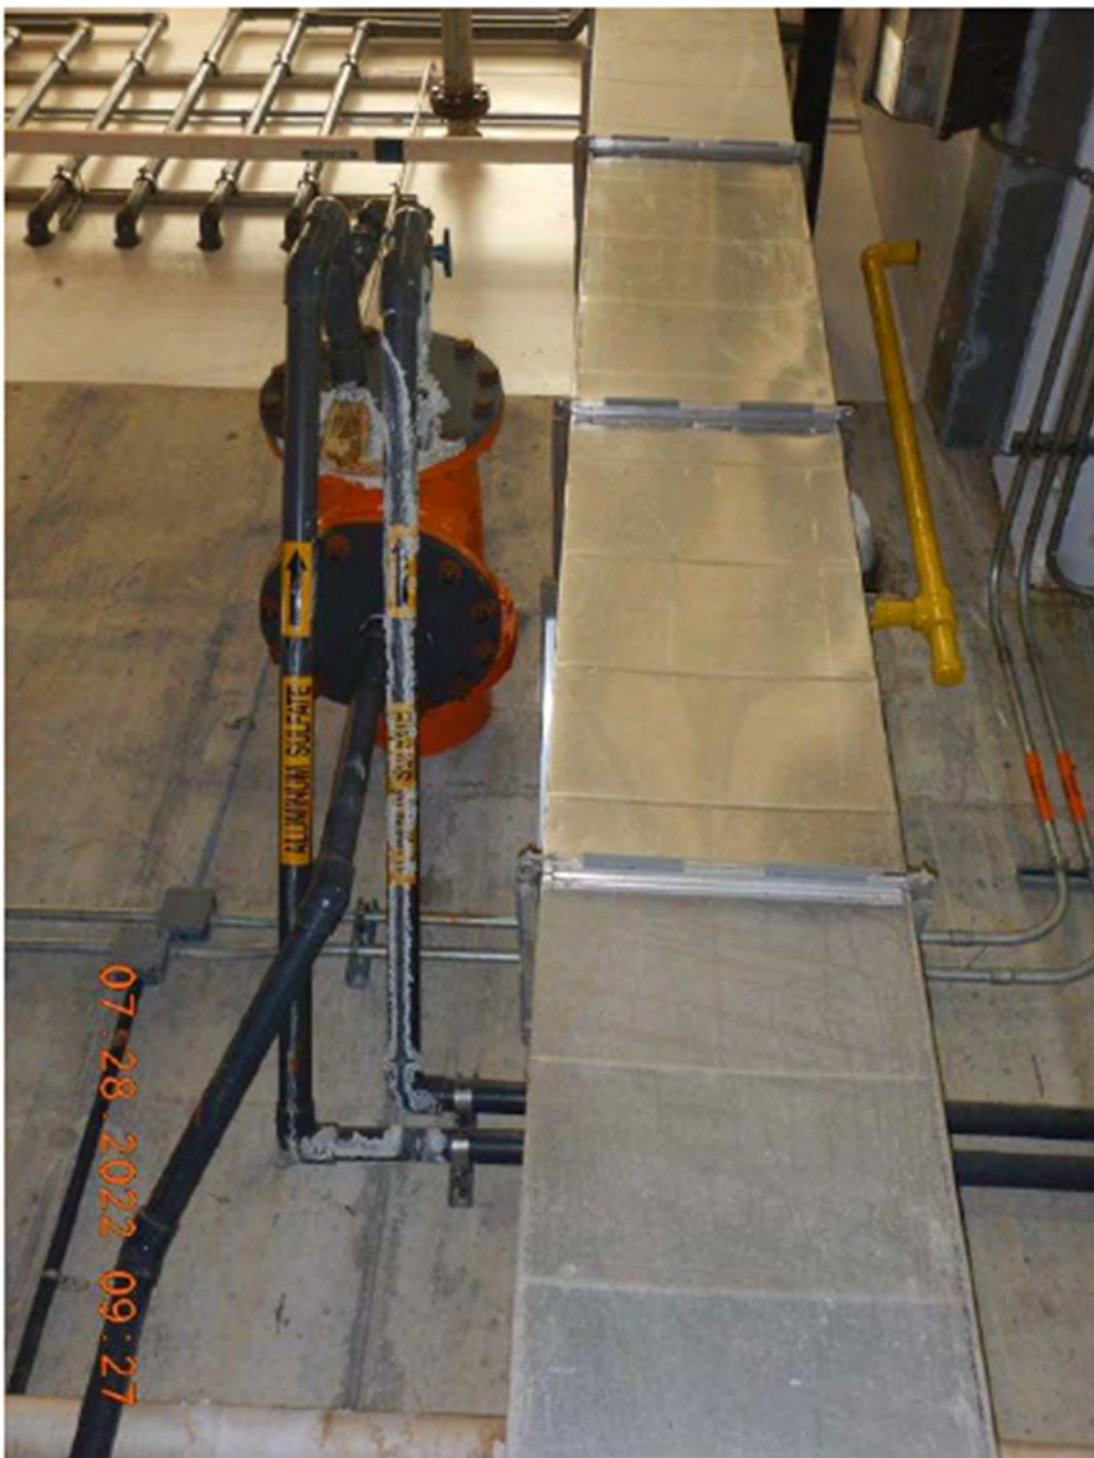
Figure 82. Aluminum sulfate day tank supply line (EPA)

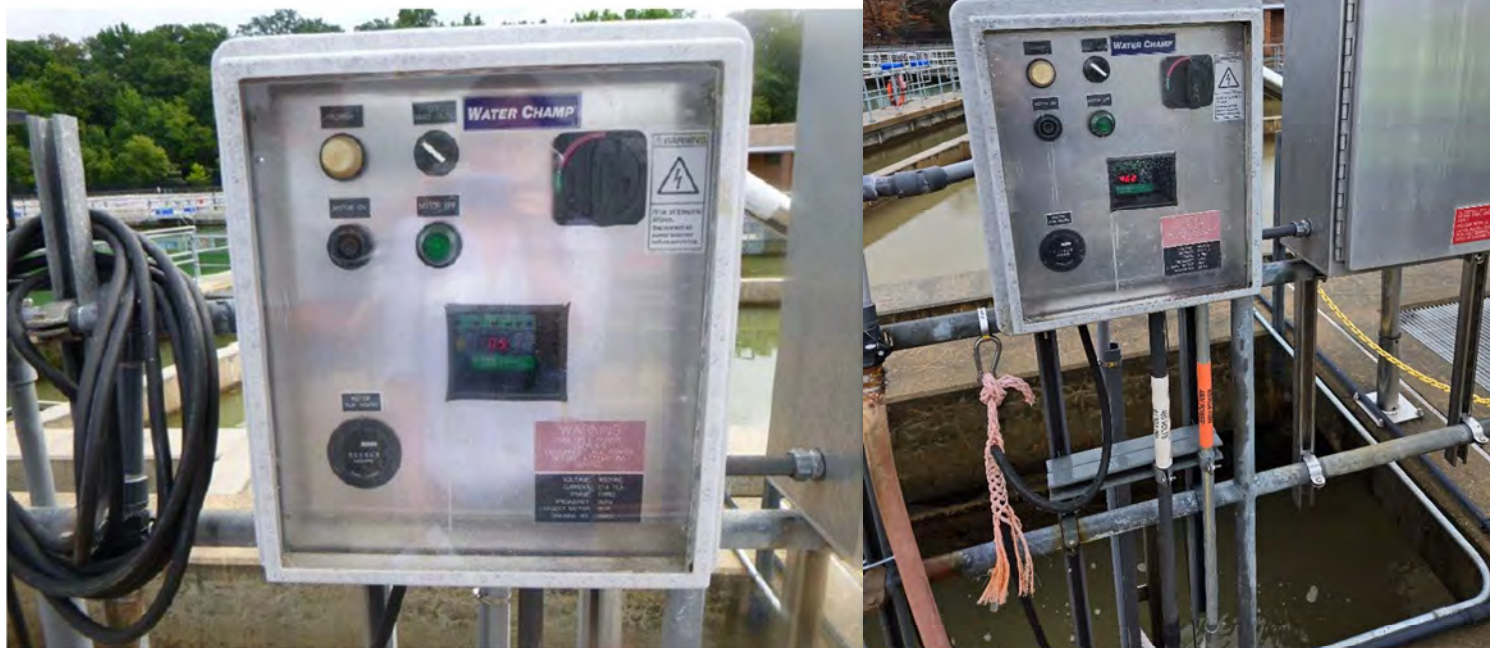
Figure 87. Water Champ flash mixer controls (Left- EPA, Right- VDH)

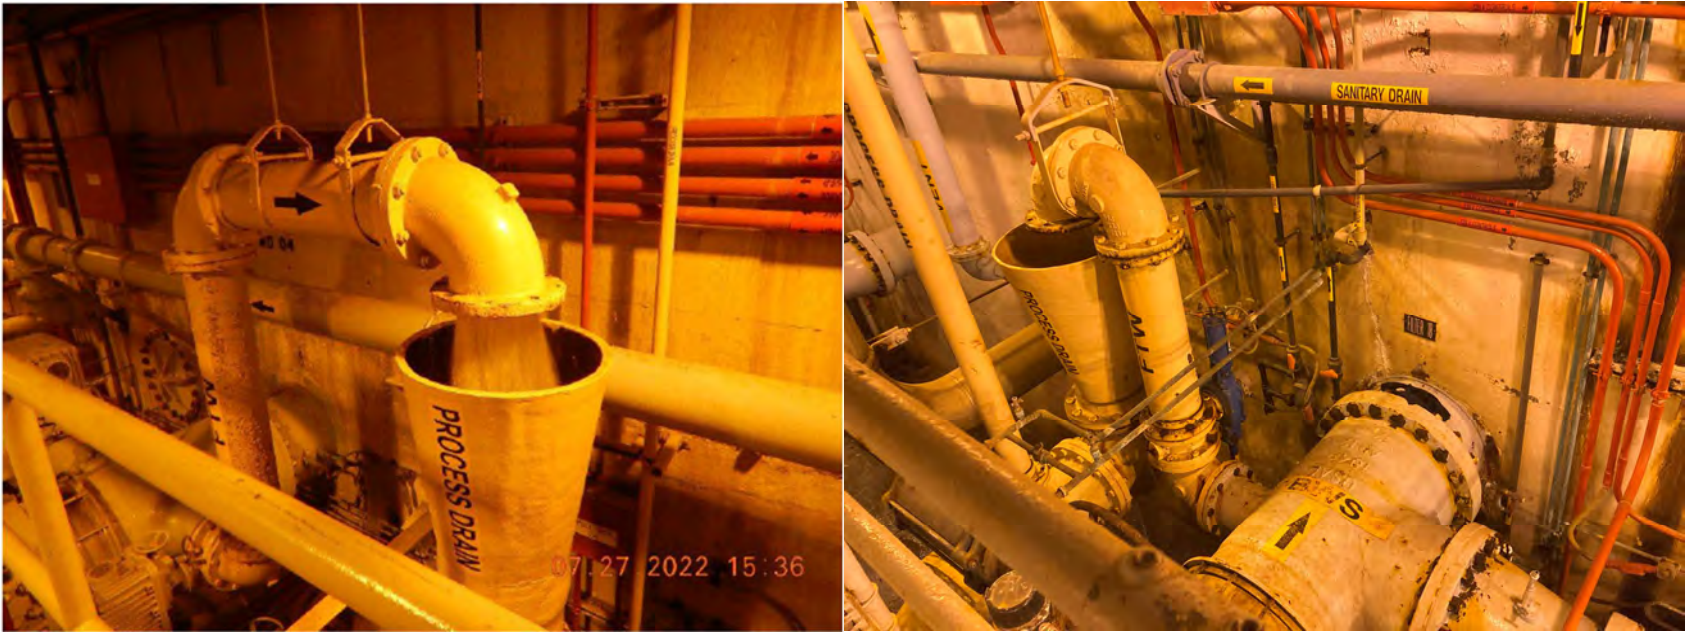
Figure 89. Process Drain (Left-EPA, Right-VDH)
