Comprehensive Waterworks Evaluation and Cost Estimate

City of Richmond, VA

Virginia Department of Health, Office of Drinking Water

VADOH 183662 | April 8, 2025

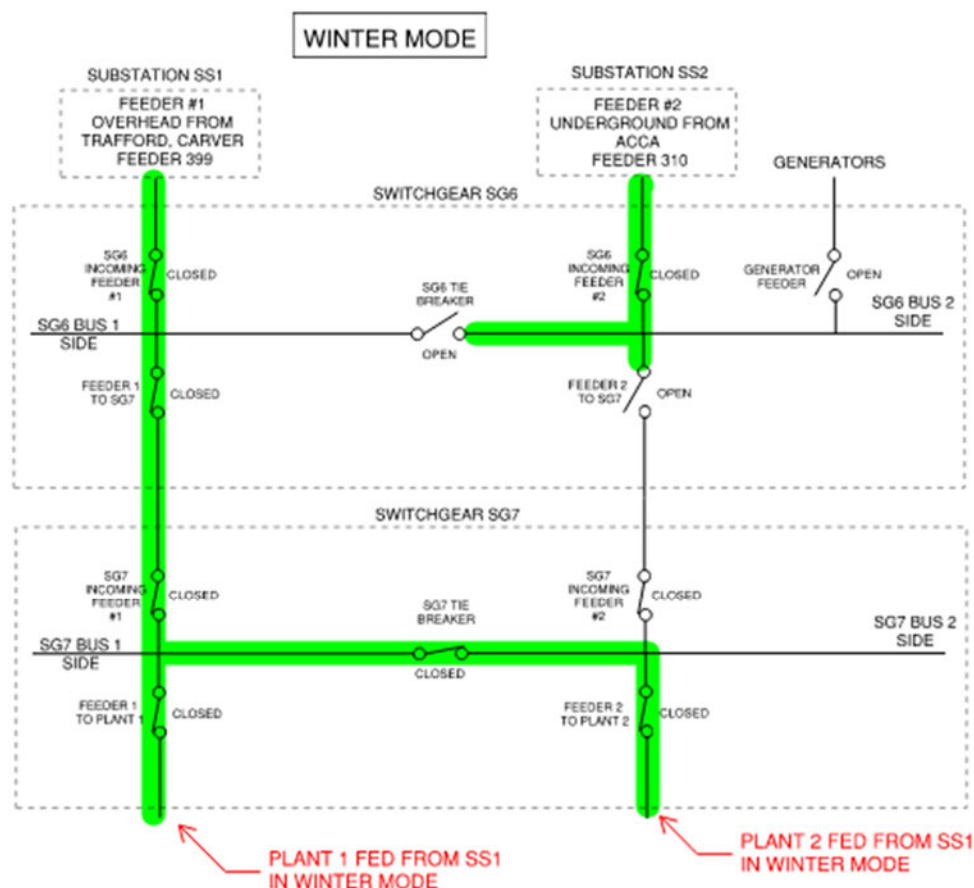
Diagram 2: Winter Mode Electrical Feed

With the WTP operating in Winter Mode, the SG6 Tie Breaker would normally sense that power is still available on the SG6 Bus 2 upon failure of the feed from SS1 and automatically switch the power feed to the Bus 2 side of the Switchgear. A failure of the SG6 Tie Breaker resulted in the breaker not automatically switching over. This resulted in a loss of power to the entire plant. See Diagram below for an illustration of power flow during the power outage of January 6, 2025. Investigation after the event determined that coil was burned out and the associated fuse was blown.

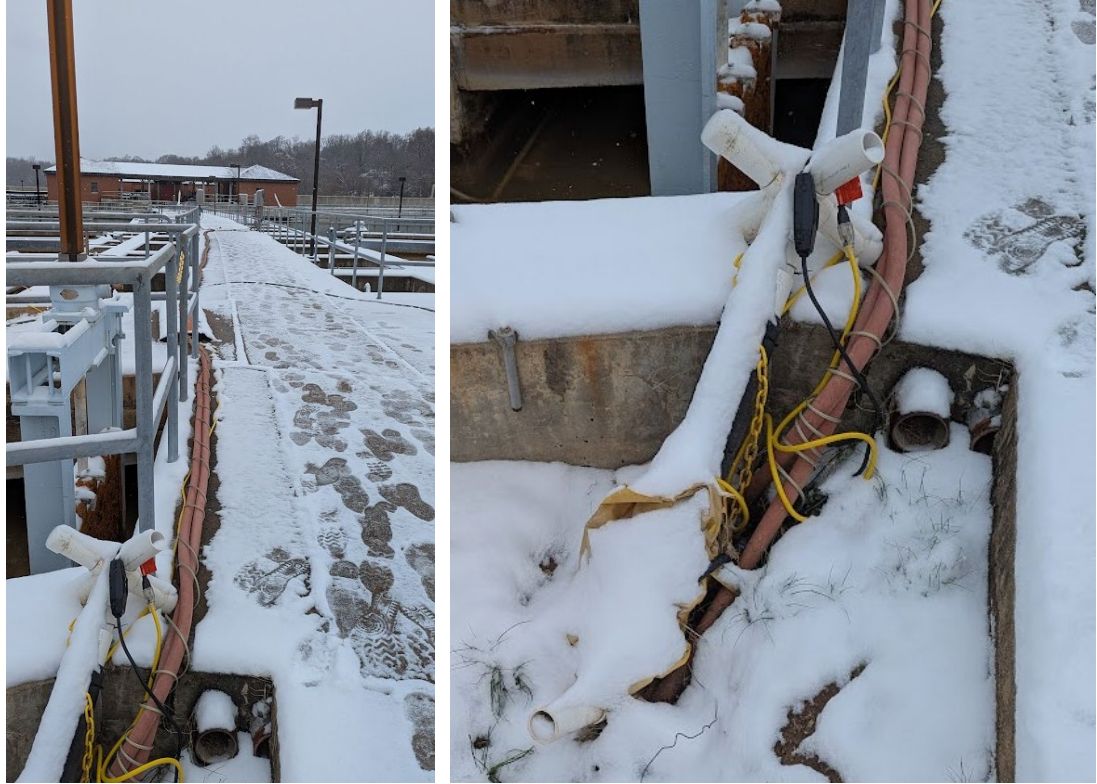
2. SEH staff observed that alum feed hose was installed in a semi-permanent fashion using flexible chemical hoses that were run above the walkway between the raw water channels before discharging into each raw water channel. SEH staff observed the chemical hoses to be routed below the grass before terminating within Plant #2. SEH staff could not locate where the chemical hose transitioned to rigid piping within the building. **12VAC5-590-860** requires that chemical feed lines be protected against freezing and specifically requires that liquid alum does not mix with water before the point of application. Recommend permanently installing feed lines in such a manner to protect them from freezing and damage minimizing trip hazards.

*Alum chemical hoses run above ground and along walkway to channel mixers.
Extension cords and heat tracing run along hoses.*

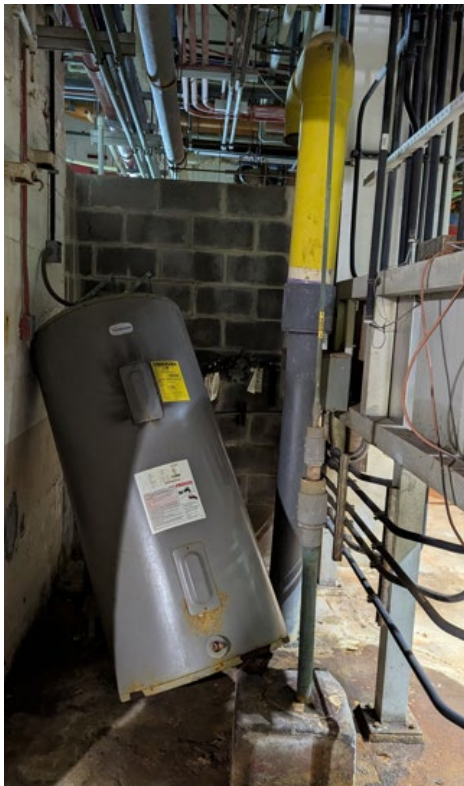
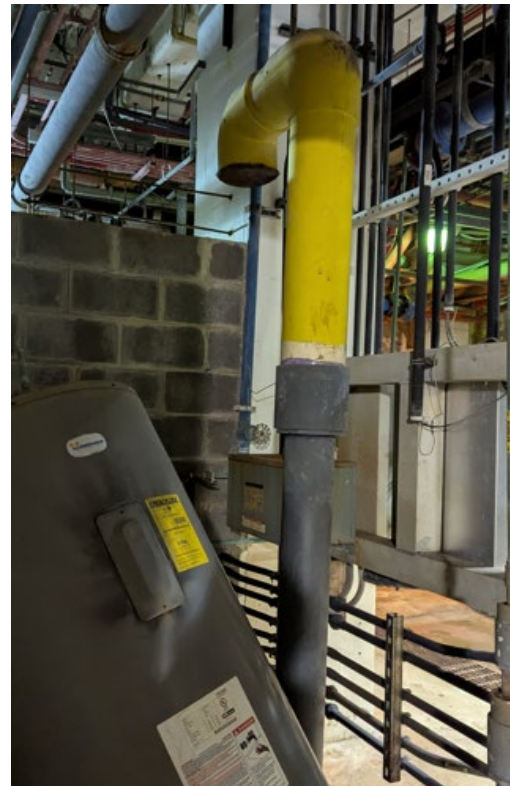
Vent Pipe in Plant #1

3. The lack of designed overflows for the plant clearwell is a critical issue. DPU staff reported that filtered water frequently surcharges and floods the filter gallery and pumping rooms which are connected. In Plant #1, DPU staff note that water has surcharged out of a PVC vent pipe located approximately 8' above the finished floor, discharging into the pump room. It appears that the vent pipe was previously raised. It is unlikely that a larger overflow pipe could be installed and extended further up out of the plant. During a surcharge event, the pump room floor slab may be subject to imbalanced water pressure forces that it may not

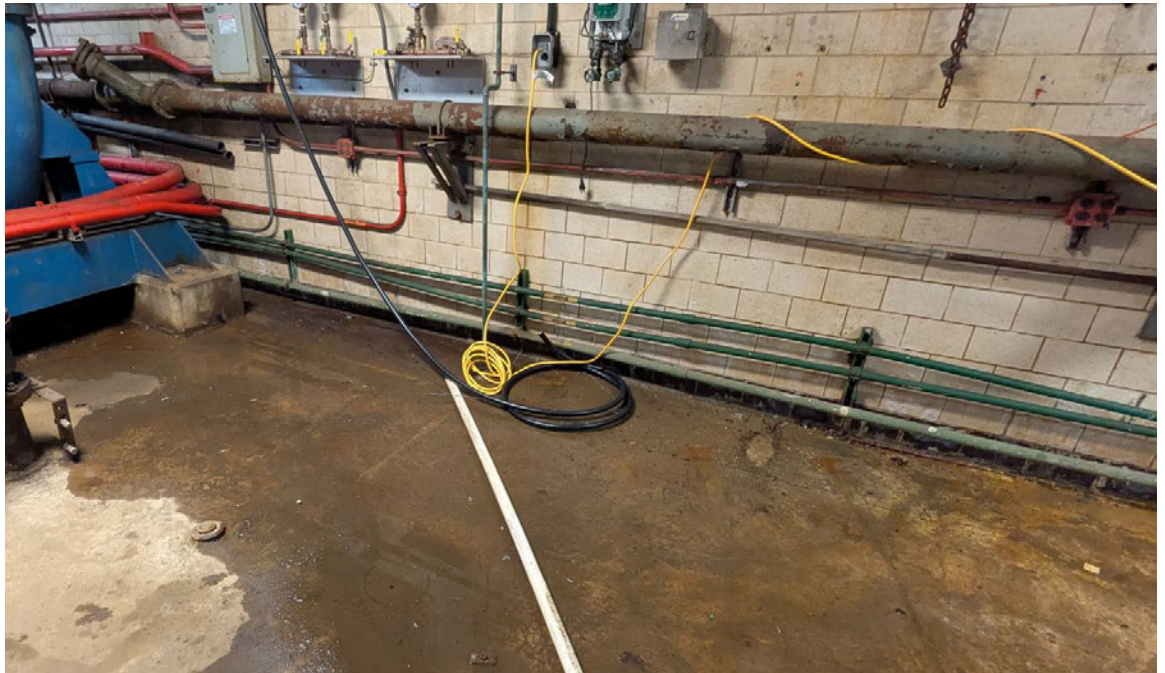
Standing Water in Plant #1 – Pumping Room

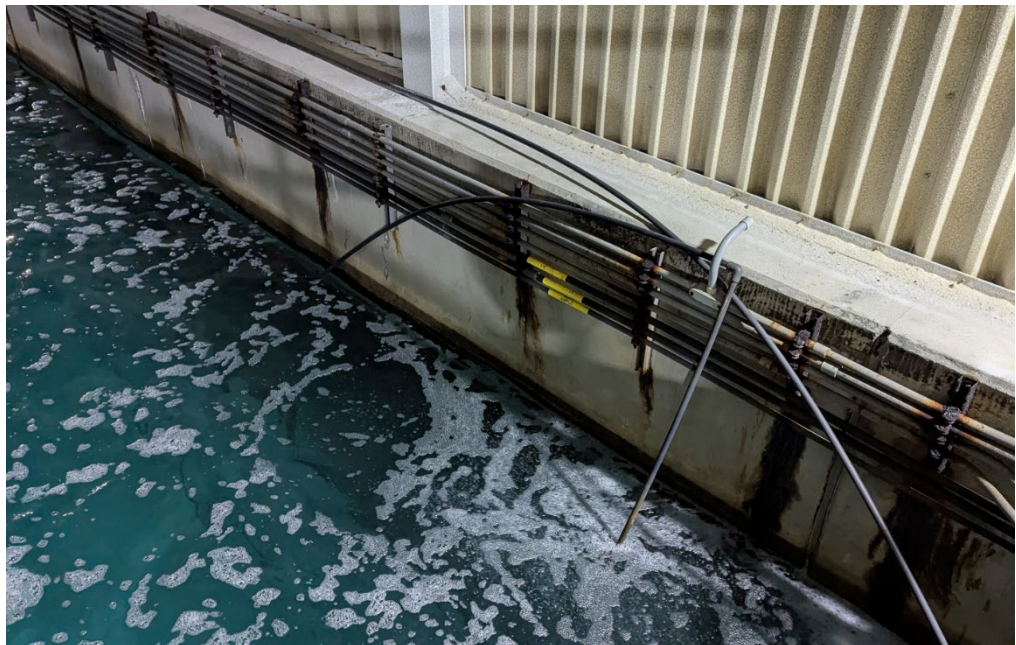
6. Piping supports throughout both basins appeared to be severely corroded and damaged. In Plant #1, several supports were broken, with two sampling or conduits hanging loose. One pipe appeared to have been pulled up onto the concrete wall, while another was found hanging below the water surface. Recommend replacing piping and supports.

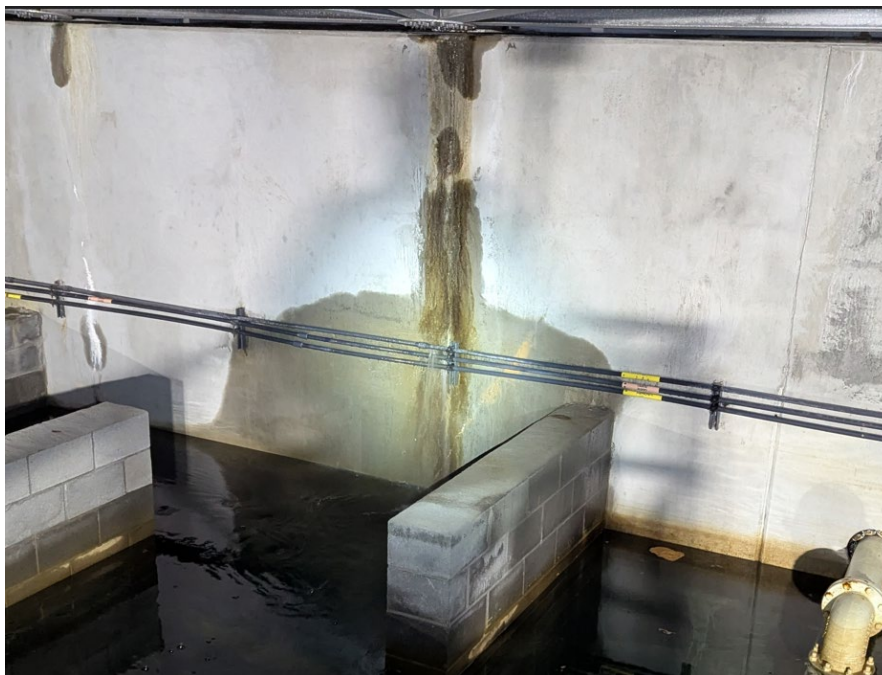
7. A PVC sample line in the north chlorine contact basin appeared to be broken and spraying significant amounts of water. Recommend replacement of the PVC pipe.

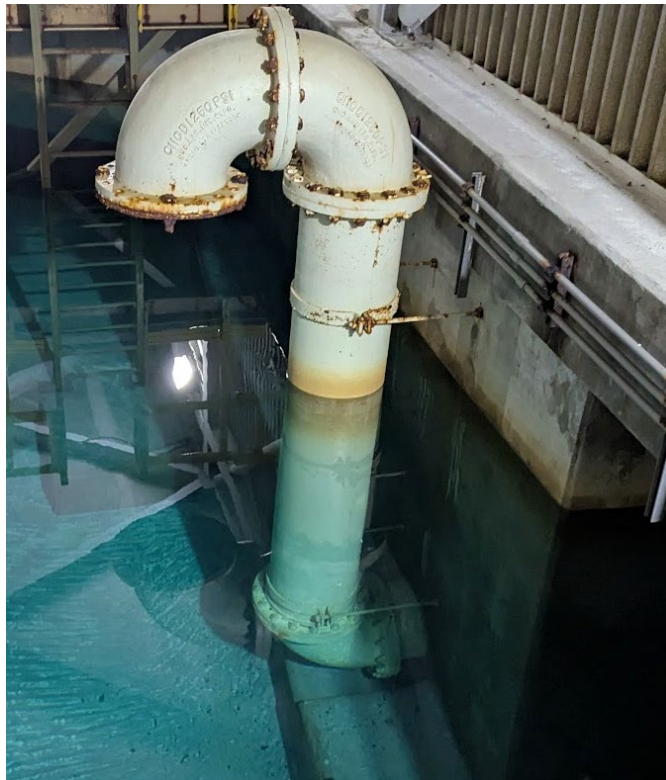
9. The Plant #1 filtered water clearwells and underdrain are vented into the north chlorine contact basin. While this does not appear to violate code, the presence and condition of any screens could not be evaluated.

Filter Plant #1 Vent into Chlorine Contact Basin
