### System Sanitary Survey Report

April 3, 2026

SUBJECT: Richmond City  
Waterworks: Richmond, City Of  
PWSID: VA4760100

Survey Date: February 23, 2026

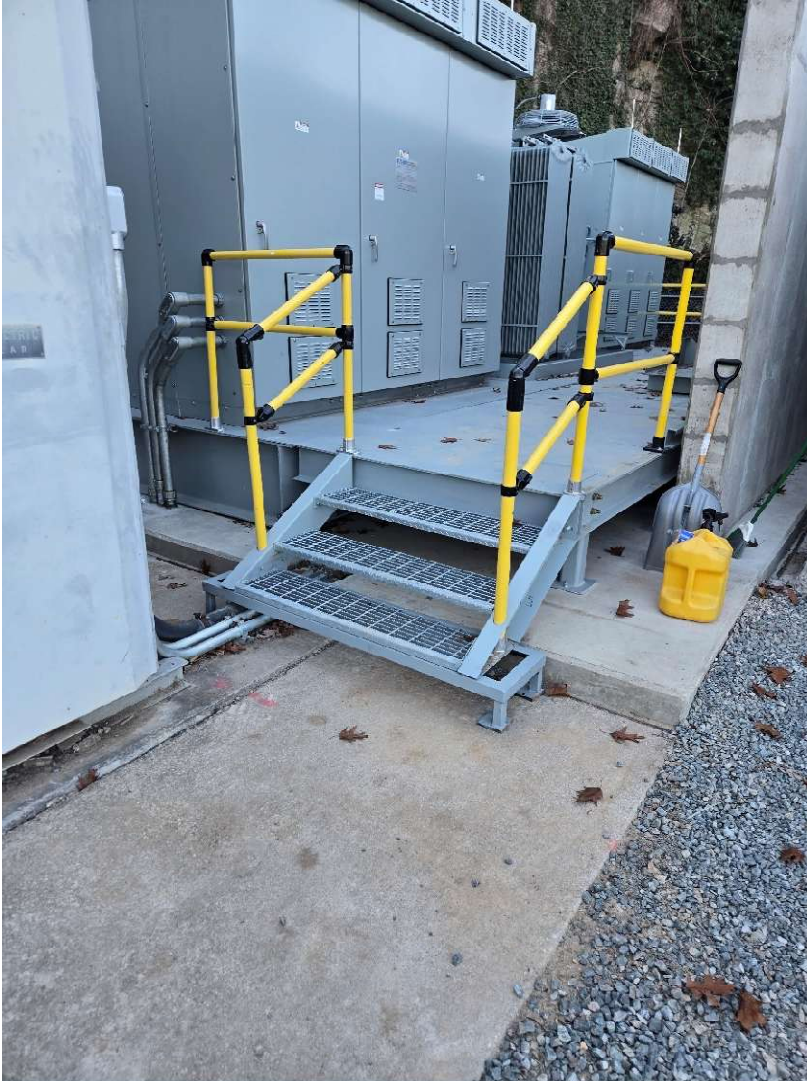
- Electrical substation project was in progress to replace/rehab the substation (Figure 1)
- Automatic transfer switch was installed to allow automatic activation of the generators should both substation feeds go down. The transfer switch was tested and worked successfully. (Figure 2)

*Figure 1. Electrical substation*

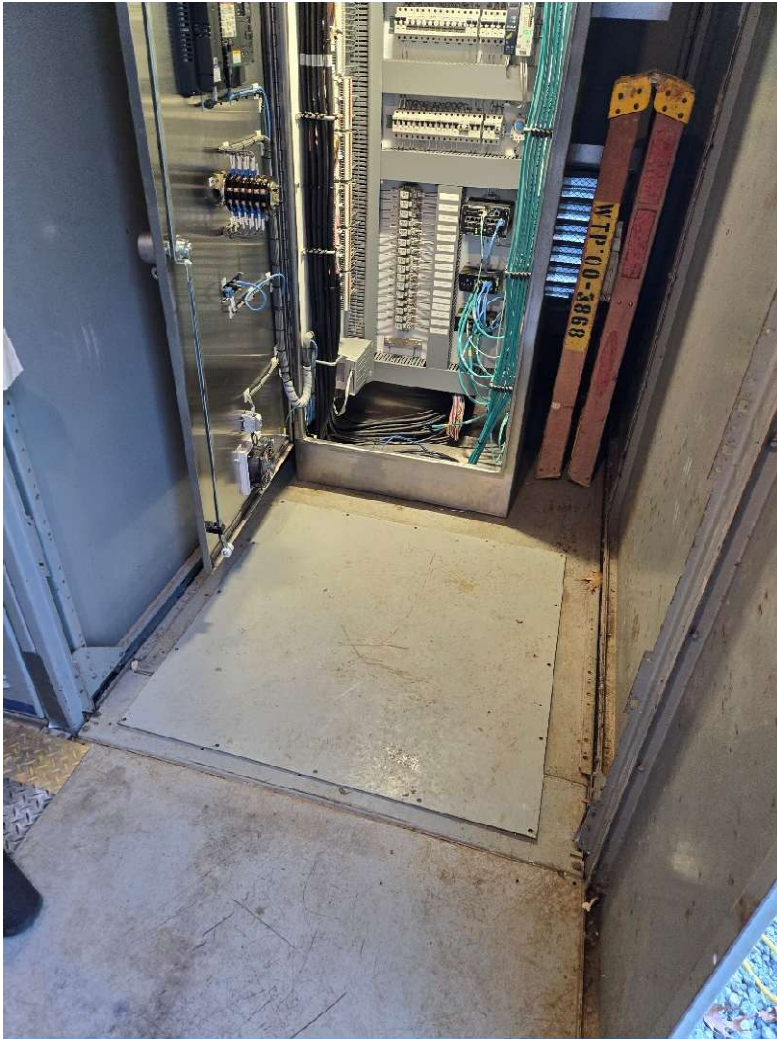
*Figure 2. Automatic transfer switch installed*

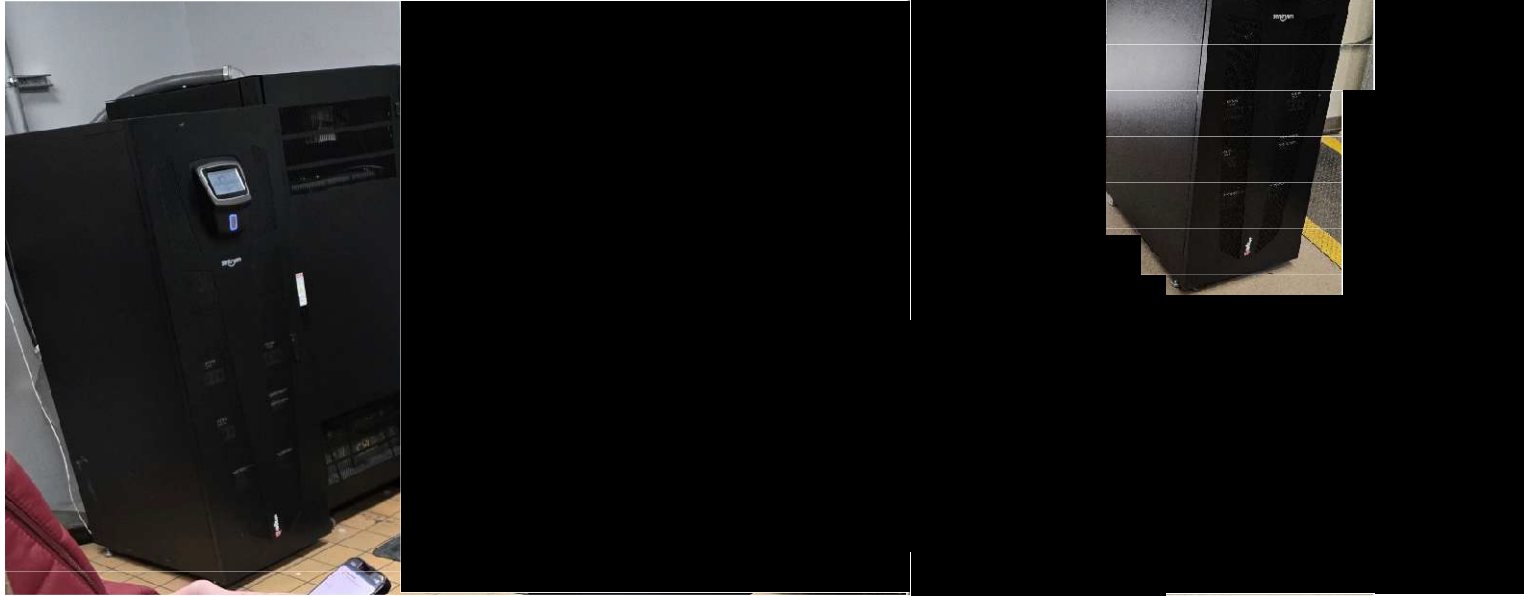
- UPS systems for both Plant 1 and Plant 2 replaced with upgraded systems and successfully tested. If activated, able to do a controlled shutdown of filters (Figure 3)
- UPS system for Plant 1 moved from closet (Figure 3)
- Implemented new UPS system checks and PM schedules
- Integrated into SCADA to notify if UPS systems lose power

Figure 3. UPS systems upgraded. Plant 1 (left), Plant 2 (right)

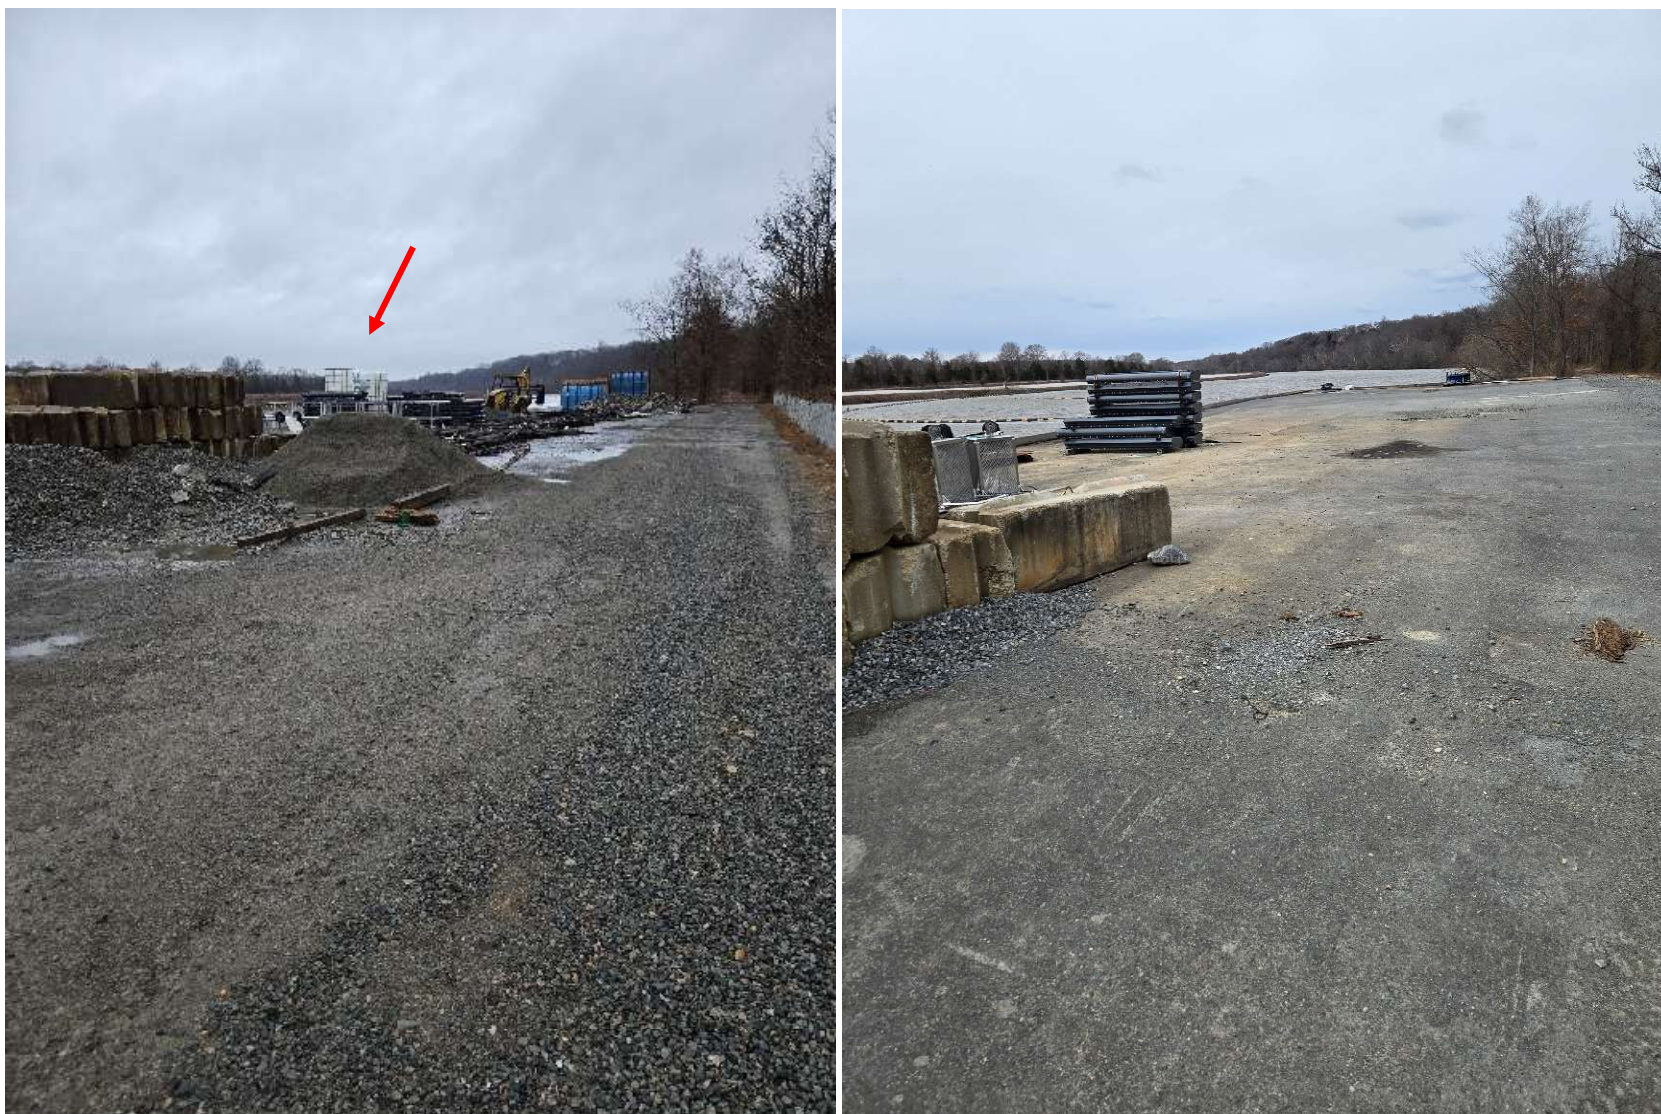
- Floodwall tested by Army Corps of Engineers
- No chemical totes observed near pre-sedimentation basin (Figure 4)
- No trash buildup observed at travelling screen collection bins (Figure 5)
- Dredging projects planned for waste lagoon and pre-sedimentation basin in March 2026
- Elevated raw water turbidity compared to average due to recent rain/snow events, no issues with treatment observed
- Copper sulfate SOP drafted, minimal use of copper sulfate
- Plant growth on earthen berm appeared to be minimized (Figure 6)
- System scheduled to install water quality monitoring at head of pre-sedimentation basin to provide advanced time to react to water quality data

Figure 4. Chemical totes at pre-sed(2025 left), No chemical totes observed (2026 right)

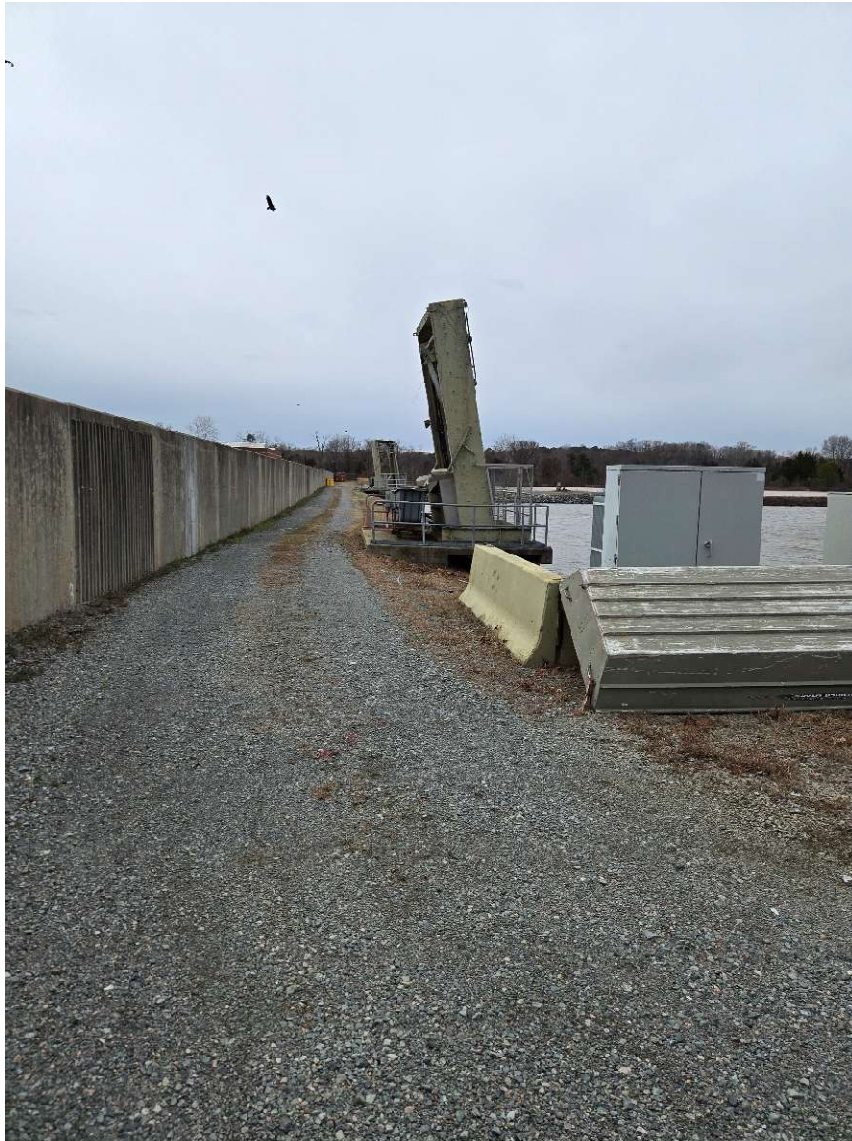
*Figure 5. Pre-sed traveling screens*

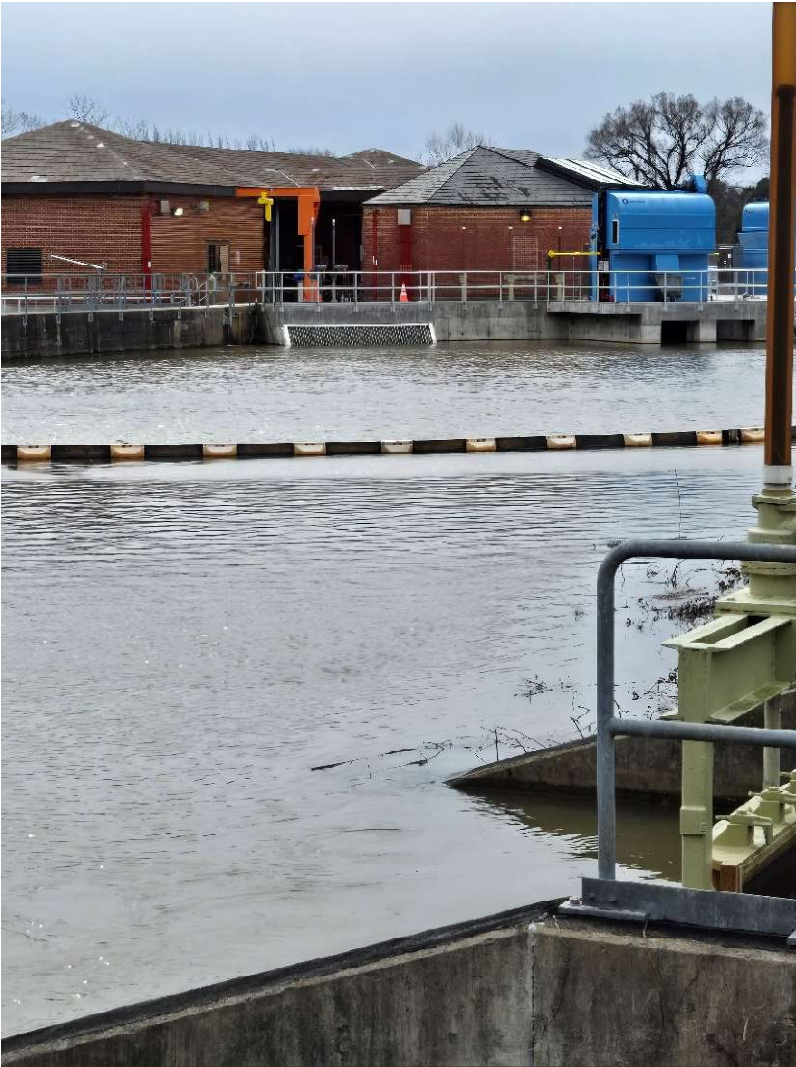
- Flow only from Pre-sedimentation basin, no flow from canal
- No issues observed at raw water basins (Figure 7)
- Screens at raw water pumps all new, project mostly complete only punch-list items remain (Figure 8)

*Figure 7. Raw water basins*

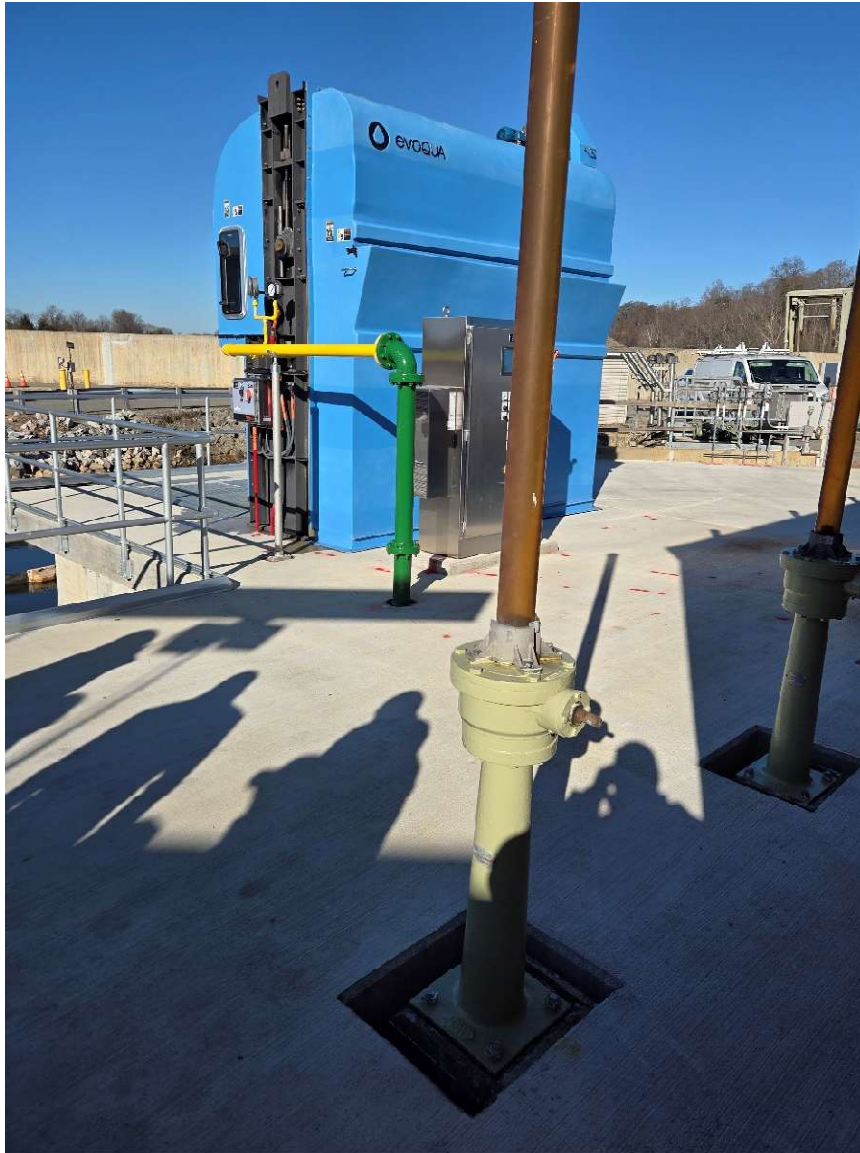
*Figure 8. New raw water screens*

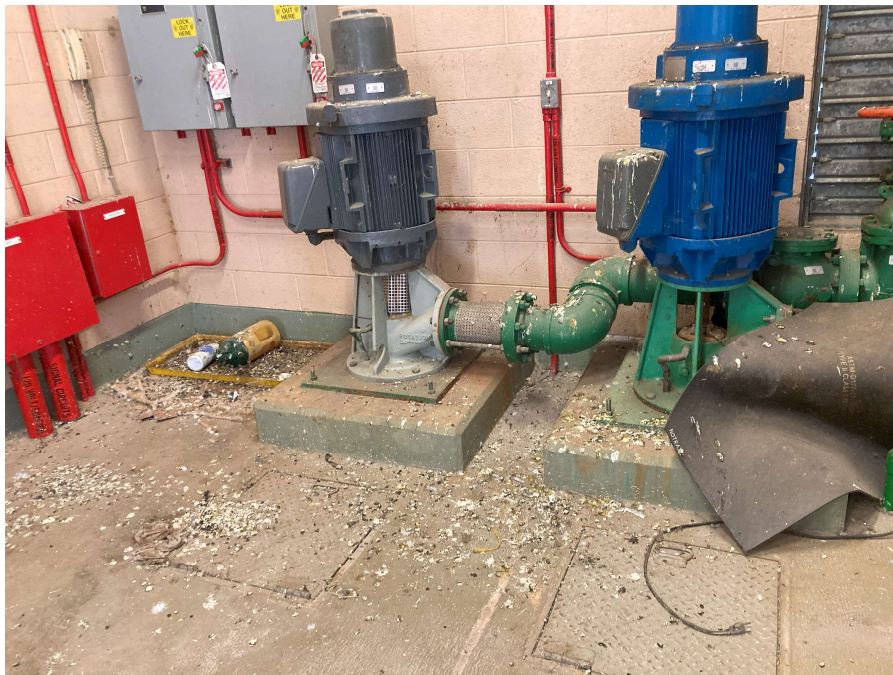
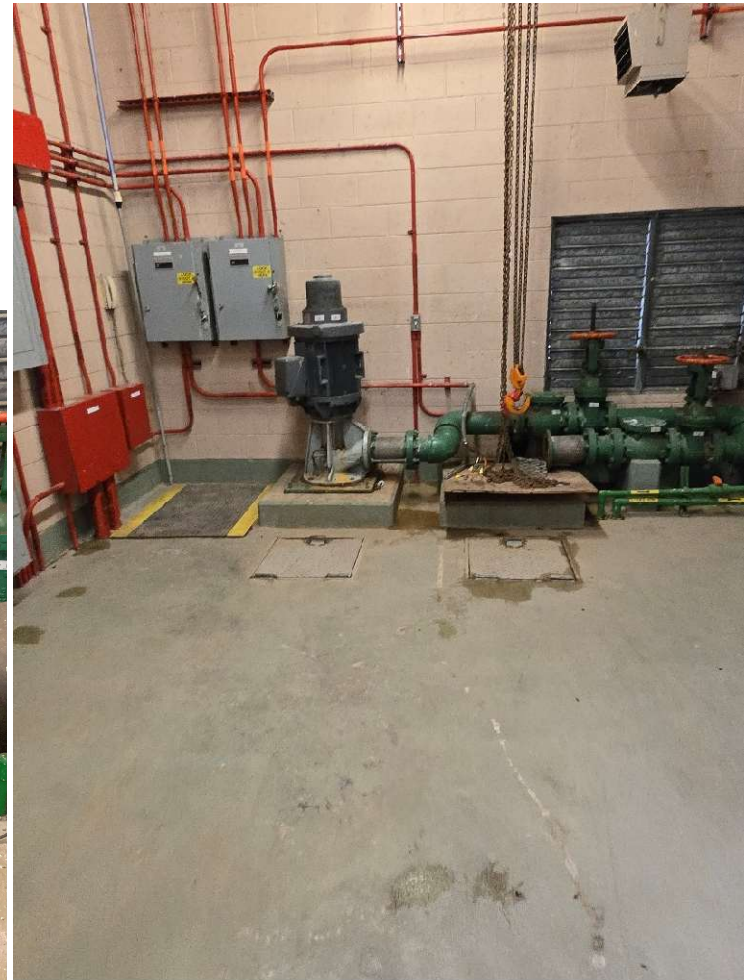
- Raw water pump shaft safety guards all in place and intact (Figure 9)
- No bird droppings or trash observed in raw water pump buildings, all buildings clean and orderly (Figure 10)
- All pumps operable
- Permanganate being fed year round downstream of raw water pumps (Figure 11)

Figure 10. Housekeeping- Bird droppings (2025 left), Cleaner area observed (2026 right)

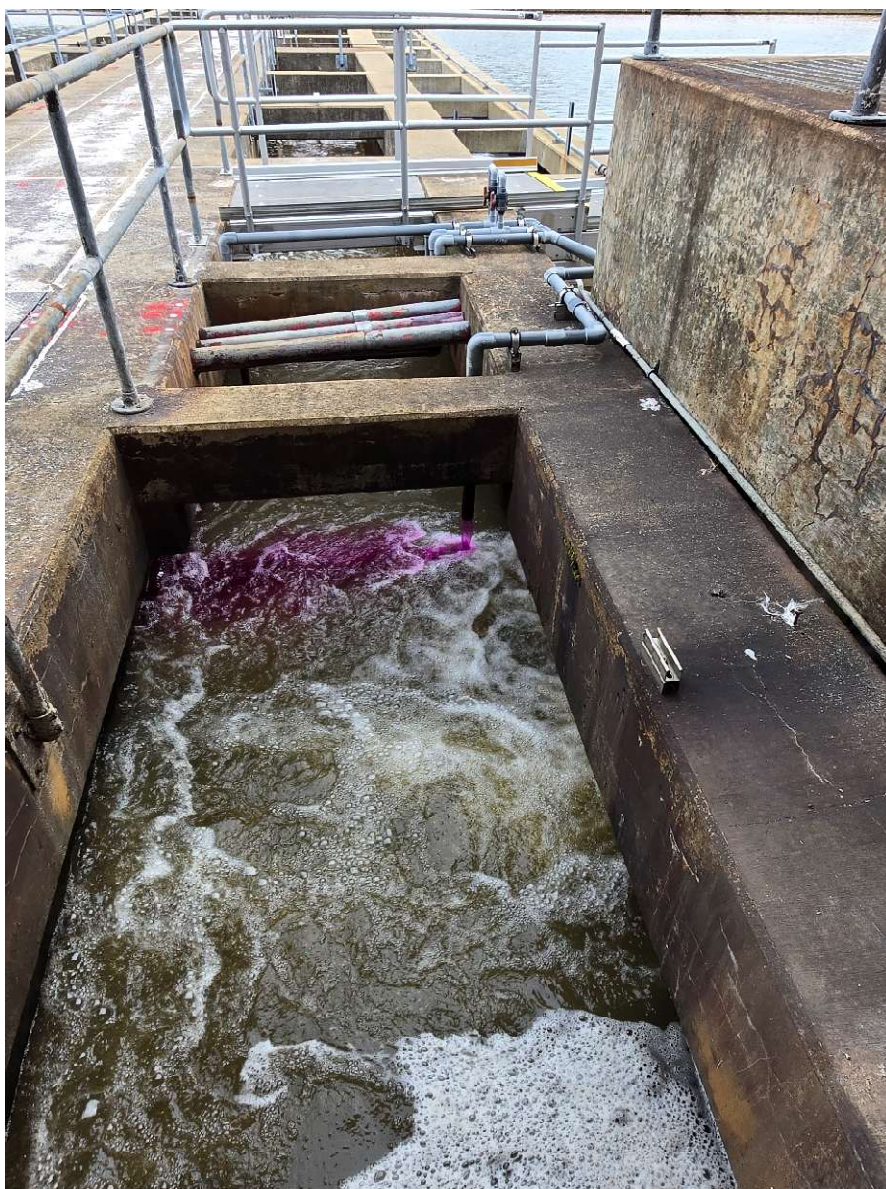
*Figure 11. Permanganate feed year-round*

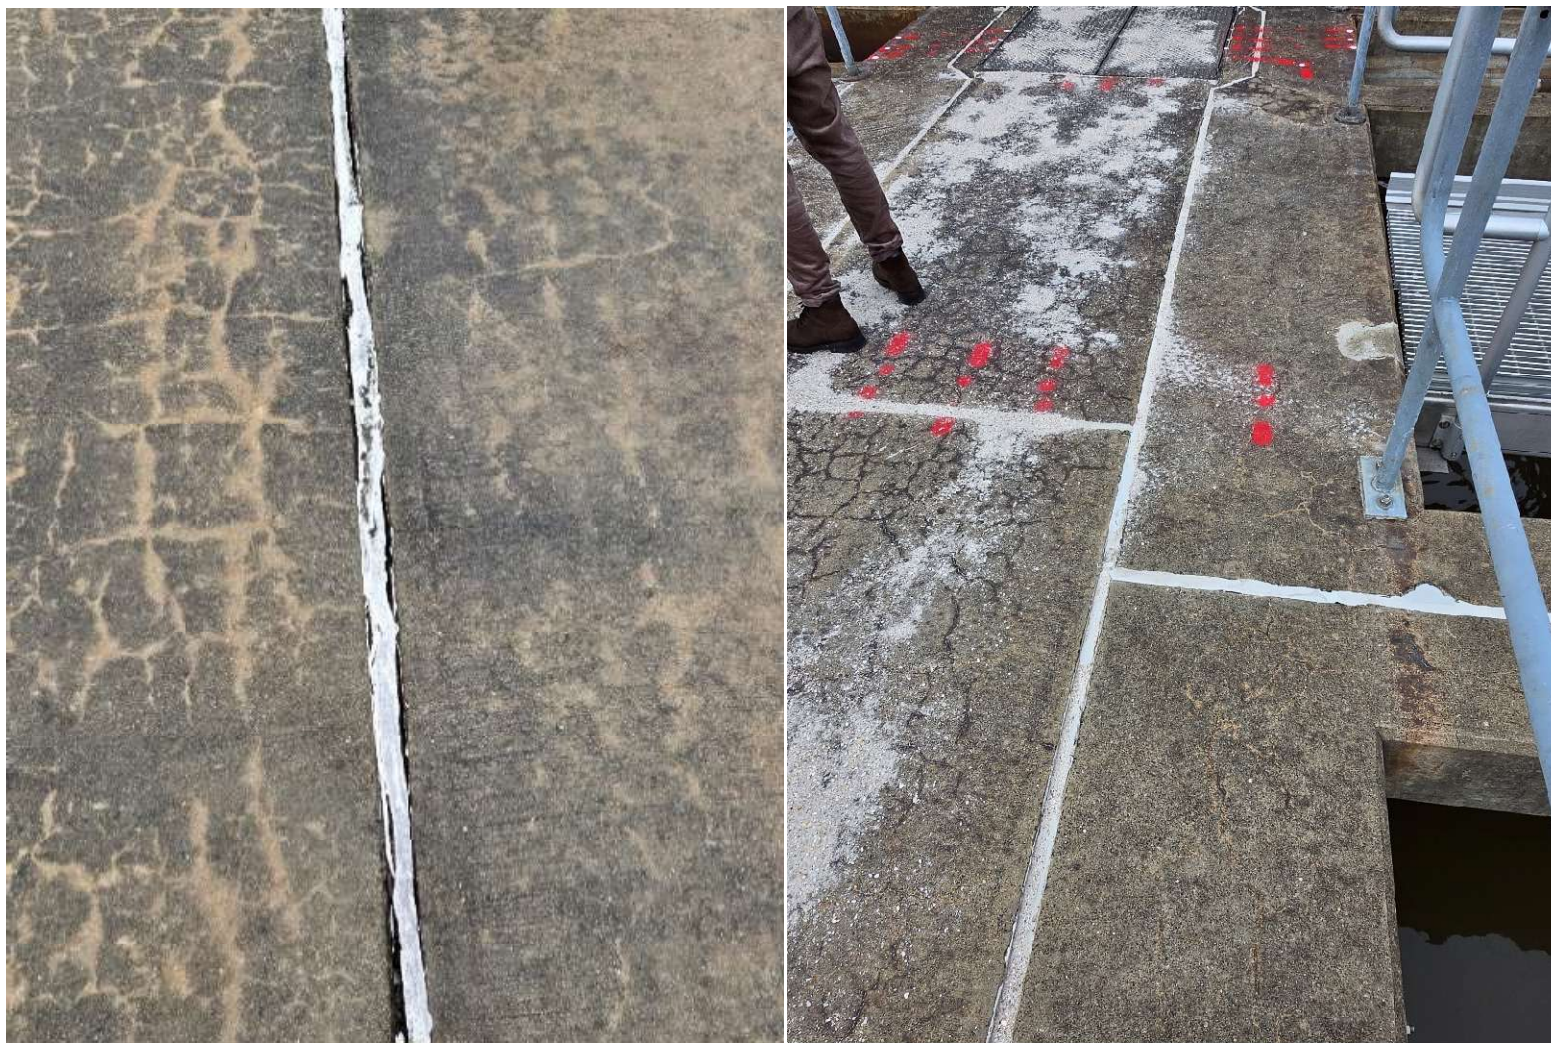
- Walkway between Plant 1 and Plant 2 from raw water pump buildings to WTP main building had repaired the sealant between concrete sections (Figure 12)

*Figure 12. Sedimentation basin walkway (2025 left), sealed (2026 right)*

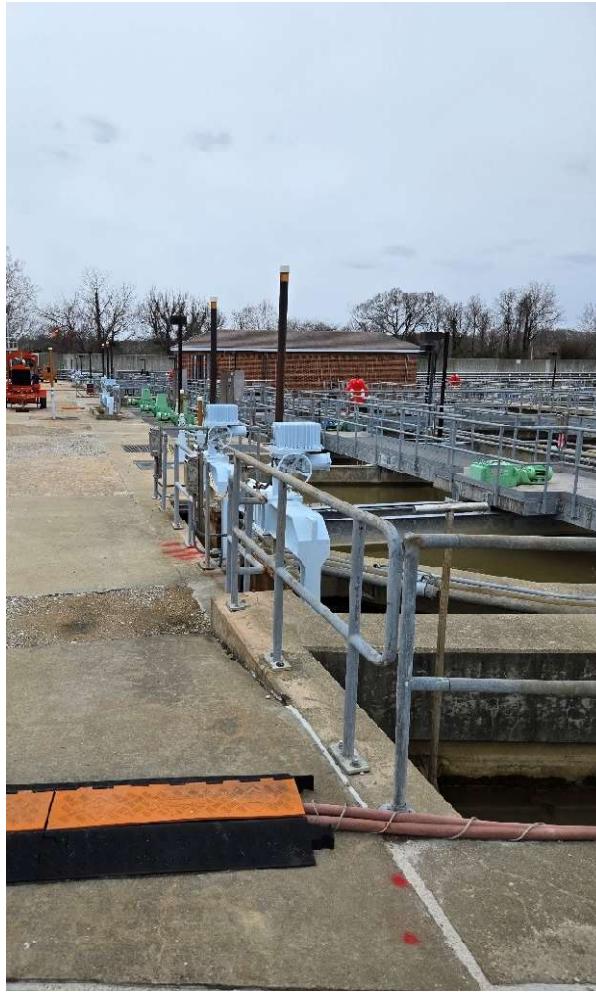
- No chemical totes observed near flocculators (Figure 14)
- Turbidimeters for settled water moved closer to sample point, shortens travel time to analyzer to provide more accurate readings

Figure 14. Chemical totes near sedimentation basins (2025), No totes observed (2026)

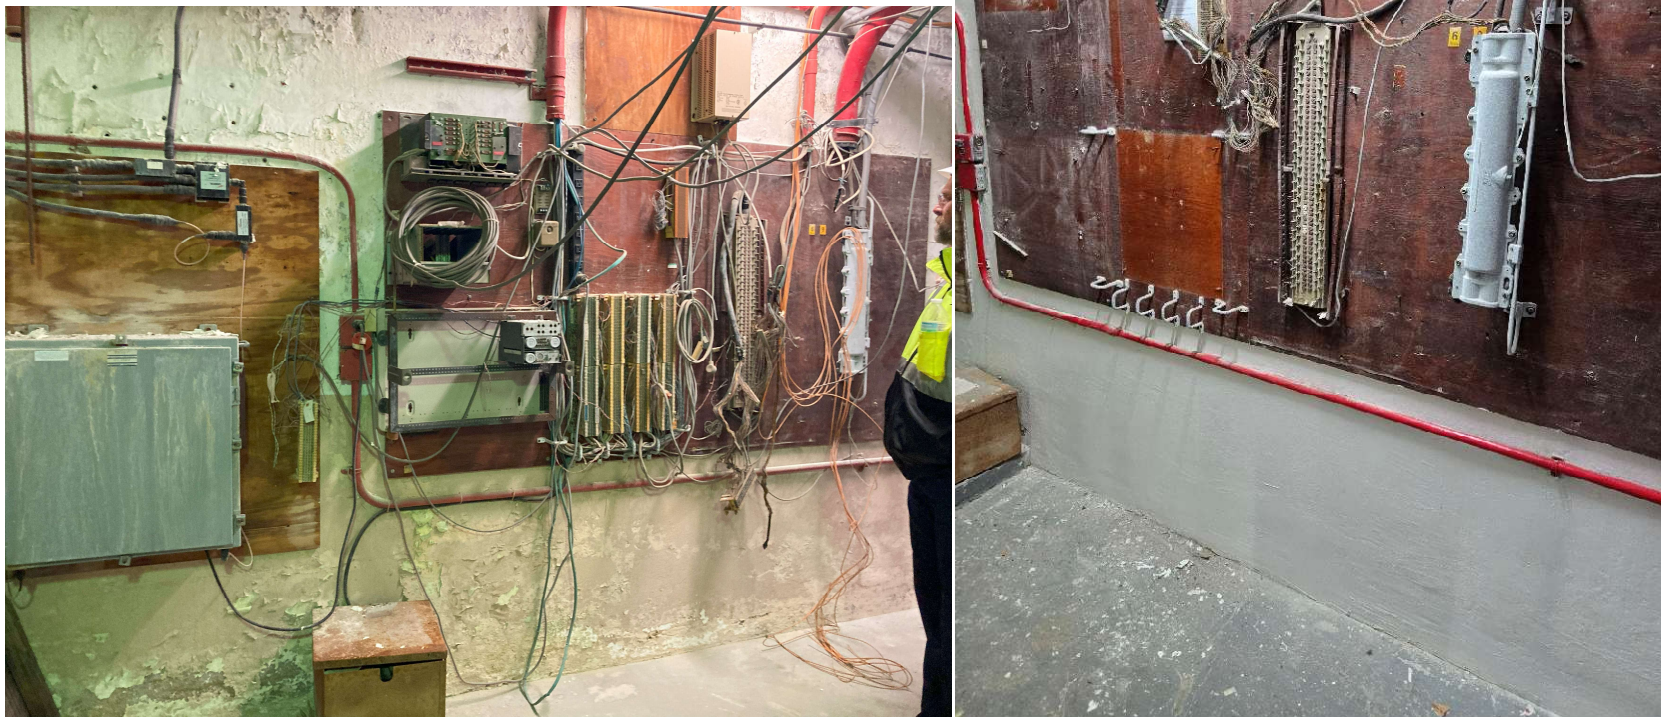
- System has resumed filter drop tests, backwash expansion tests. Plans to incorporate routine filter rise tests in 2026.
- Some of the obsolete electrical wires and associated equipment that were previously observed in the filter gallery have been removed as much as feasible and cleaned up (Figure 15)

*Figure 15. Obsolete equipment abandoned in place (2025), Wiring removed as much as possible (2026)*

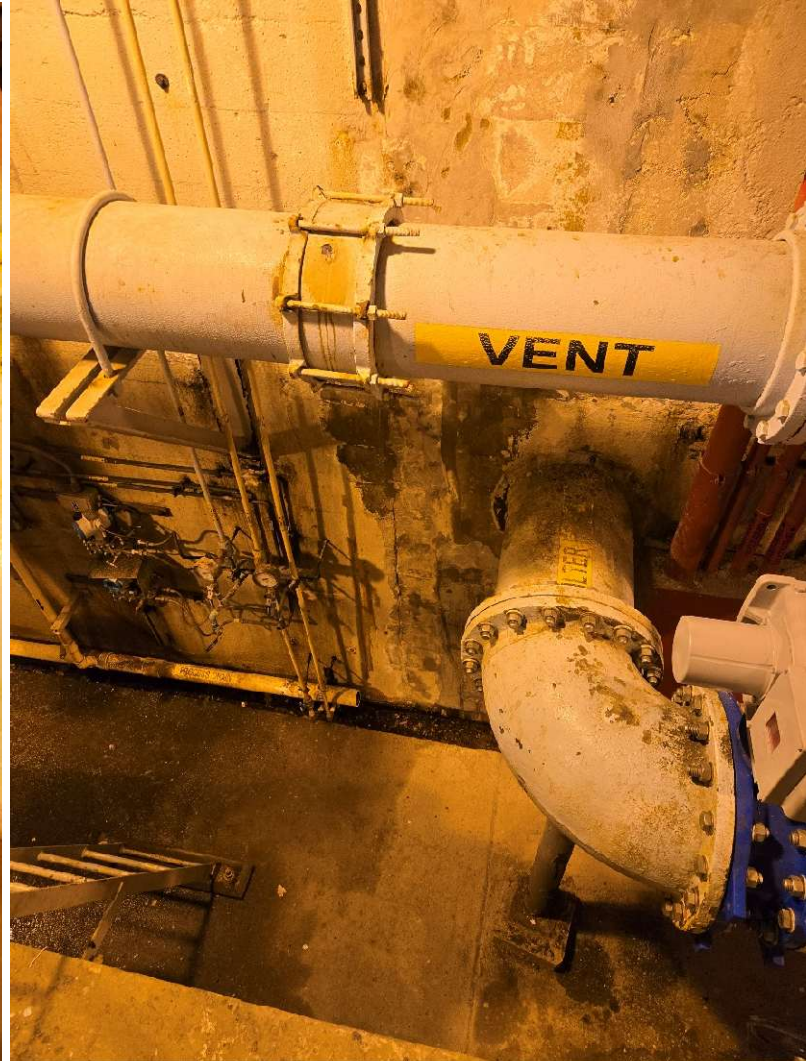
- No active leaks or biological growth observed (Figure 16, Figure 17)
- Backwash waste area appeared to have less standing water (Figure 19)

Figure 16. Filter 6 leaking through wall (2025); No leak observed (2026)

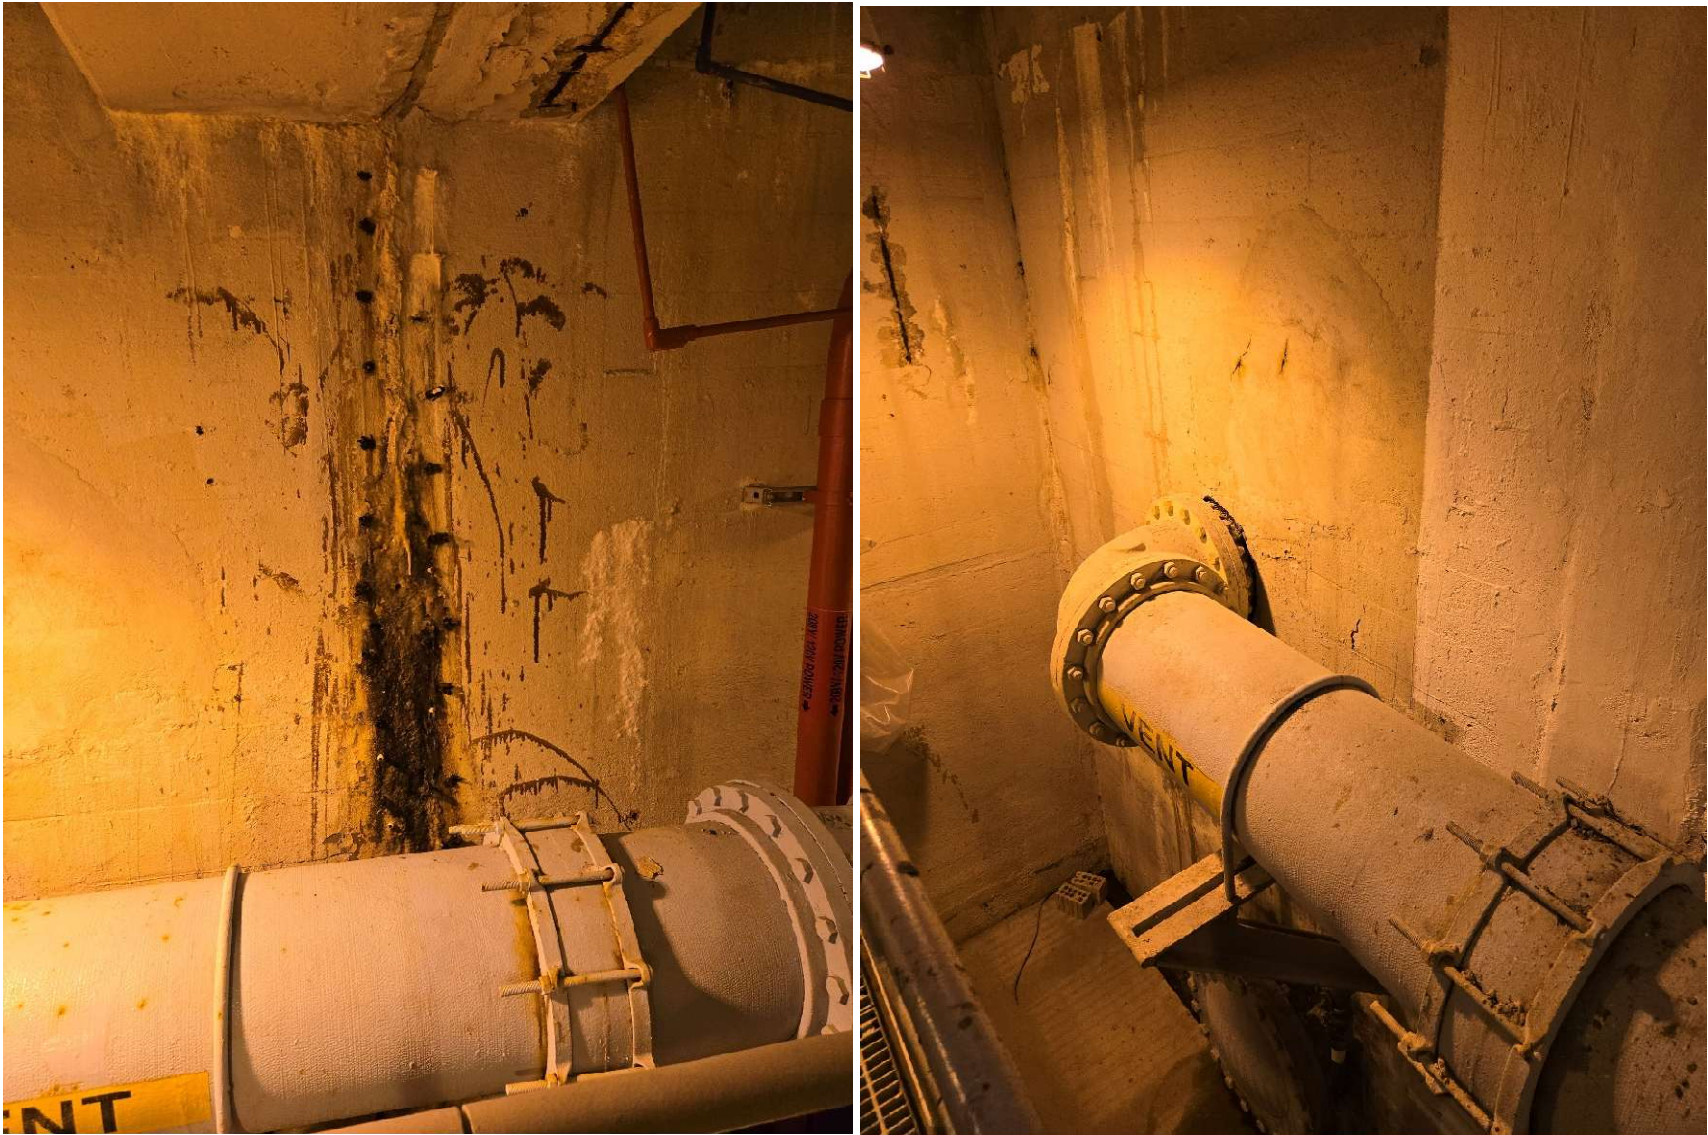
Figure 17. Leak and biological growth (2025); No leak observed (2026)

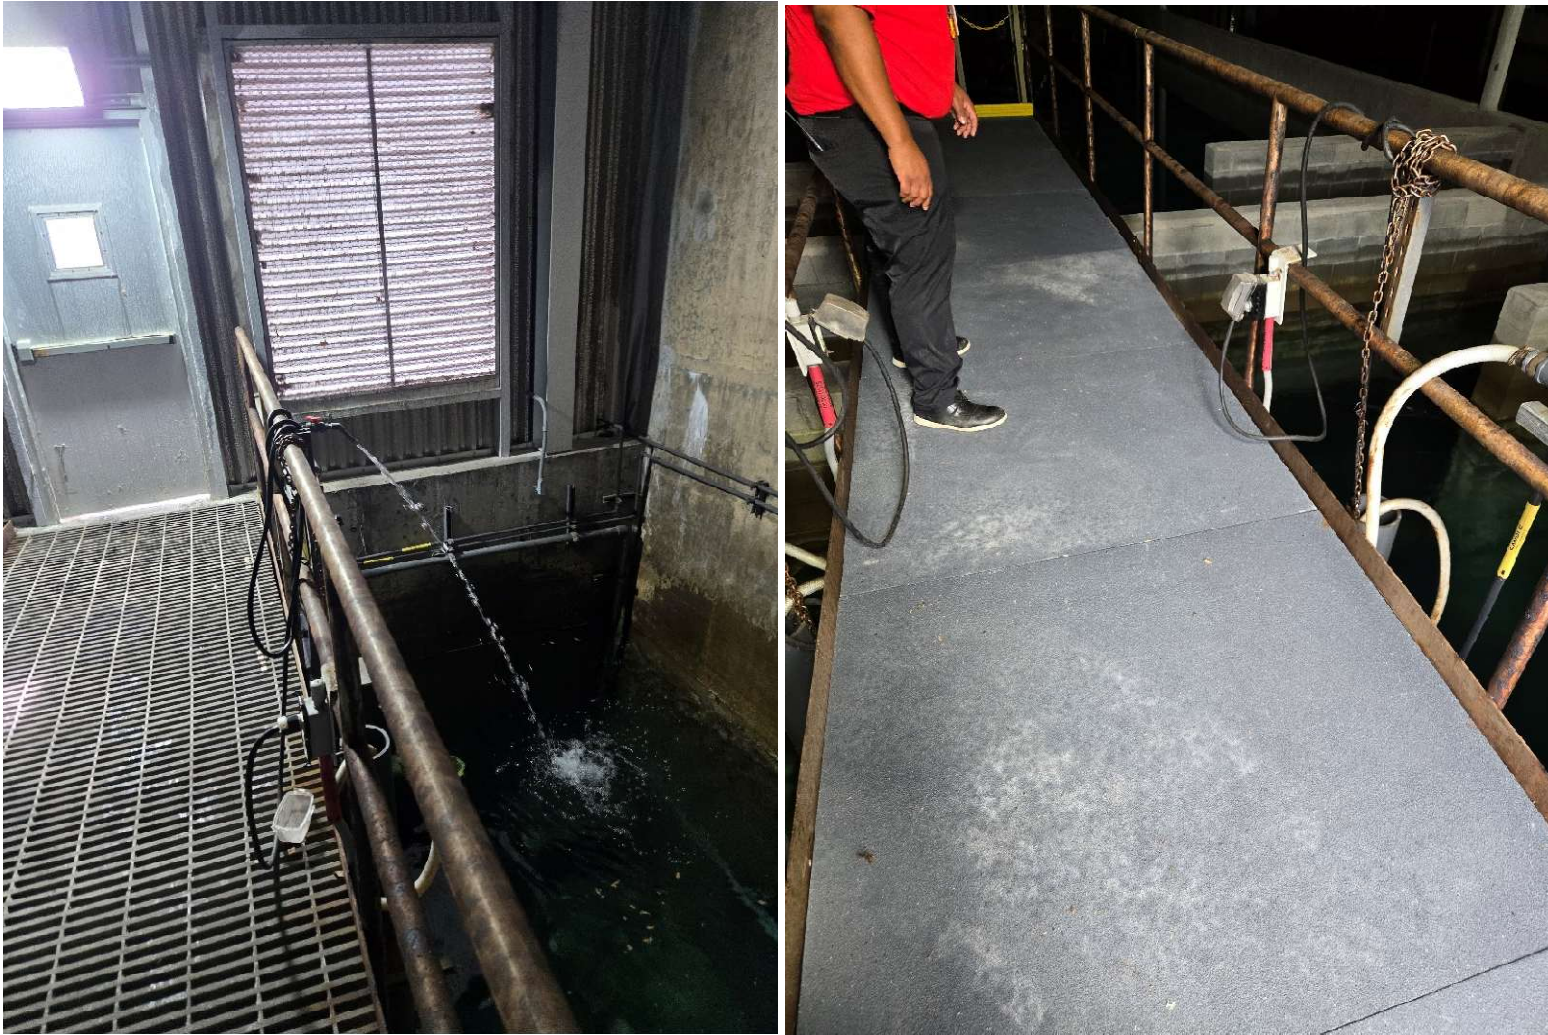
- All walkways into finish water basins have curbing, solid walkways to prevent dirt from falling into water (Figure 20)
- Walkways appeared clean with no debris observed (Figure 20)
- No scum observed at end of basins (Figure 21)
- System instituted routine cleaning of basins
- Previously observed obsolete PVC lines have been removed (Figure 22)
- Finish water basin lighting appears to have improved, brighter inside basins

*Figure 20. Water beneath grates visible, no solid base on walkway (2025); Grates covered (2026)*

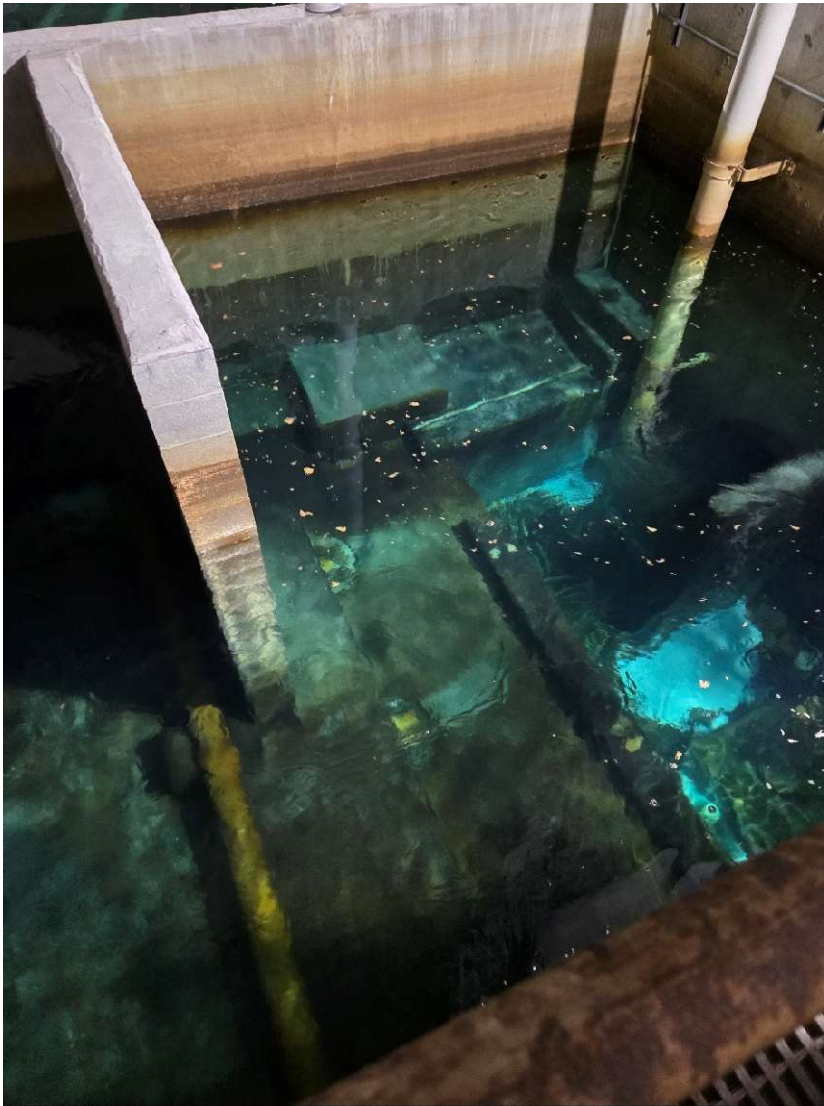
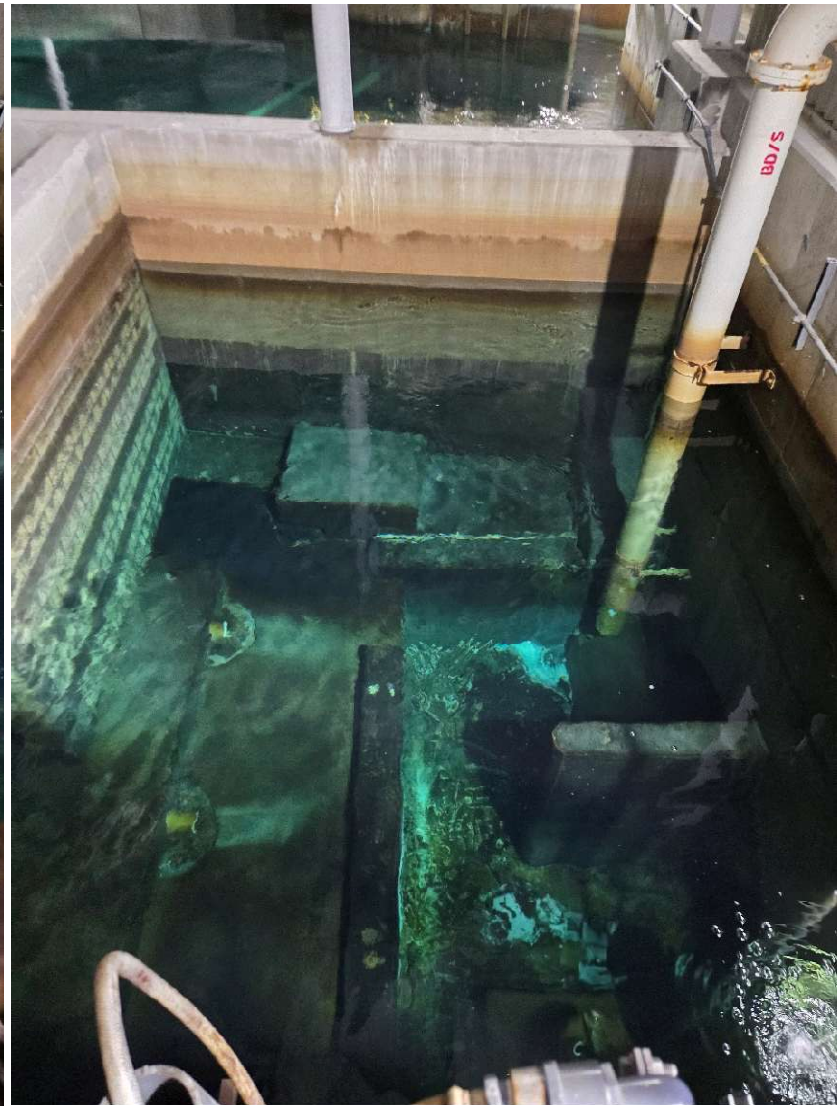
Figure 21. Scum observed end of aeration basin (2025); Not observed (2026)

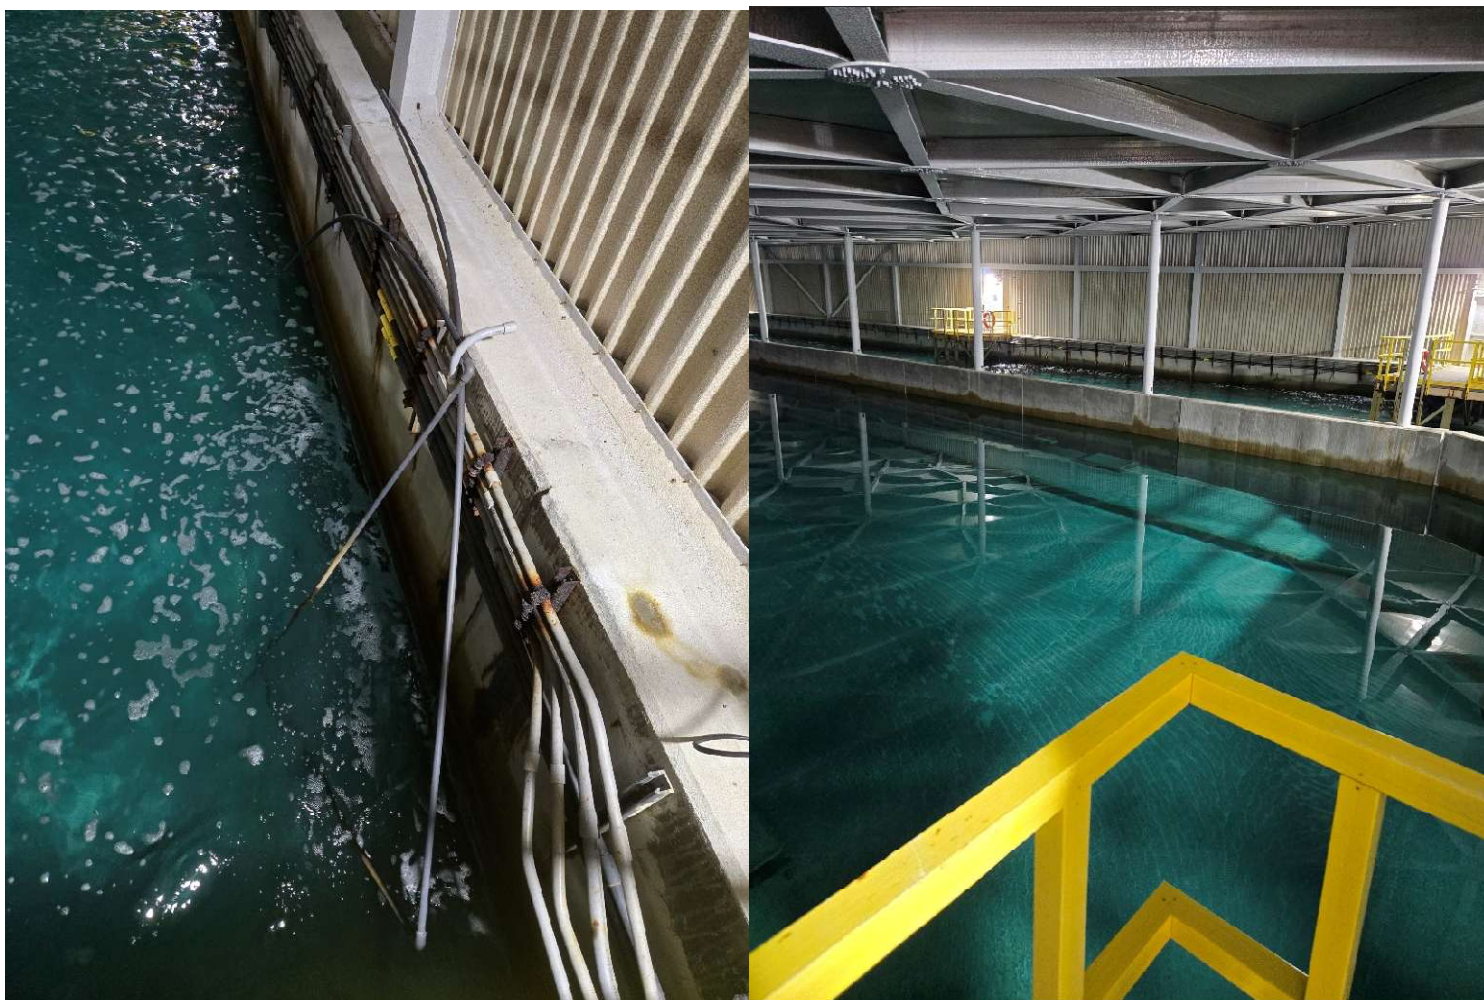
*Figure 22. PVC pipe in water (2025), No hanging piping observed on sides (2026)*
