### System Sanitary Survey Report

April 3, 2026

SUBJECT: Richmond City  
Waterworks: Richmond, City Of  
PWSID: VA4760100

Survey Date: February 23, 2026

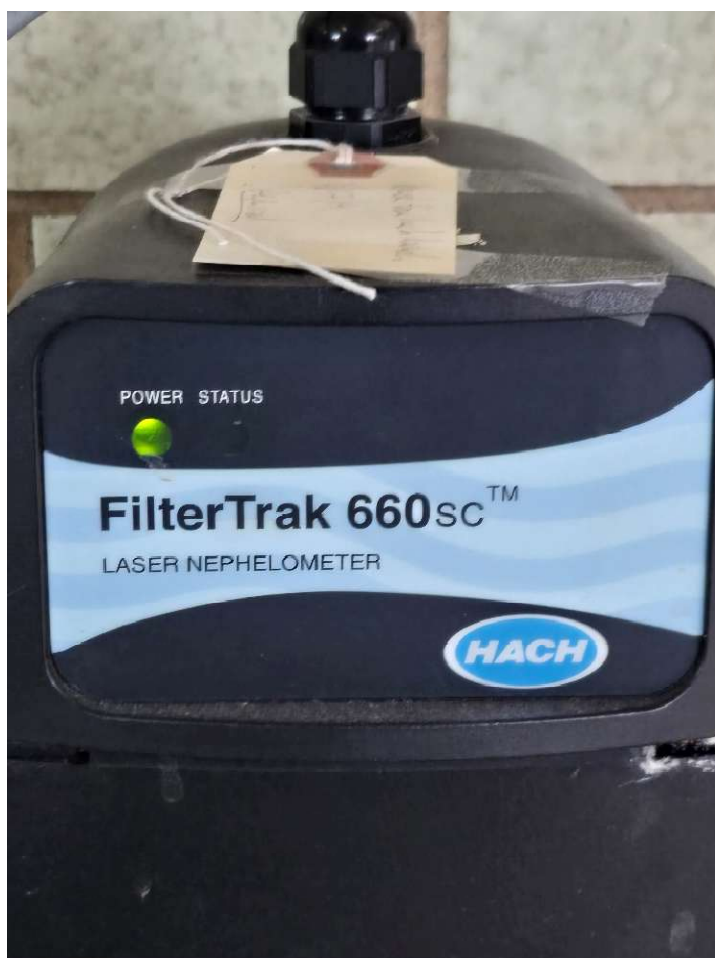
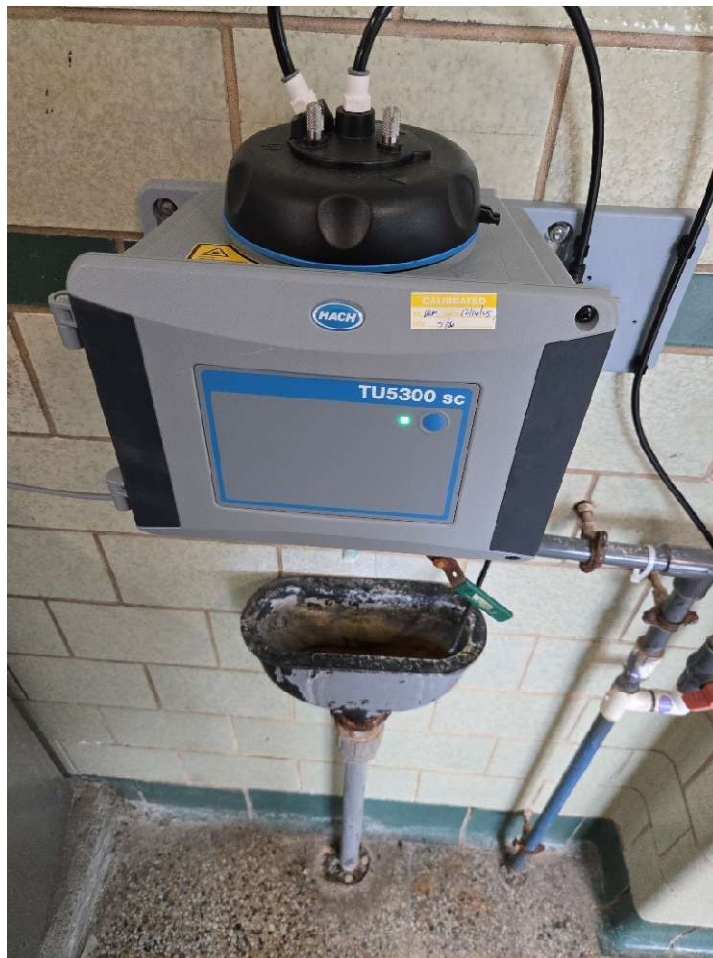
- Filter turbidimeters have been replaced with new equipment that have approved analytical methods (Figure 23)
- After around June 2025, there were no instances of individual filter turbidity readings of 2.00 NTU or greater on the monthly operation reports. Appeared to be a SCADA issue. System indicated they investigated signal span and have corrected previously observed issue

Figure 23. Obsolete turbidimeters (2025), New turbidimeters (2026)

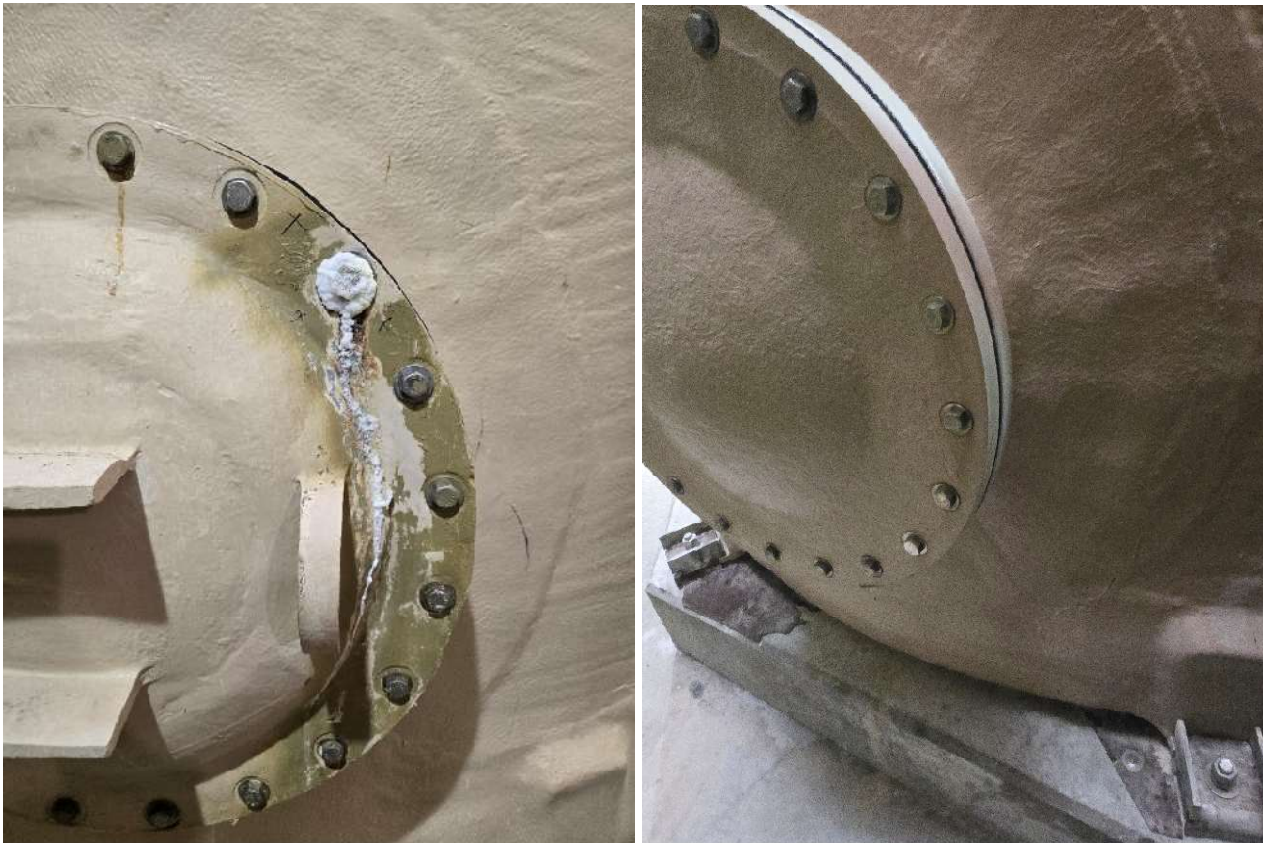
- All chemicals except polymer are now flow paced
- Polymer transfer pumps have been secured, rooms appear to be cleaner than previously observed
- No active leaks observed at sodium hypochlorite or alum storage tanks, area appears clean with no crystallized chemical observed on the floor or around manways (Figure 24)

*Figure 24. Chemical leaks (2025), Not observed (2026)*

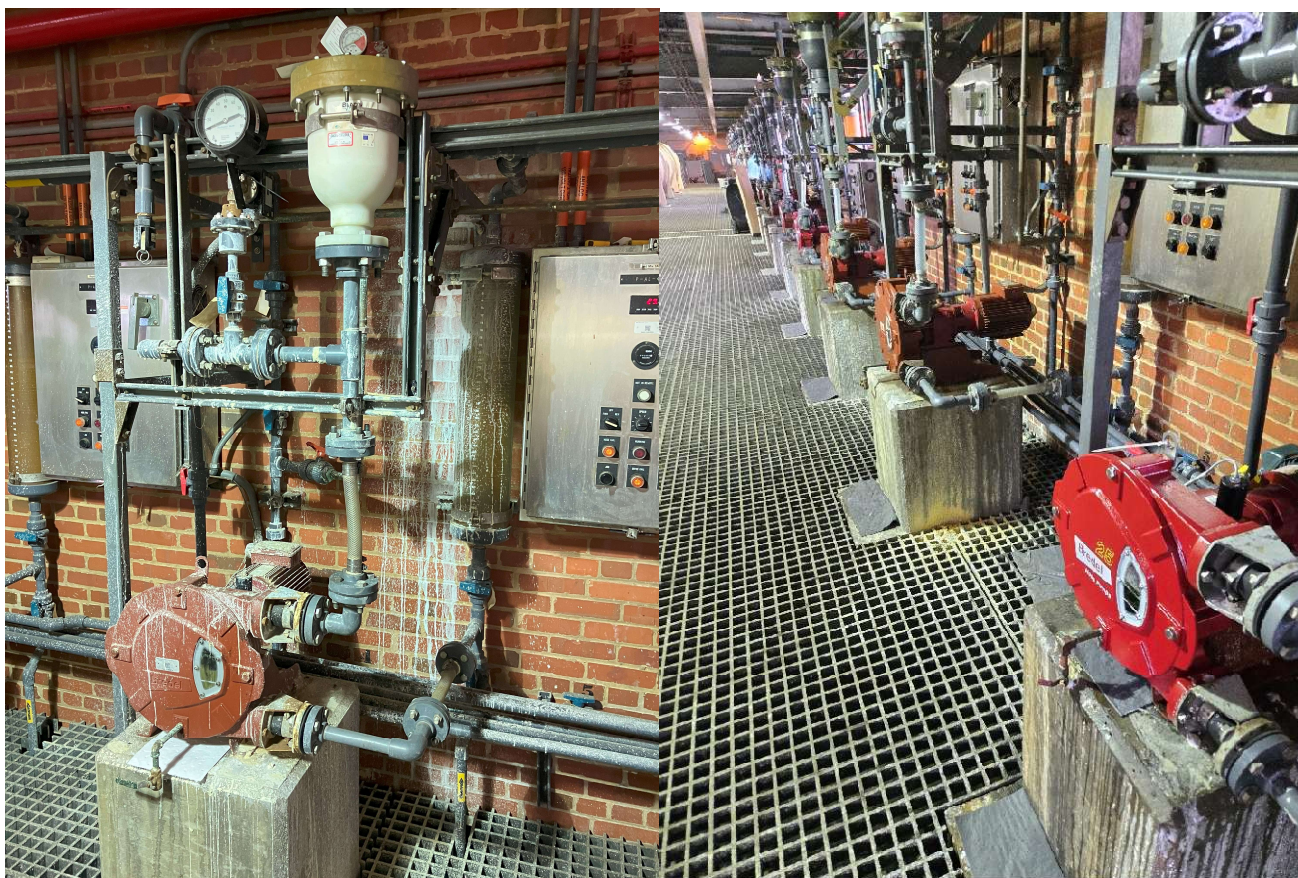
- Alum feed pumps all appear functional, no leaks or mess observed (Figure 25)
- No active chemical leaks observed at Korah pump stations
- System conducts routine calibration and feed rate testing of chemical feed pumps, spreadsheets observed

Figure 25. Chemical leaks (cont.) (2025), Not observed (2026)

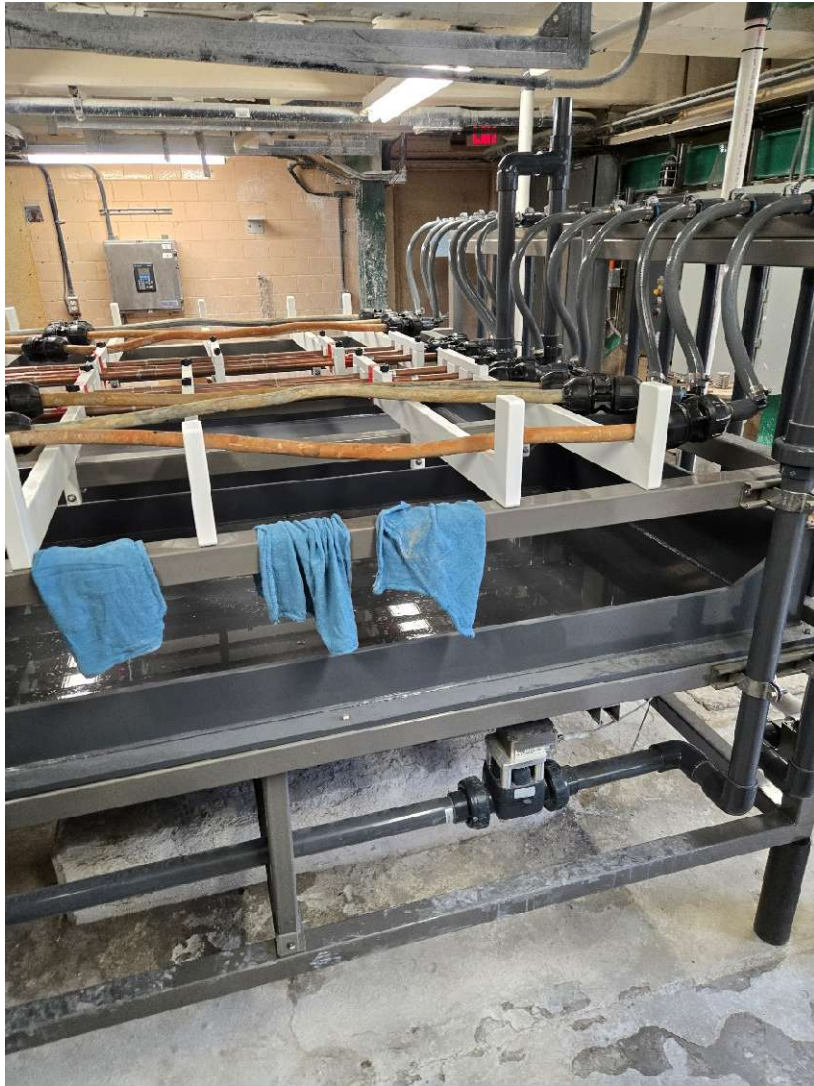
- Pipe loop for corrosion control optimization and studies installed, will startup in March 2026

*Figure 26. Pipe loop installation*

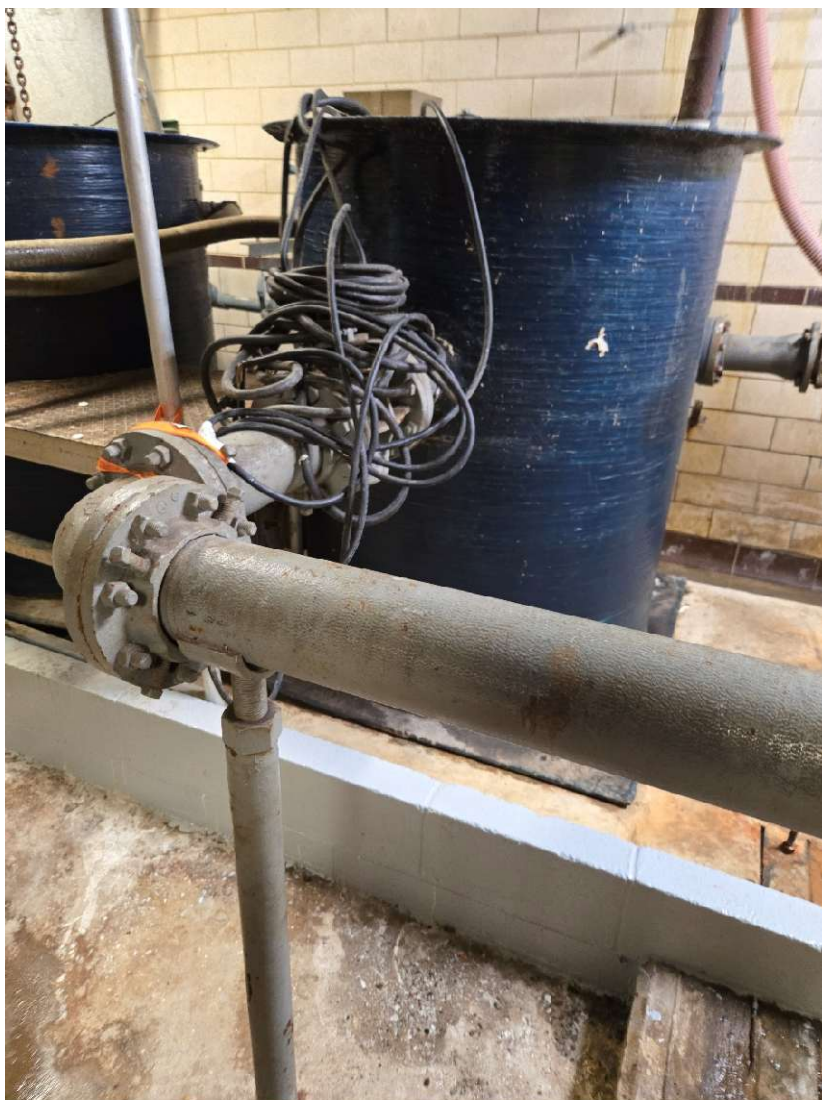
*Figure 27. Sanitary waste storage tank with concrete containment curbing*

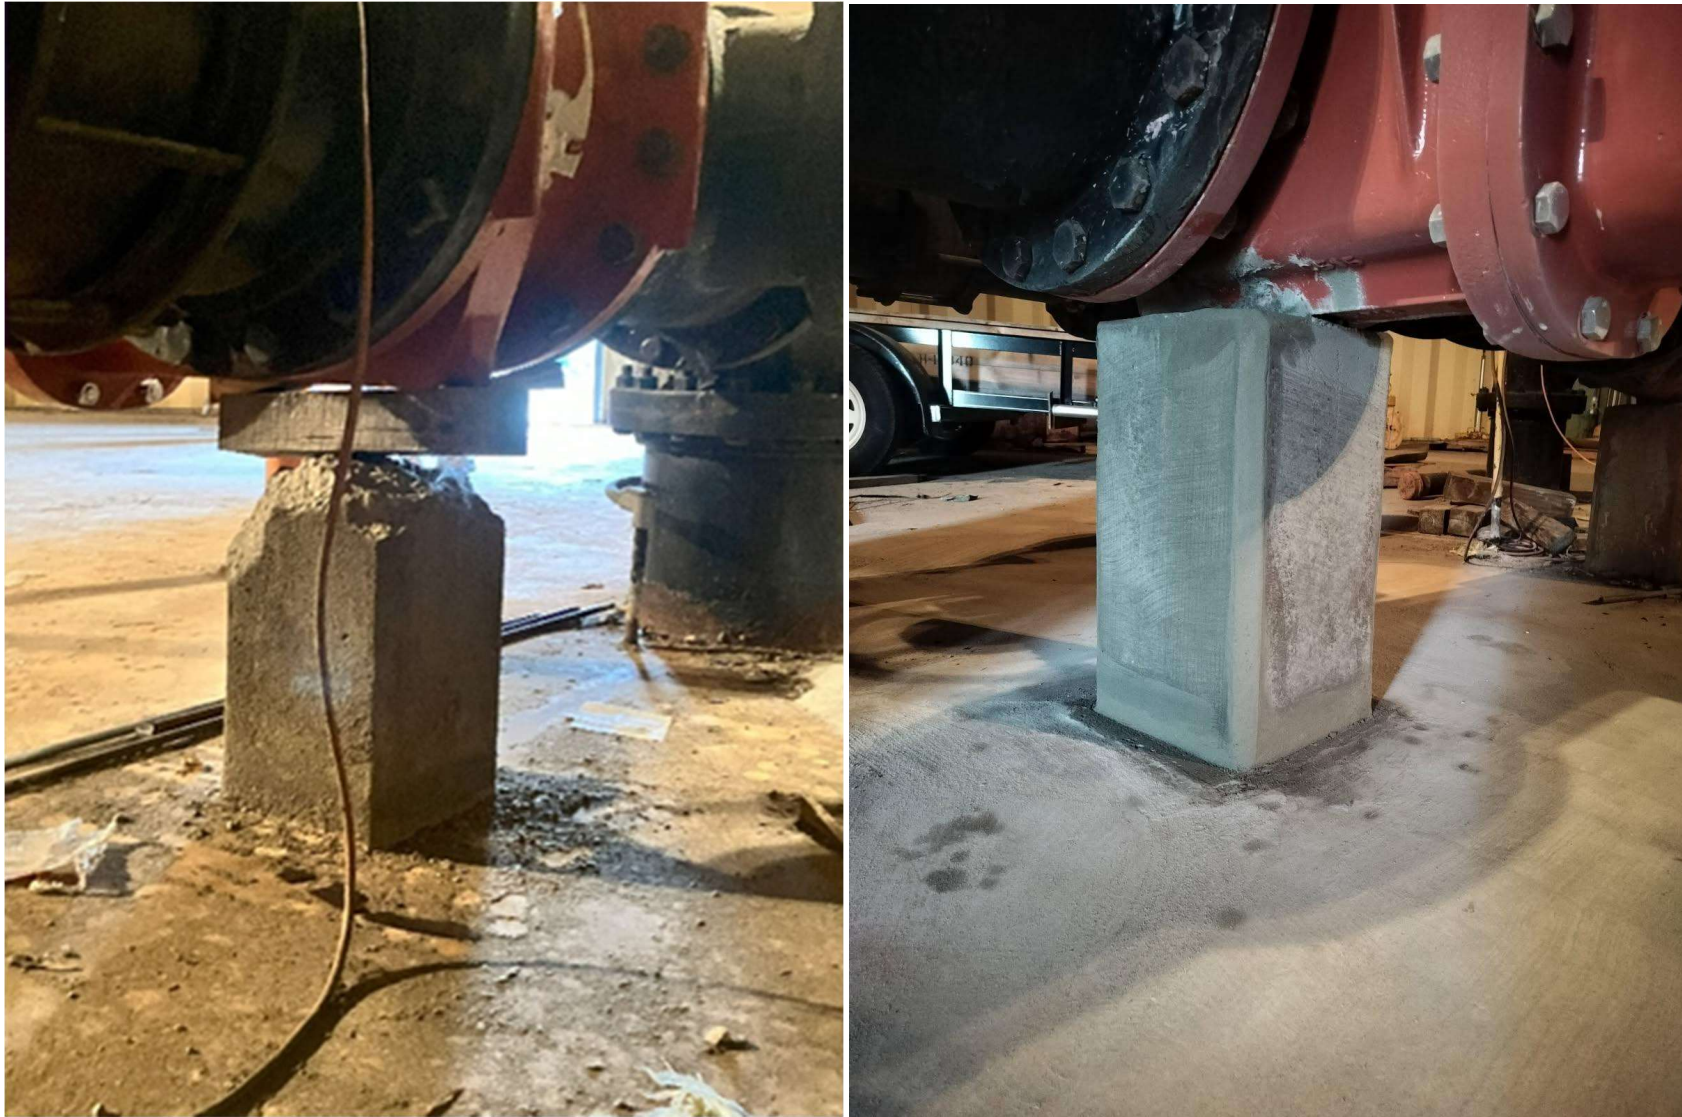
*Figure 29. Wood supporting valve due to eroded concrete support (2025), Support repaired (2026)*

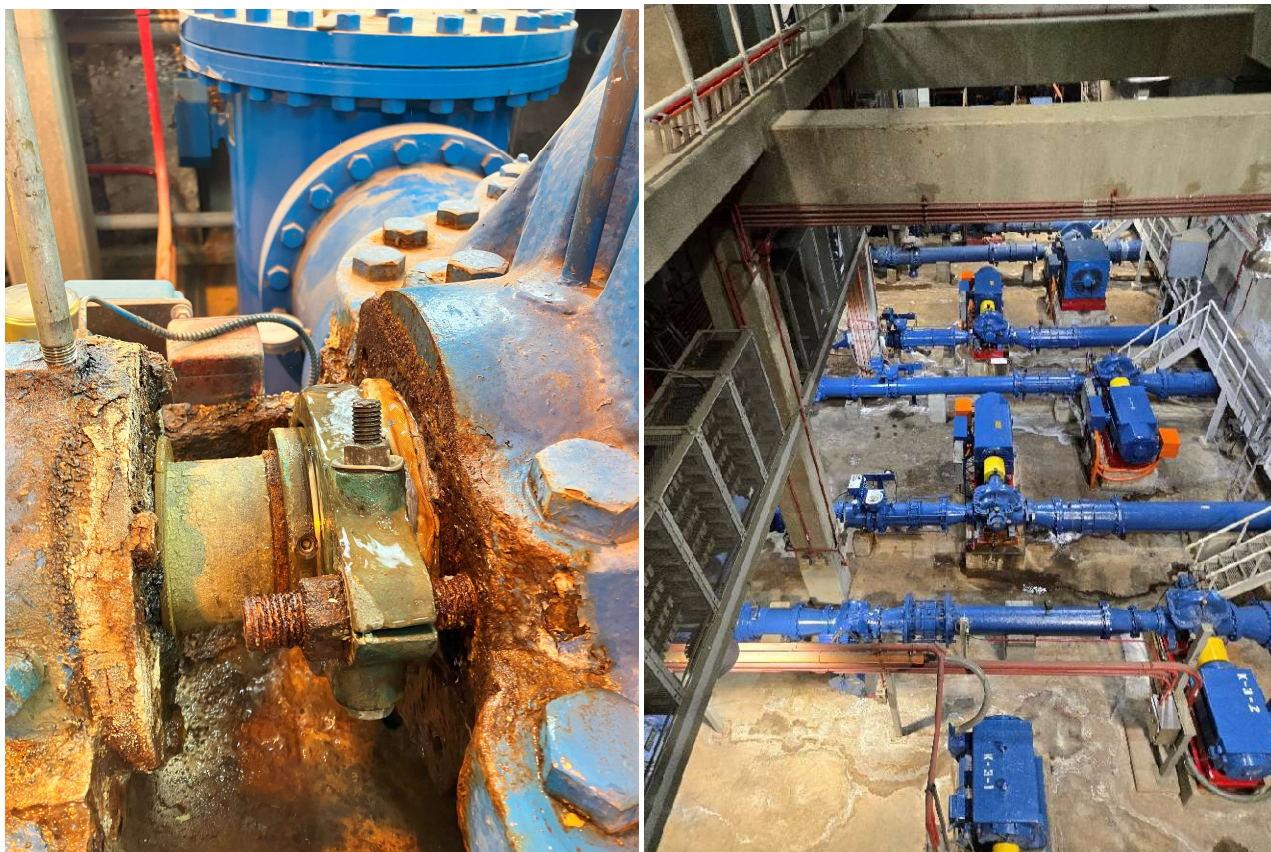
- Project to move new vacuum priming systems upstairs
- Pumps have been painted, no visible rust
- Minimal standing water observed, all pump seal water was routed to nearby floor drains
- All pumps available for use

*Figure 30. Corrosion at several pumps (2025), Pumps painted and no visible corrosion (2026)*
