### System Sanitary Survey Report

SUBJECT: Richmond City  
Waterworks: Richmond, City Of  
PWSID: VA4760100

Survey Date: February 23, 2026

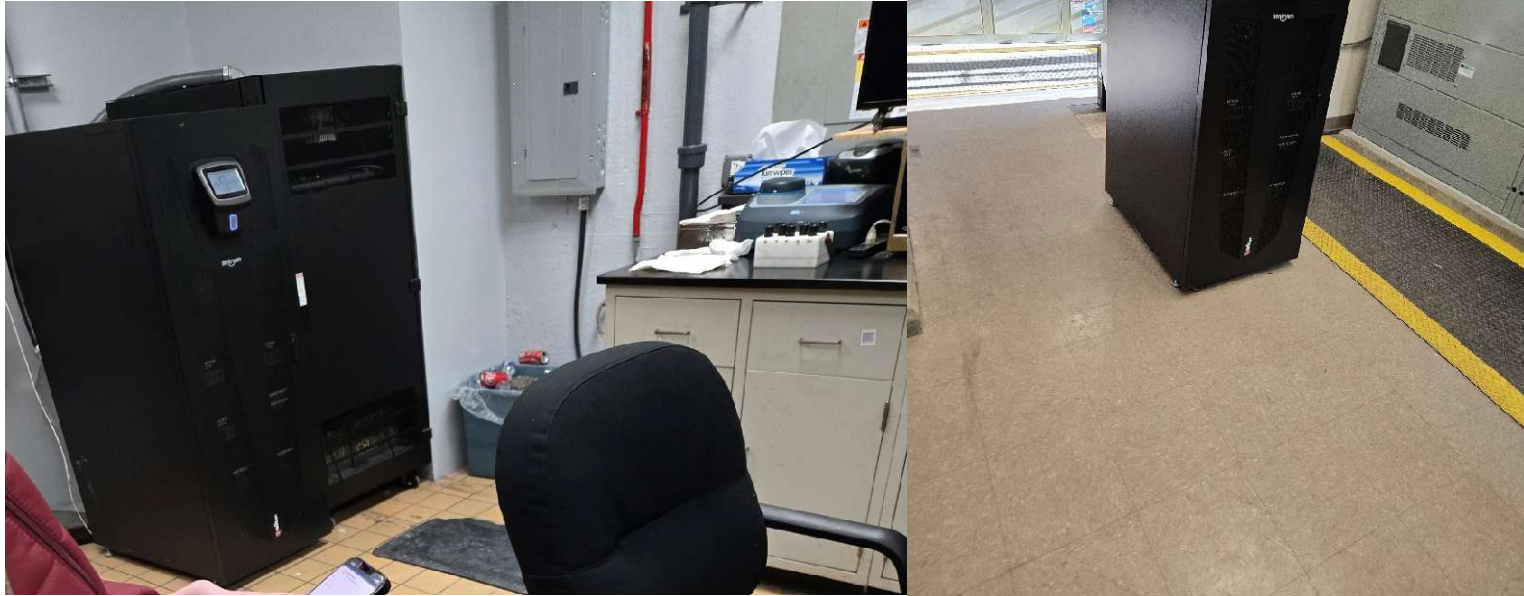
- UPS systems for both Plant 1 and Plant 2 replaced with upgraded systems and successfully tested. If activated, able to do a controlled shutdown of filters (Figure 3)
- UPS system for Plant 1 moved from closet (Figure 3)
- Implemented new UPS system checks and PM schedules
- Integrated into SCADA to notify if UPS systems lose power

Figure 3. UPS systems upgraded. Plant 1 (left), Plant 2 (right)

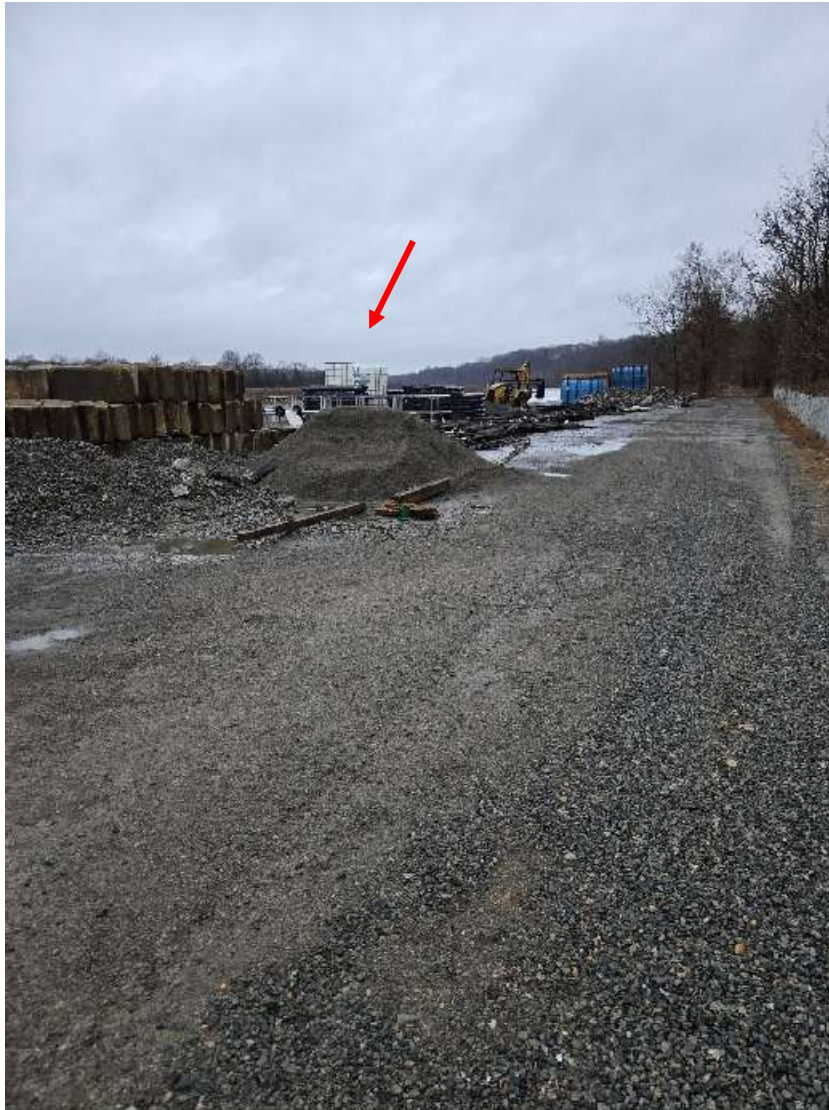
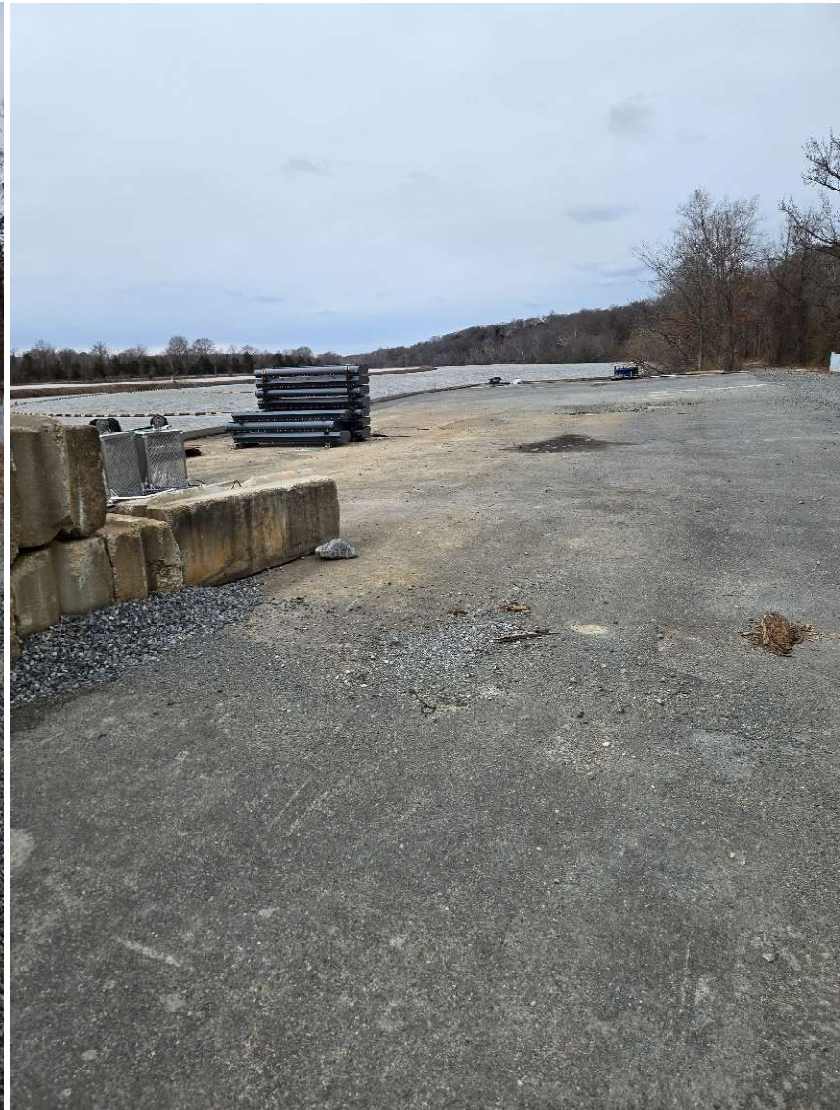
- Floodwall tested by Army Corps of Engineers
- No chemical totes observed near pre-sedimentation basin (Figure 4)
- No trash buildup observed at travelling screen collection bins (Figure 5)
- Dredging projects planned for waste lagoon and pre-sedimentation basin in March 2026
- Elevated raw water turbidity compared to average due to recent rain/snow events, no issues with treatment observed
- Copper sulfate SOP drafted, minimal use of copper sulfate
- Plant growth on earthen berm appeared to be minimized (Figure 6)
- System scheduled to install water quality monitoring at head of pre-sedimentation basin to provide advanced time to react to water quality data

Figure 4. Chemical totes at pre-sed(2025 left), No chemical totes observed (2026 right)

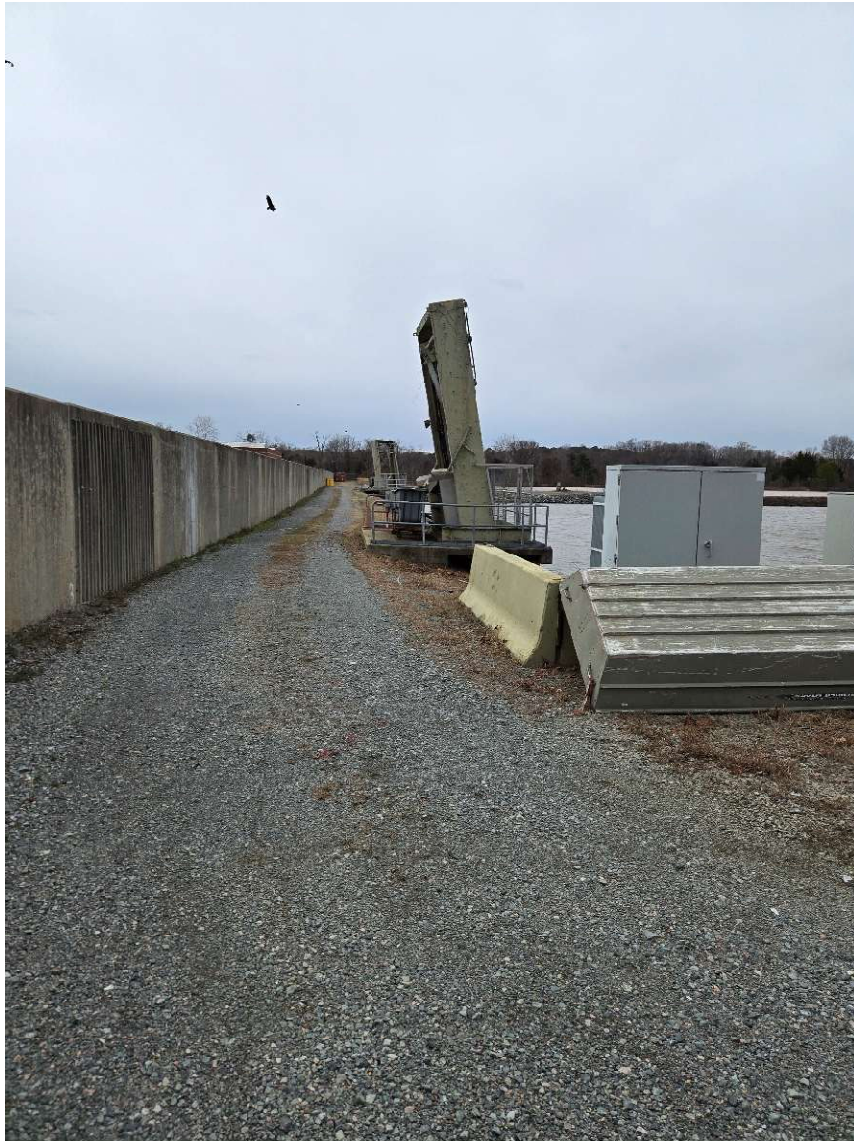
*Figure 5. Pre-sed traveling screens*

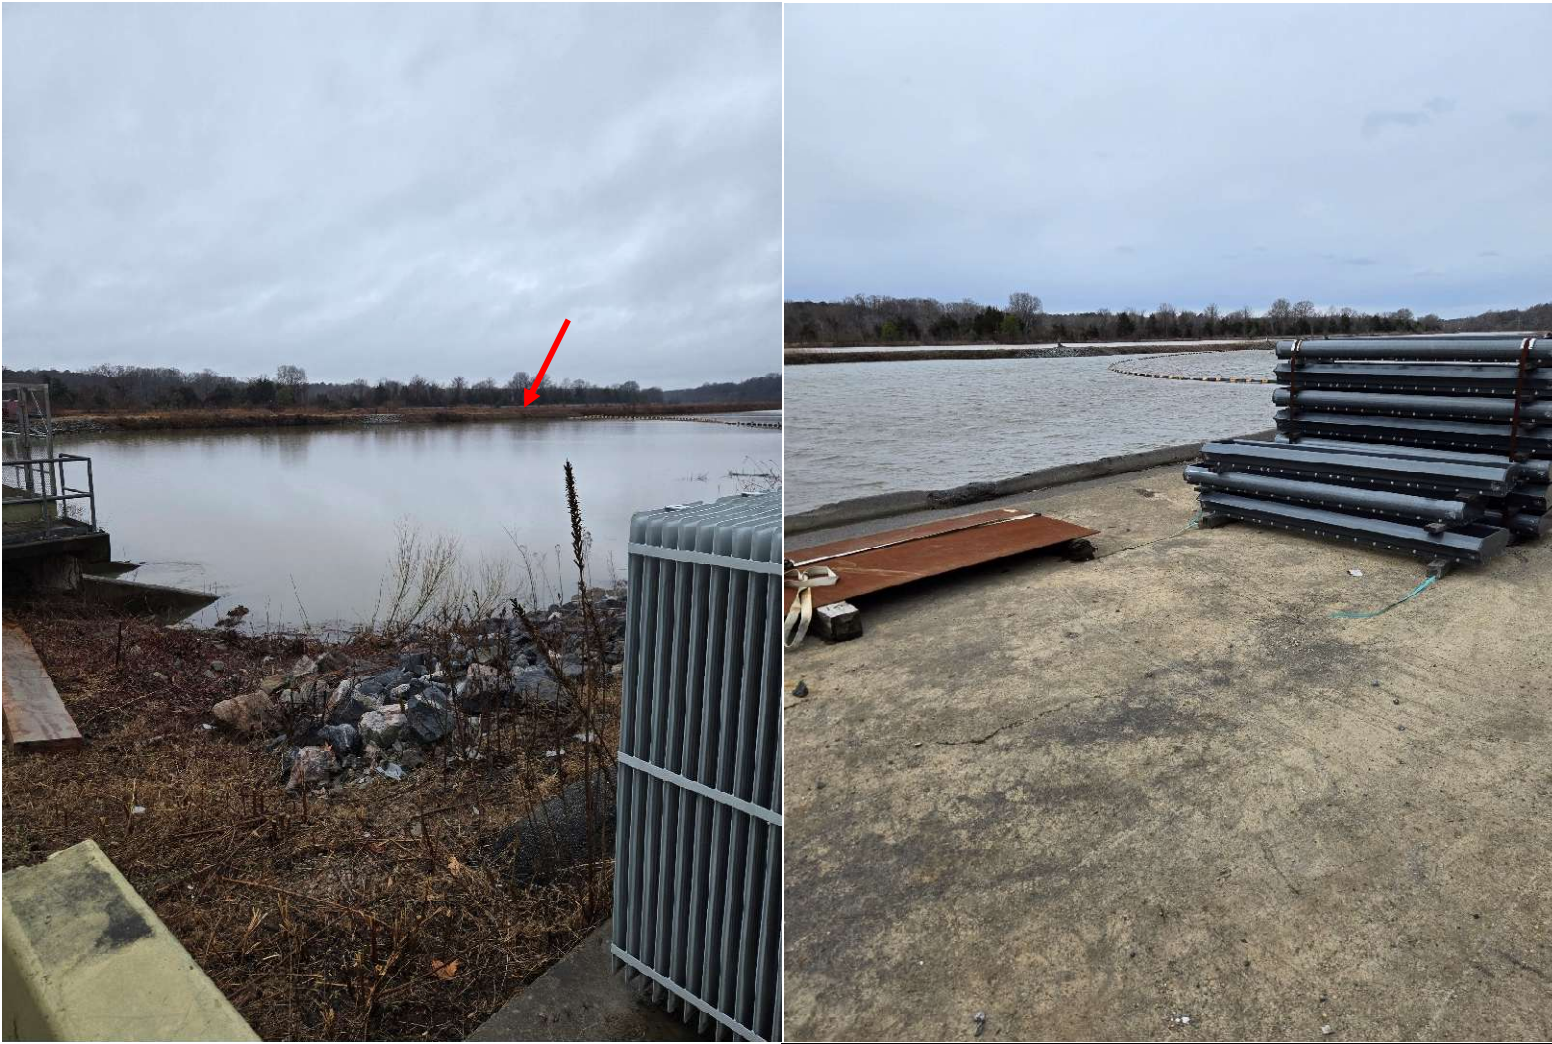
Figure 6. Earthen berm between lagoon and raw water intake channel (2025 left), Shrubs less growth observed (2026 right)

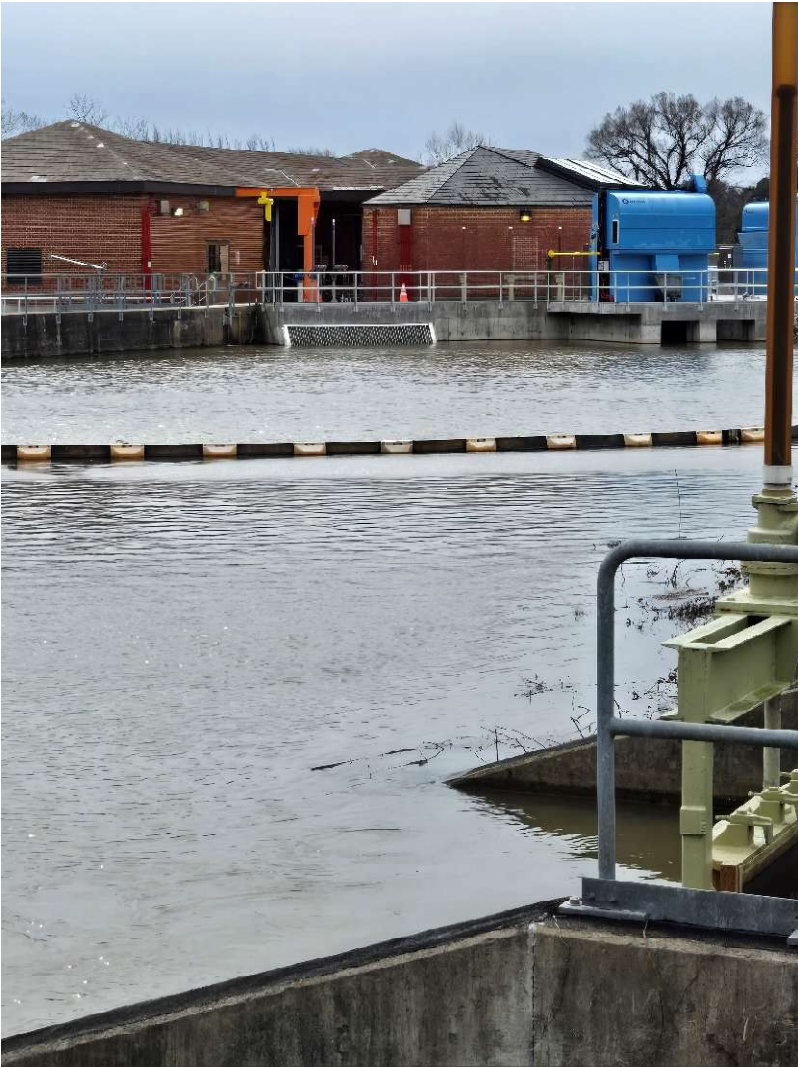
- Flow only from Pre-sedimentation basin, no flow from canal
- No issues observed at raw water basins (Figure 7)
- Screens at raw water pumps all new, project mostly complete only punch-list items remain (Figure 8)

*Figure 7. Raw water basins*

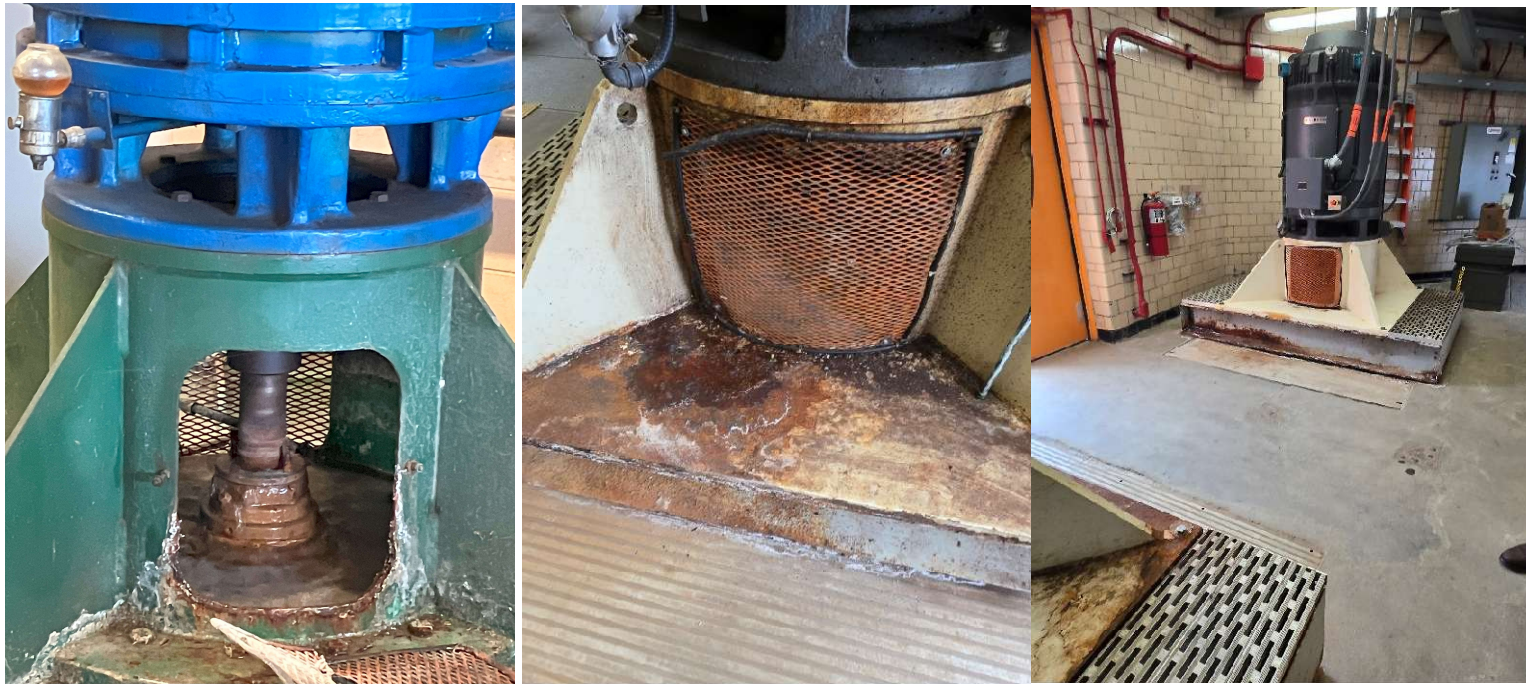
- Raw water pump shaft safety guards all in place and intact (Figure 9)
- No bird droppings or trash observed in raw water pump buildings, all buildings clean and orderly (Figure 10)
- All pumps operable
- Permanganate being fed year round downstream of raw water pumps (Figure 11)

Figure 9. Raw pump motor screen (2025 left), Screen intact, all raw water pumps checked (2026 two photos on right)

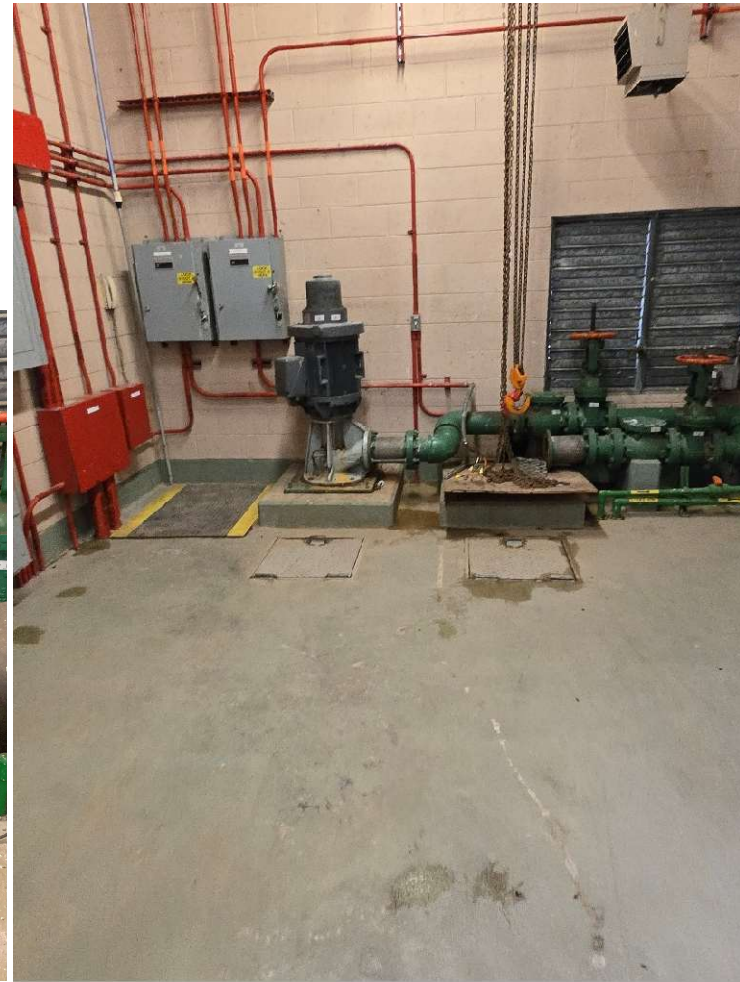
Figure 10. Housekeeping- Bird droppings (2025 left), Cleaner area observed (2026 right)

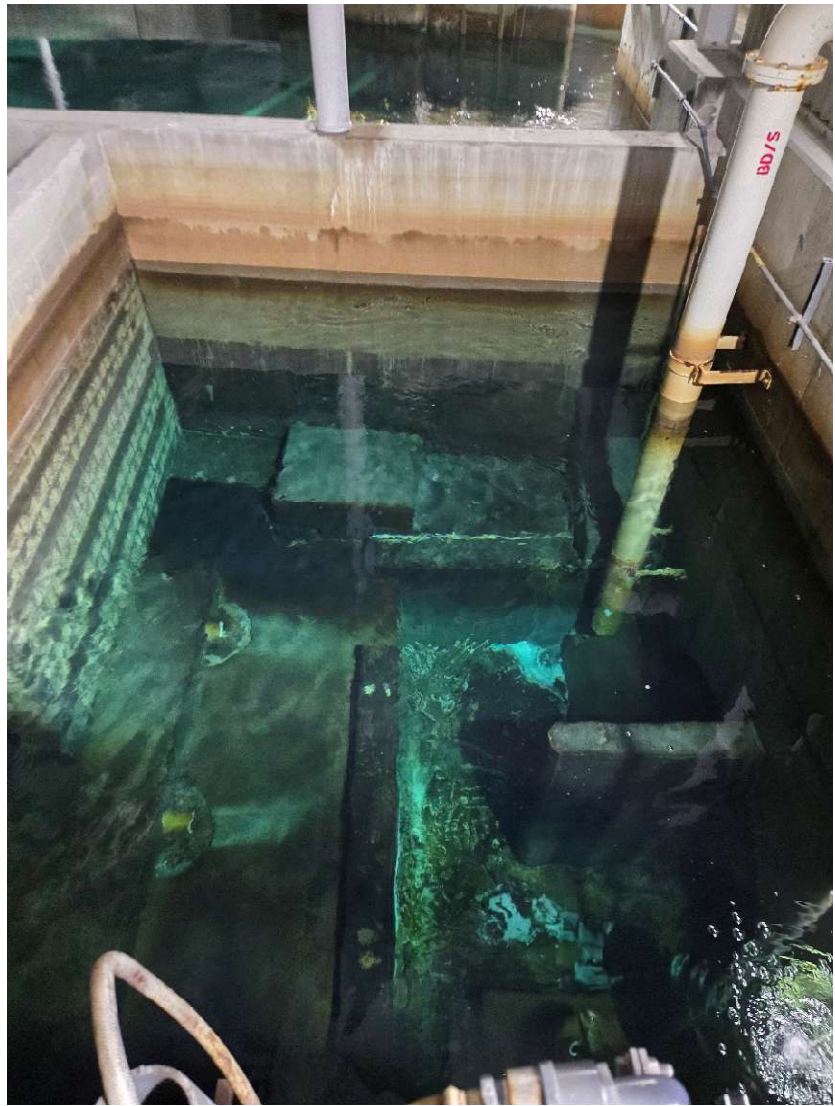
- All walkways into finish water basins have curbing, solid walkways to prevent dirt from falling into water (Figure 20)
- Walkways appeared clean with no debris observed (Figure 20)
- No scum observed at end of basins (Figure 21)
- System instituted routine cleaning of basins
- Previously observed obsolete PVC lines have been removed (Figure 22)
- Finish water basin lighting appears to have improved, brighter inside basins

Figure 21. Scum observed end of aeration basin (2025); Not observed (2026)
