MESSONGO AND GUILFORD CREEKS Growing Area # 076 Accomack County Shoreline Sanitary Survey

Date: 11 July 2022

Survey Period: November 19, 2021 – April 18, 2022

Surveyed By: R. Snead & T. Charnock

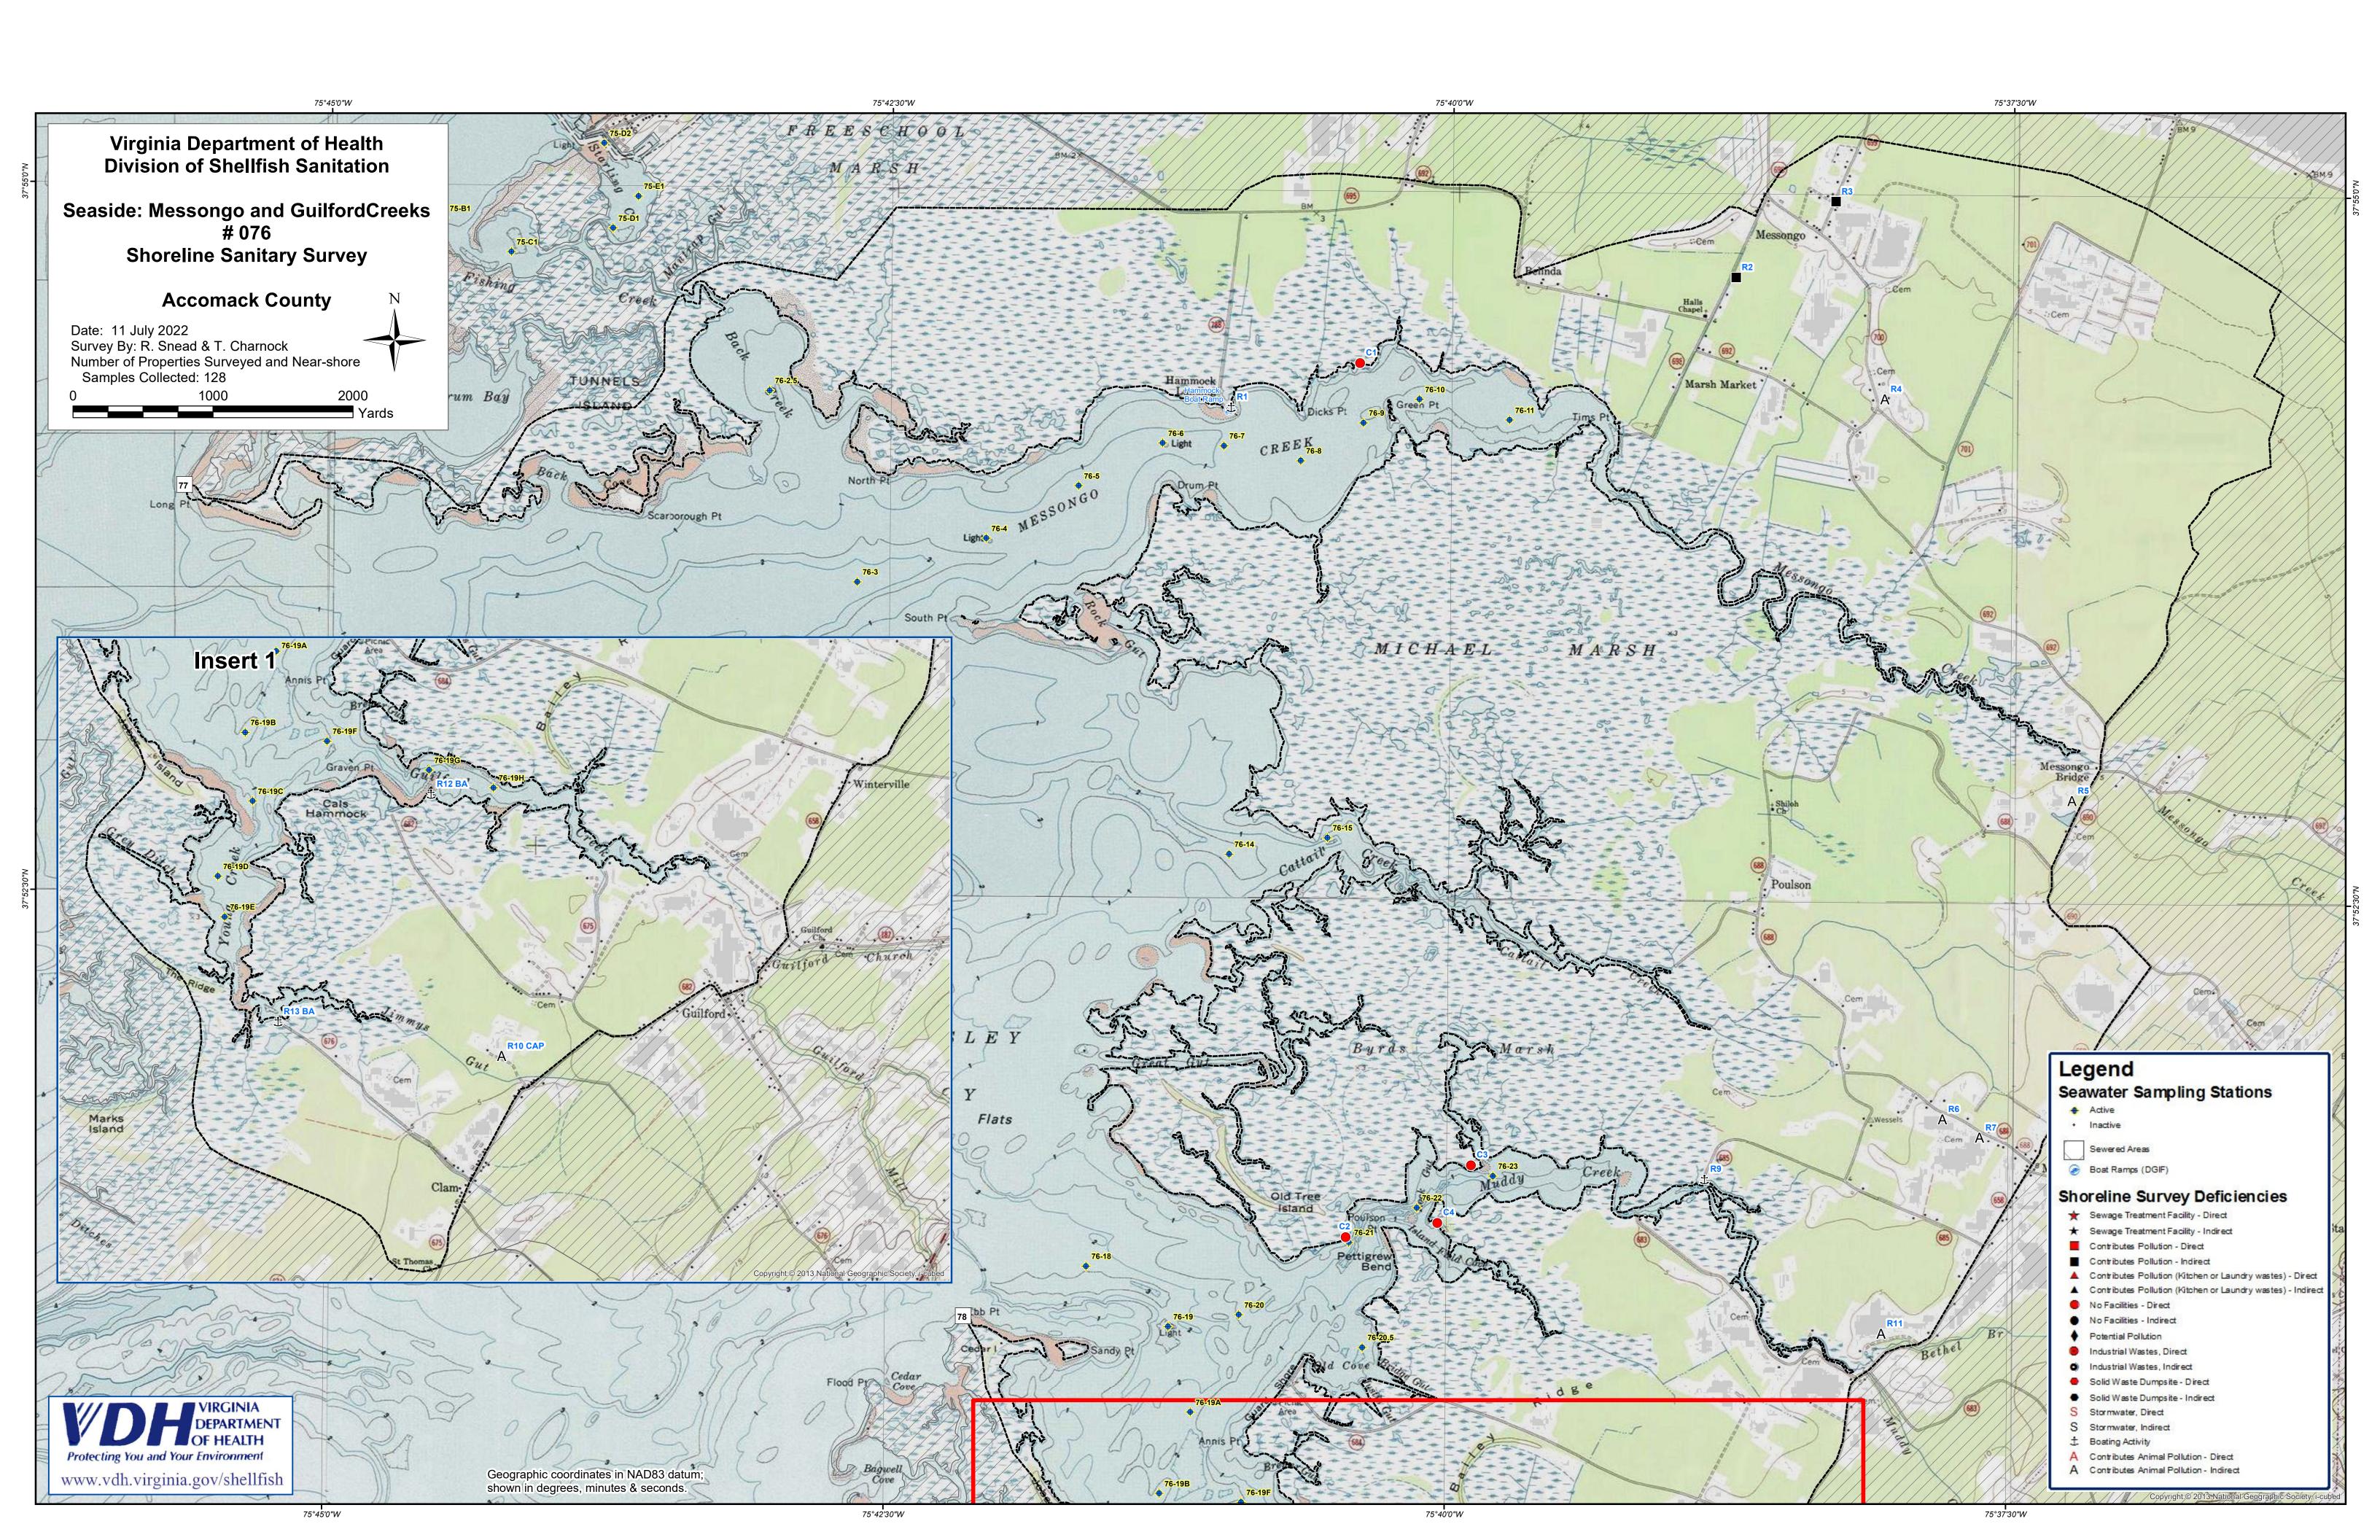
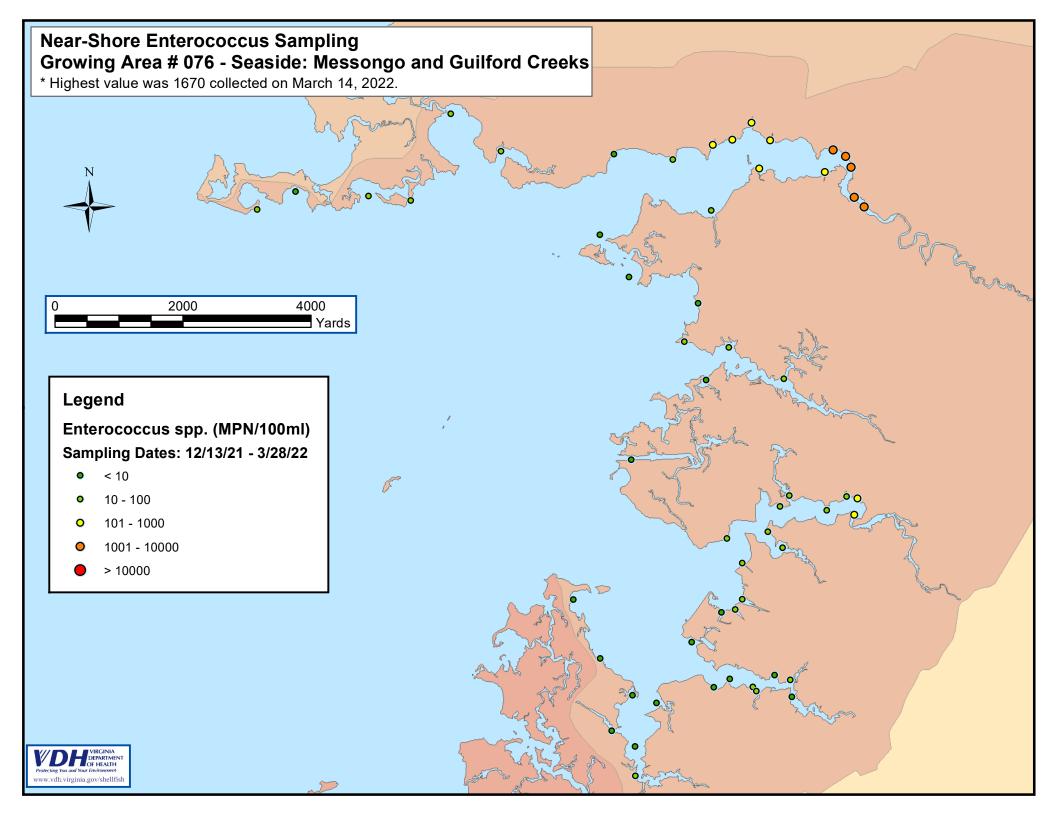
Hydrographic data, sampling times and range of enterococcus concentrations measured are shown in the table below. Maps of the enterococcus sampling are shown at the conclusion of this report.
