### **CRADDOCK CREEK Growing Area # 083 Accomack County Shoreline Sanitary Survey**

**Date:** 7 June 2023

**Surveyed By:** T. Charnock, R. Snead, & I. Geeson

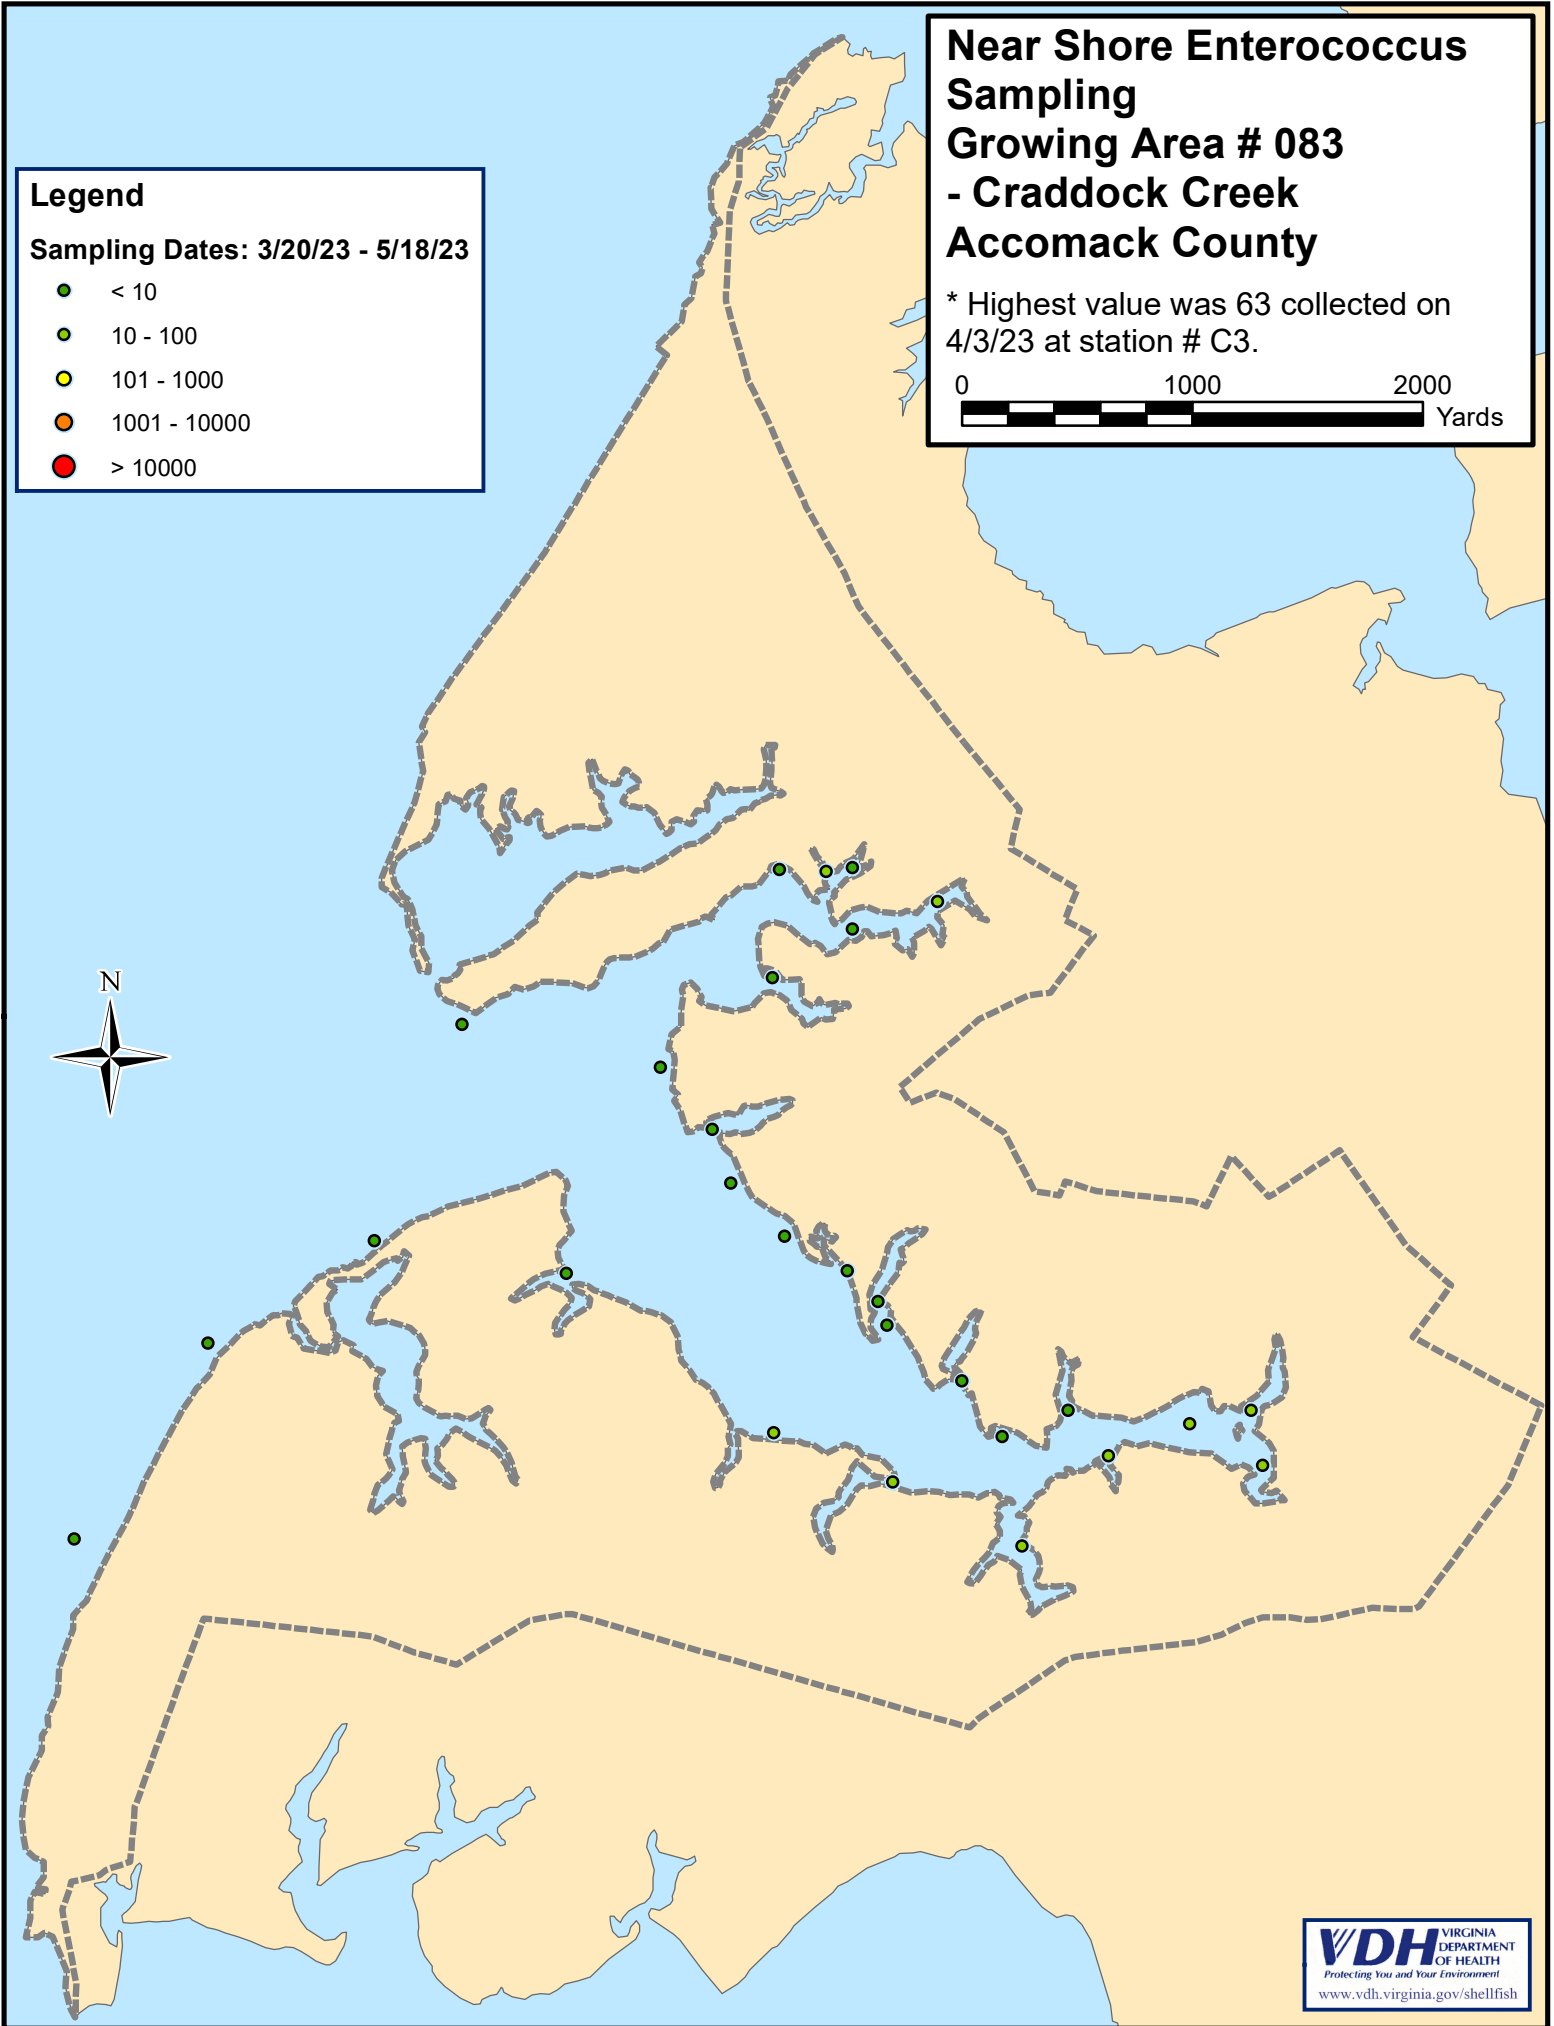
**Near Shore Enterococcus  
Sampling  
Growing Area # 083  
- Craddock Creek  
Accomack County**

\* Highest value was 63 collected on  
4/3/23 at station # C3.

**Sampling Dates: 3/20/23 - 5/18/23**

Hydrographic data, sampling times and range of enterococcus concentrations measured are shown in the table below. Maps of the enterococcus sampling are shown at the conclusion of this report.
