Ref: ECOFLO® Biofilter – ST/STB model series
 Renewal of TL3 general approval

On July 2002, Premier Tech Aqua sought and received Provisional Approval, GMP #118, from the Commonwealth of Virginia’s Department of Health for the ECOFLO® ST-650 and STB-650 onsite wastewater treatment system. This Provisional Approval includes a monitoring program designed to gather performance data in order to verify that ECOFLO® technology meets the standards set by the Virginia Department of Health (VDH).

In 2008, Premier Tech Aqua obtained, after duly completing the approved monitoring program and as per Sewage Advisory Committee recommendation, TL3 general approval for the ECOFLO® Biofilter GMP #118. Approval was initially granted for the only ECOFLO® Biofilter model, the ST/STB-650 designed to accommodate up to 600 gpd, available on the market. But along the year additional models were developed. These other models were approved by VDH and listed under the same approval. The table 1 below presents the different ECOFLO® Biofilter of the ST/STB model series certified and listed under ANSI/NSF Standard 40. An important thing to know is that for all the models approved and listed below, all wastewa

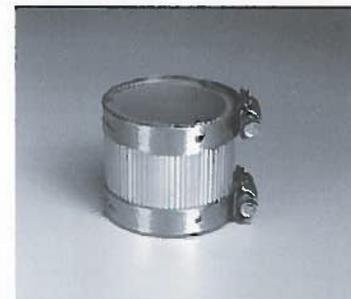
1902K3, Centralizer with Adapter Kit
