ROSIER CREEK Growing Area # 001 King George and Westmoreland County Shoreline Sanitary Survey

Date: 1 February 2024

Survey Period: September 20 – October 31, 2023

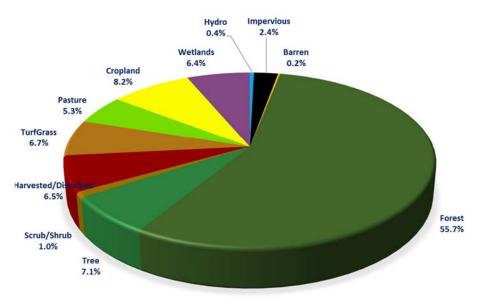
GROWING AREA 1 LAND COVER

Within Growing Area 1, there are 1109 land parcels. Land Cover data are shown below.

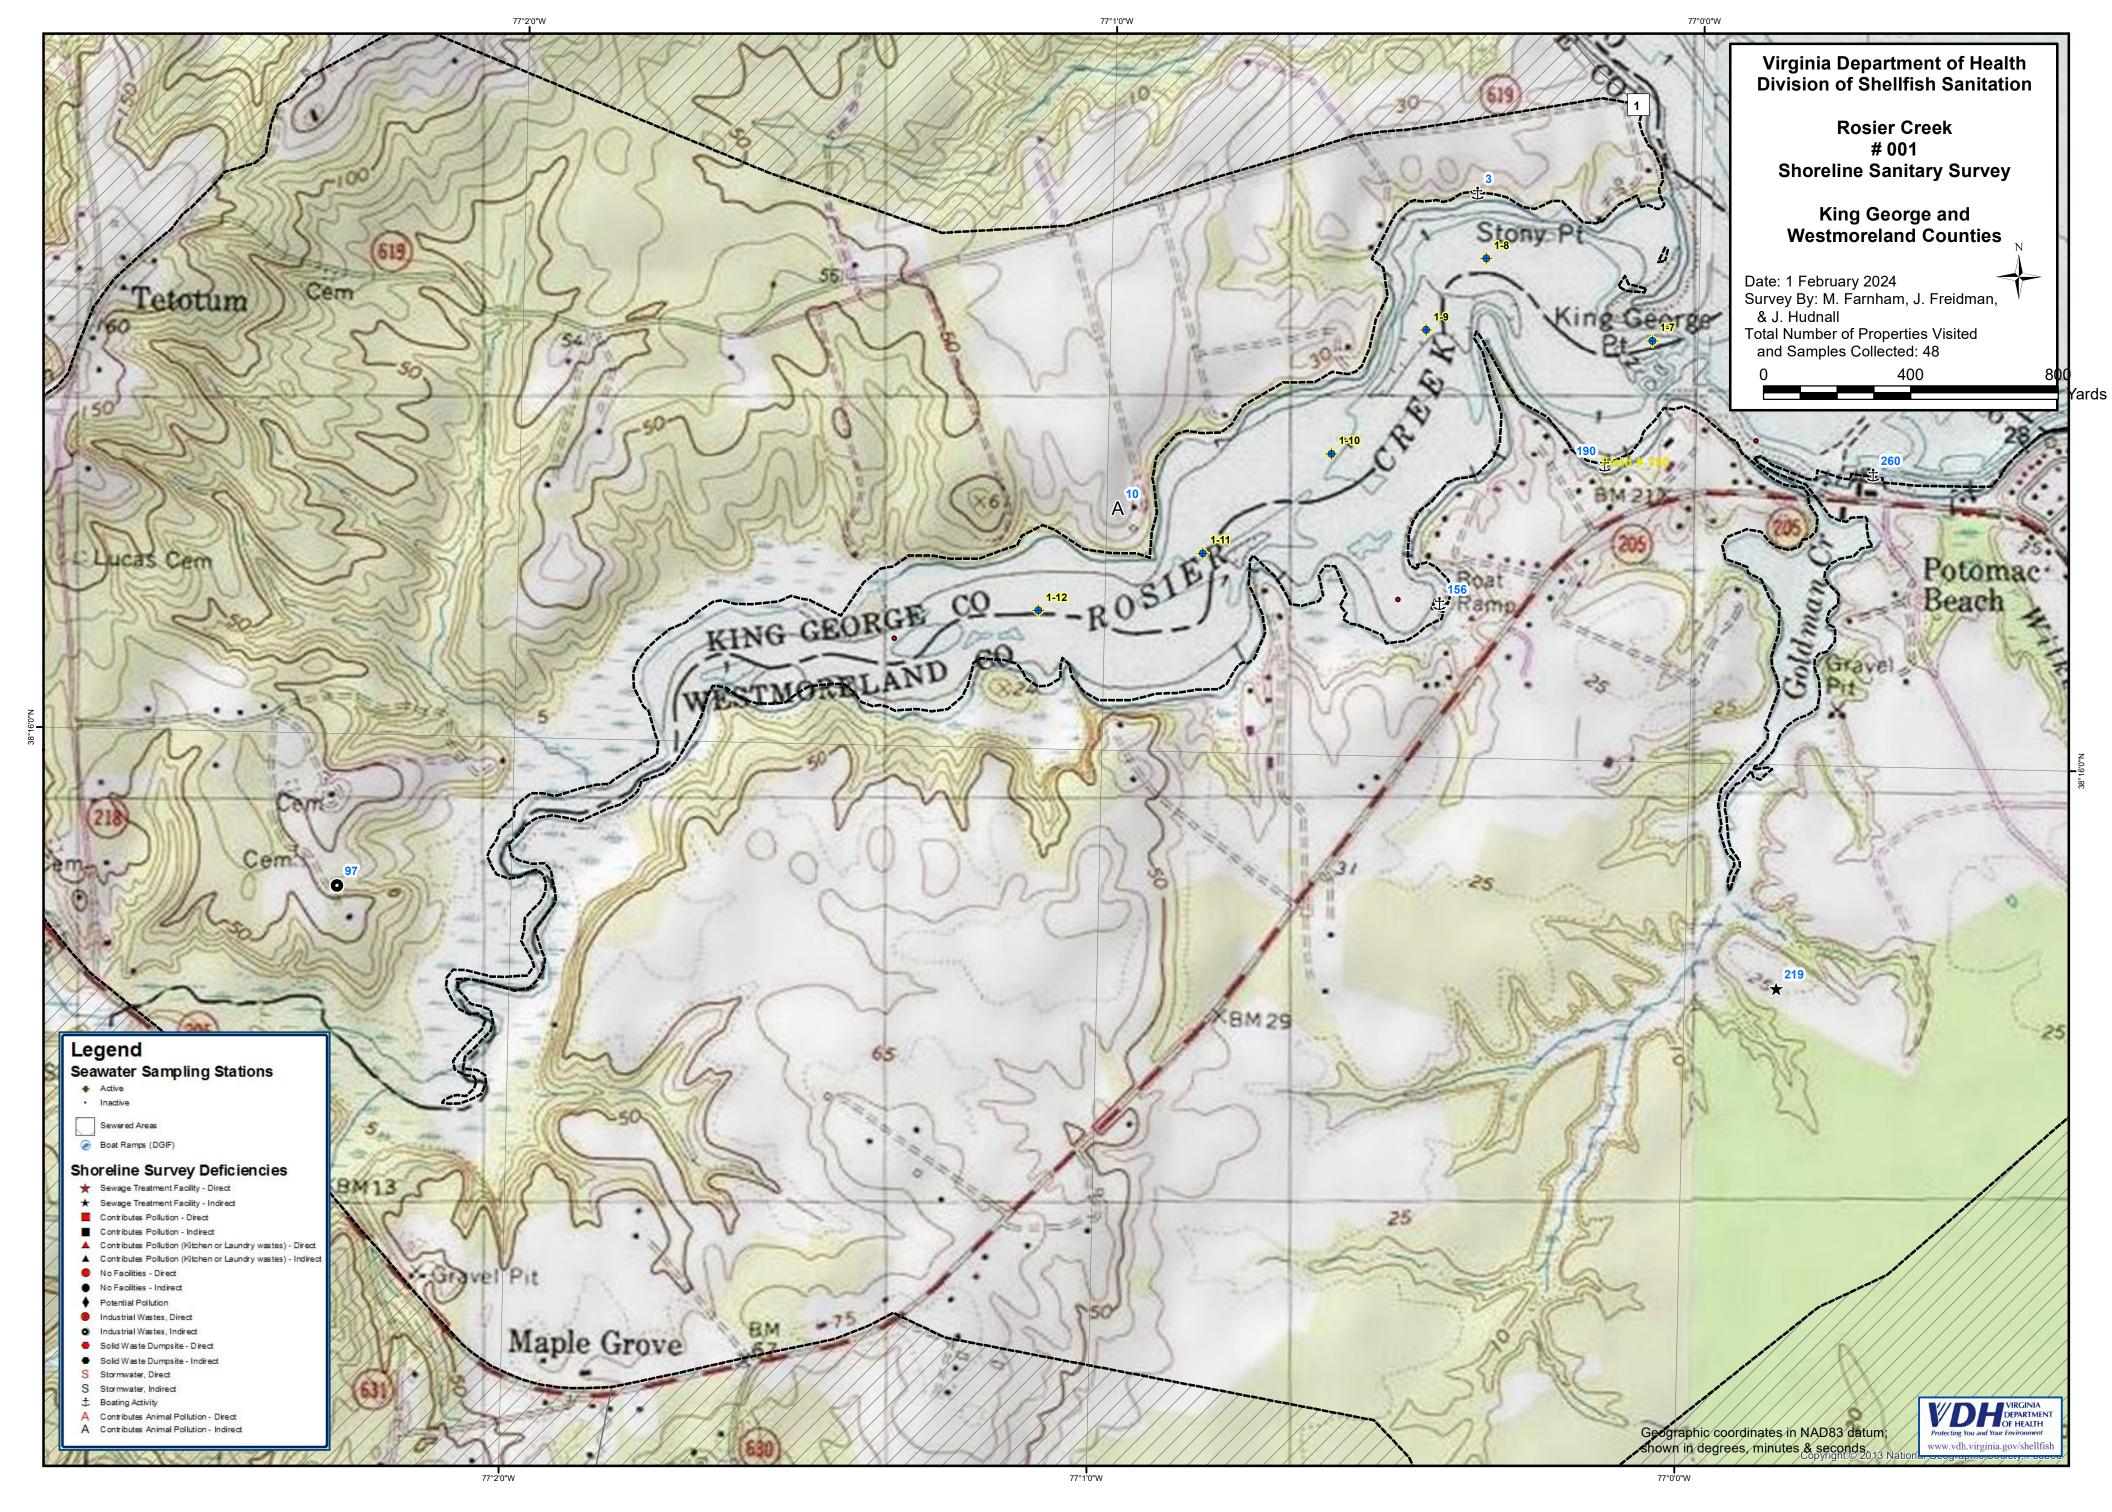
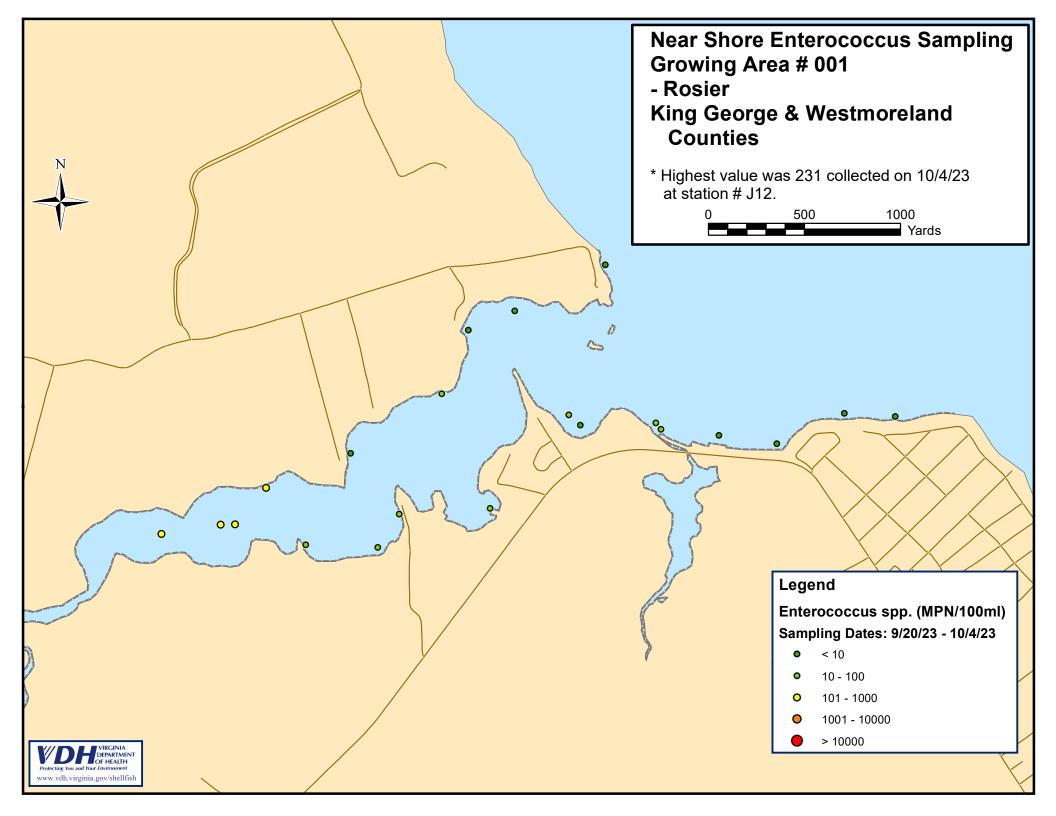
Hydrographic data, sampling times and range of enterococcus concentrations measured are shown in the table below. Maps of the enterococcus sampling are shown at the conclusion of this report.
