RAPPAHANNOCK RIVER: URBANNA AND WHITING CREEKS Growing Area # 029 Middlesex County Shoreline Sanitary Survey

Date: June 1, 2025

Survey Period: April 1, 2025 – May 22, 2025

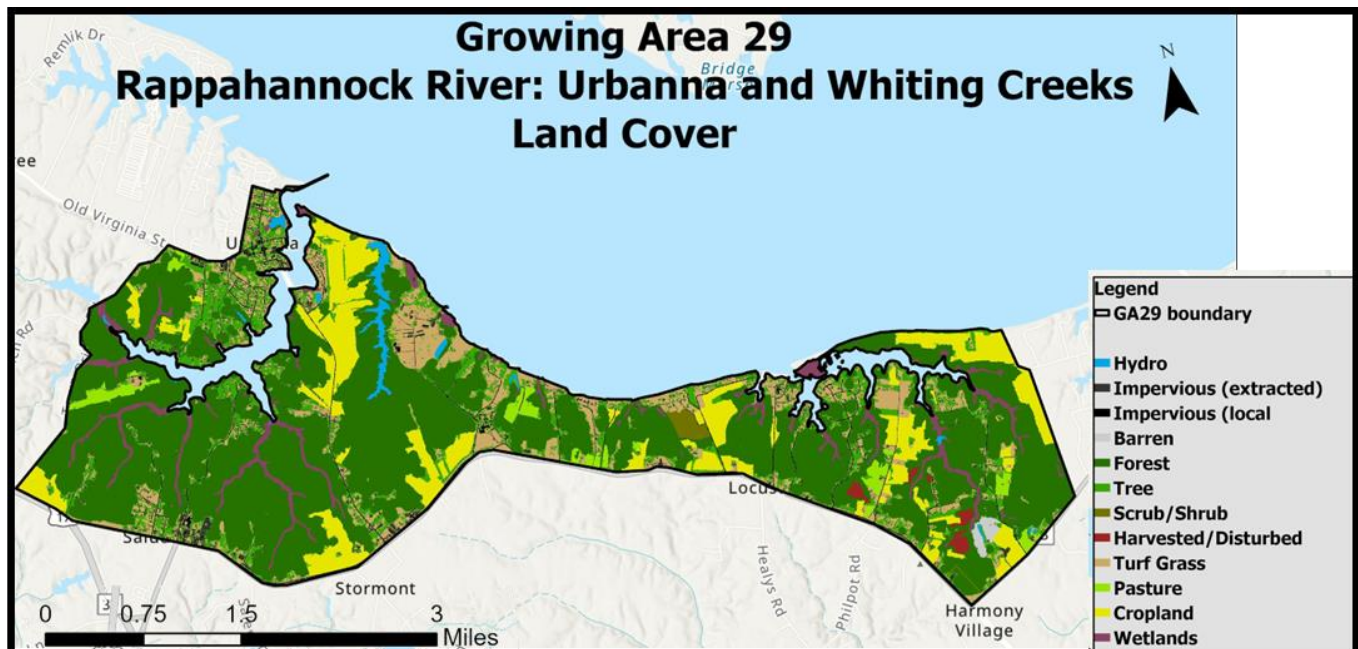
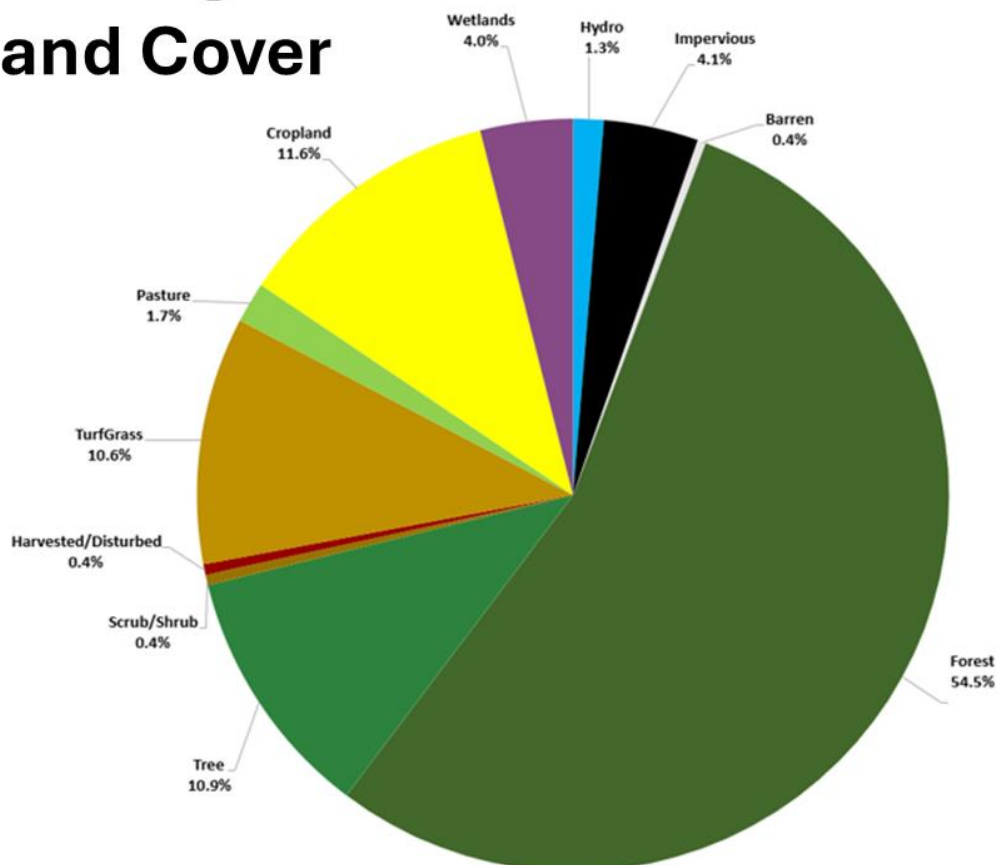
Growing Area 29 Land Cover

Land Cover data are shown in the map below and summarized in the following pie chart.
