Mobjack Bay: East River
Growing Area # 041
Mathews County
Shoreline Sanitary Survey

Date: 8 August 2024

Survey Period: February 1, 2024 – July 18, 2024

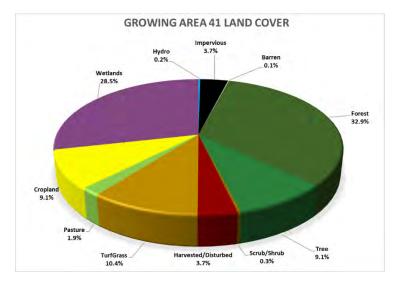
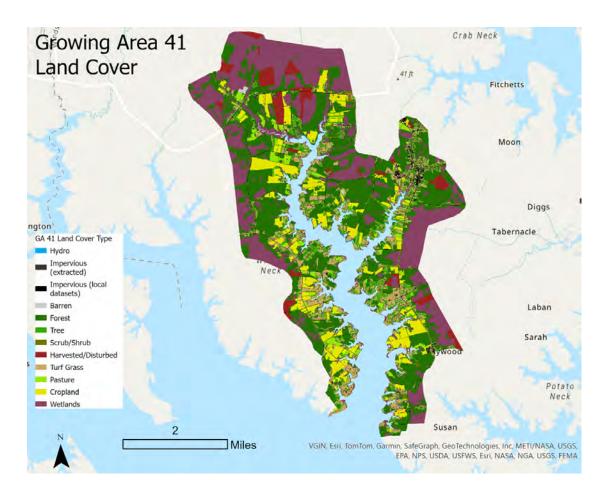
Within Growing Area 41 there are 2502 land parcels. Land Cover data are shown below

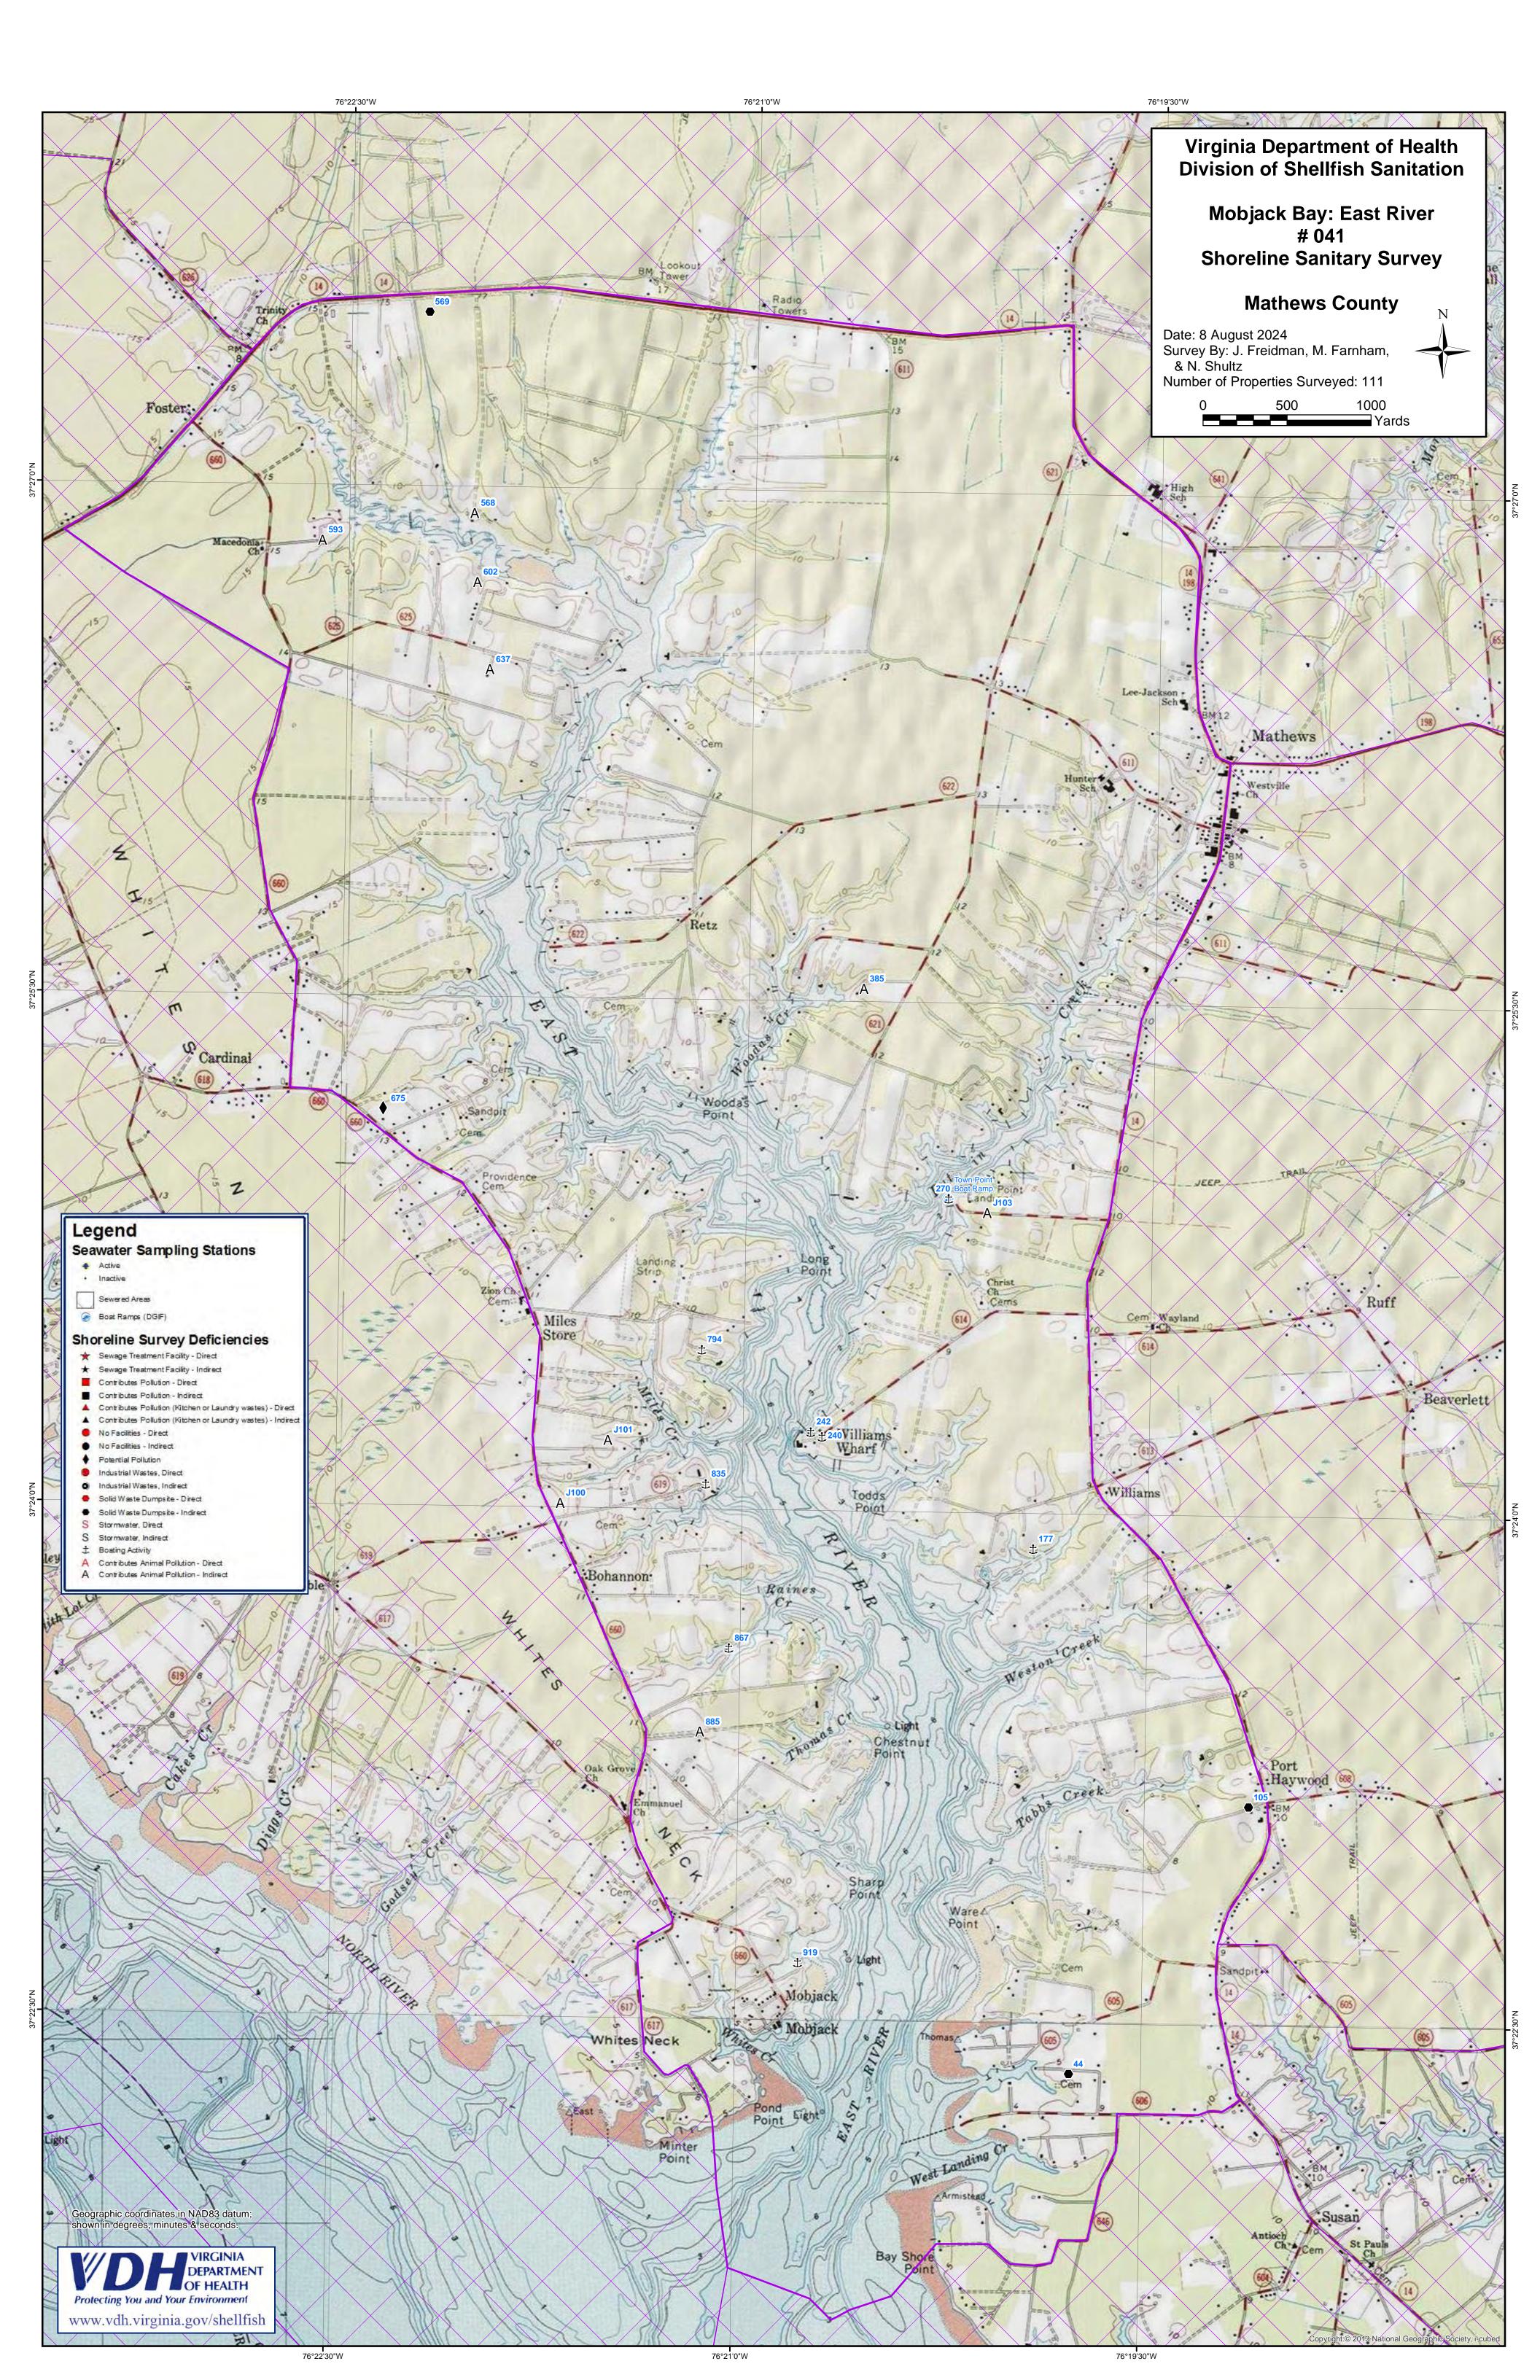
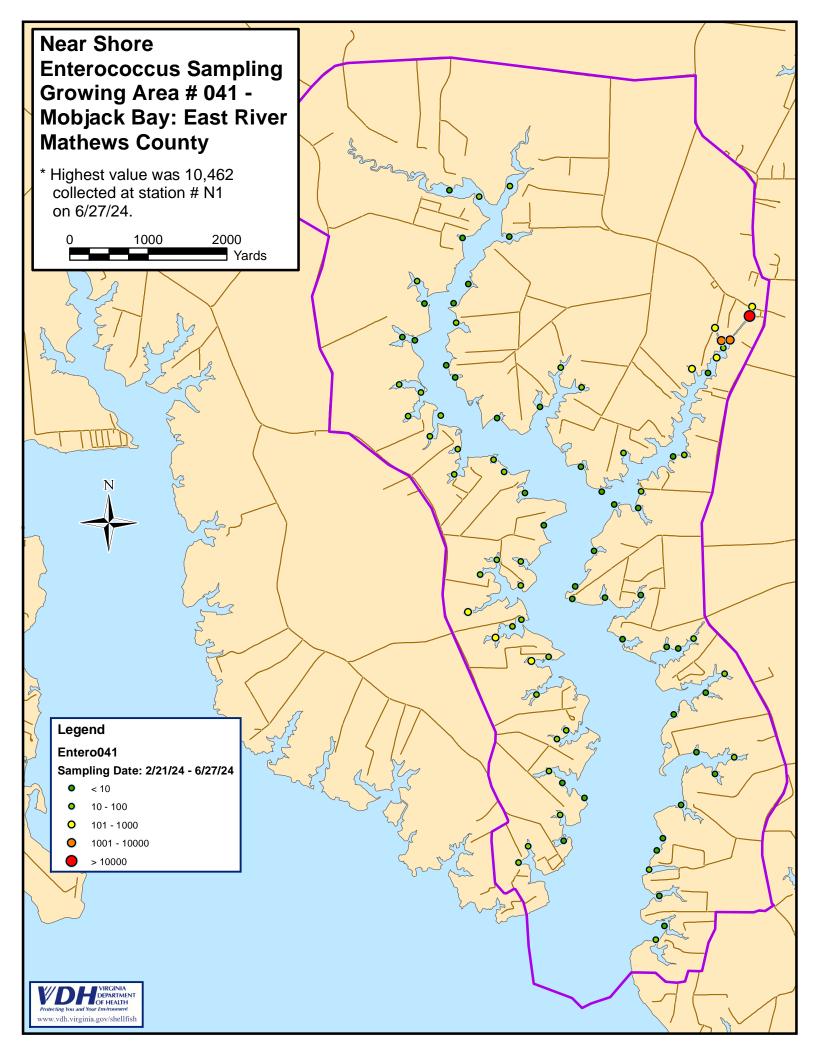
The table below shows hydrographic data, sampling times, and the range of enterococcus concentrations measured. Maps of the enterococcus sampling locations are provided at the end of this report.
