NANDUA AND CURRATUCK CREEKS Growing Area # 082 Accomack County Shoreline Sanitary Survey

Date: 6 August 2024

Survey Period: January 4, 2024 – July 31, 2024

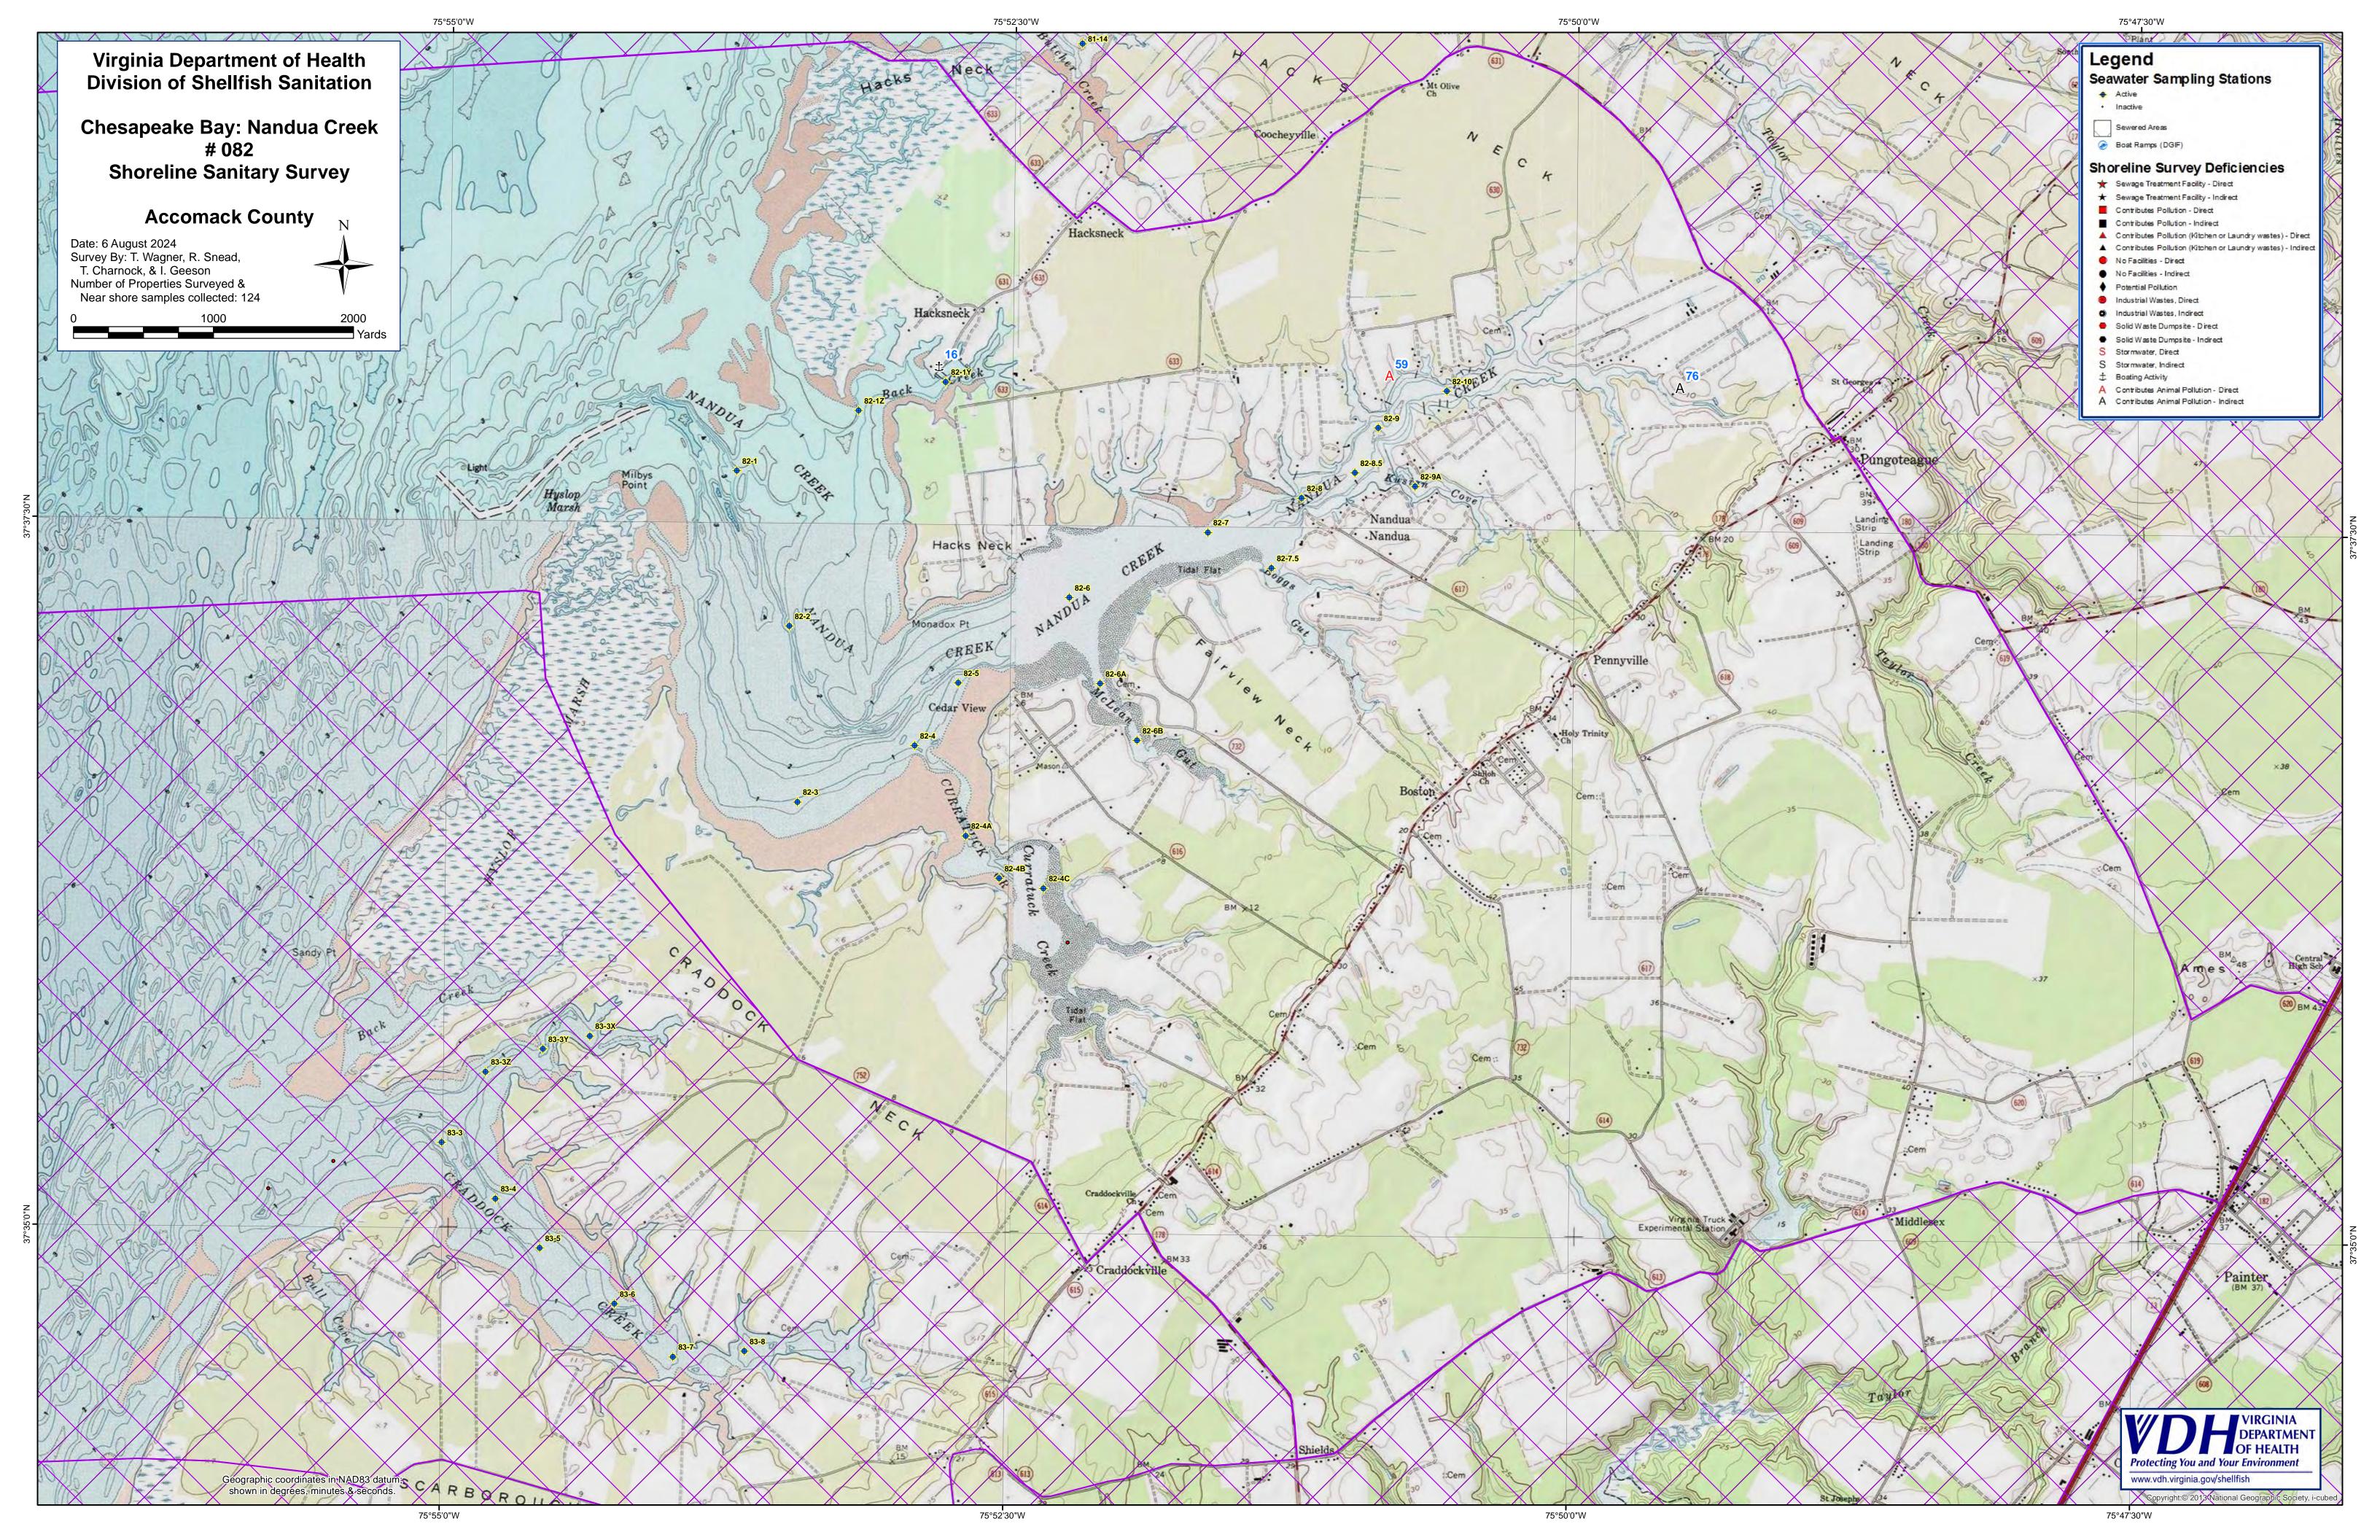
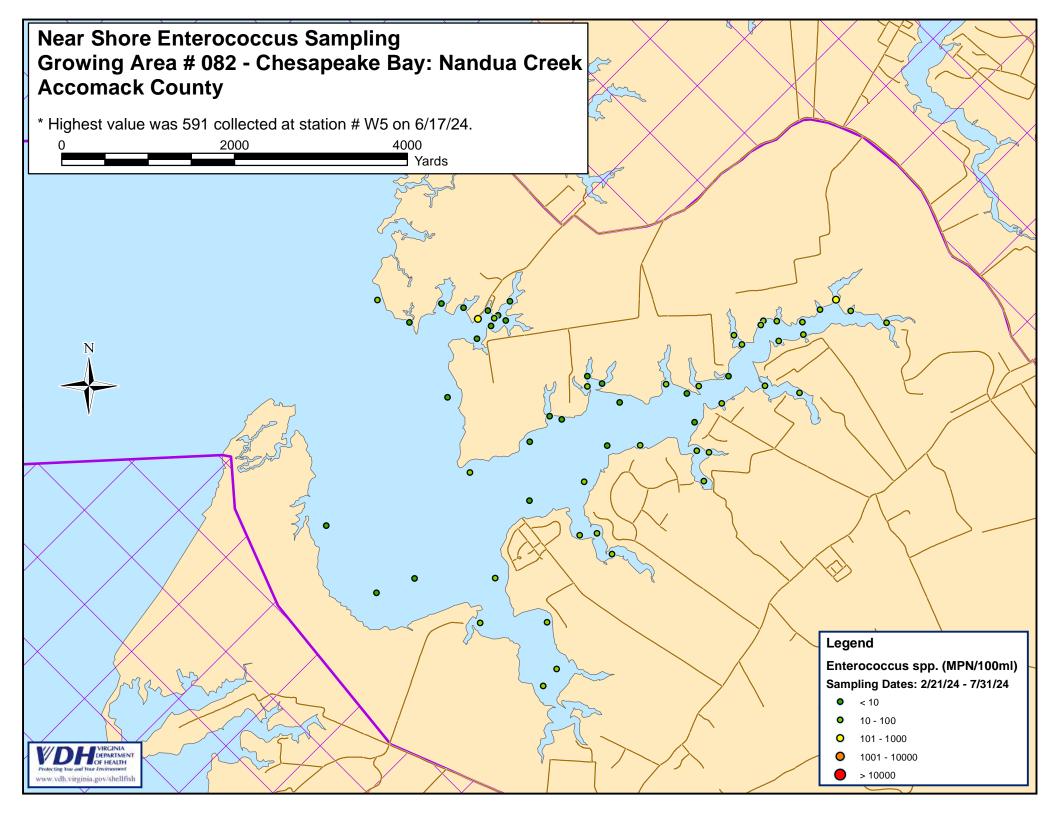
Hydrographic data, sampling times and range of enterococcus concentrations measured are shown in the table below. Maps of the enterococcus sampling are shown at the conclusion of this report.
