OFFICE OF DRINKING WATER

RE: City of Richmond, PWSID 4760100

On August 7, 2025, I conducted a site visit to the City of Richmond Water Treatment Plant (WTP) to verify completion of several items identified as significant deficiencies in our sanitary survey conducted in January and February of 2025. While on site, there was also discussion on progress on outstanding items related to the significant deficiencies and the consent orders issued on June 13 and July 1, 2025. Overall, general observations were that the water treatment plant was significantly improved in terms of general housekeeping and organization. No debris or garbage was observed in the filter pipe gallery and items were stored in an organized fashion. There appears to be steady forward positive progress in addressing systemic issues at the waterworks and should be noted.

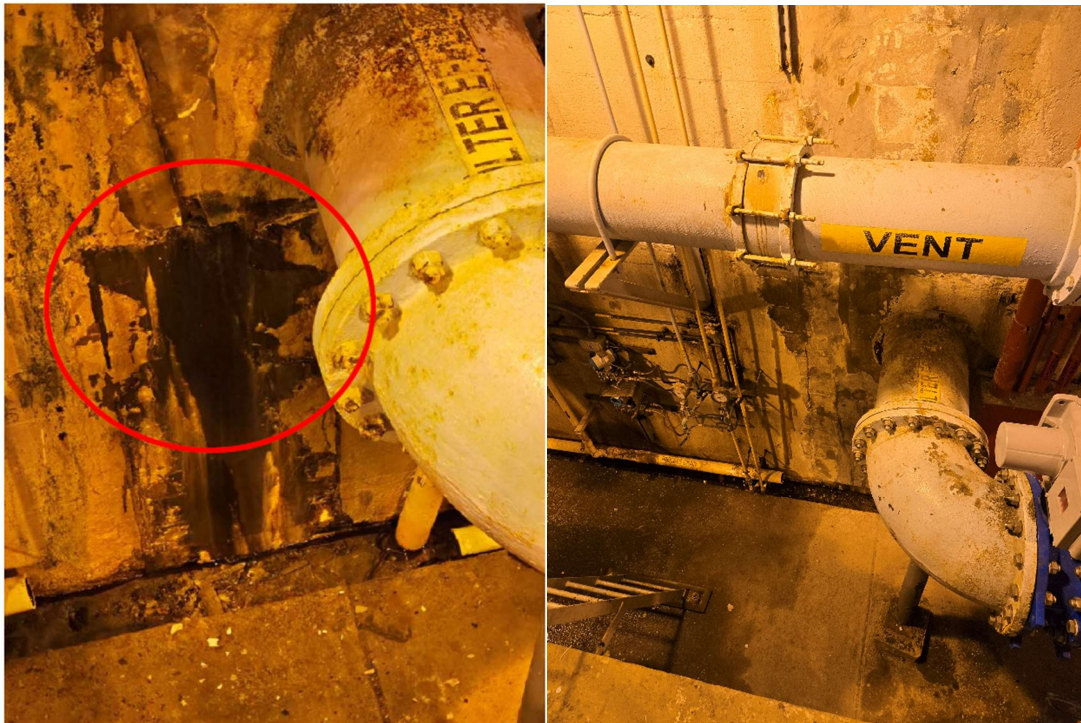
VDH- 02	Filter No. 6 appeared to have an active leak through the concrete in the filter pipe gallery. Prolonged leaking could potentially compromise the concrete and result in failure of the filter.	VDH Sanitary Survey Report	Significant Deficiency	<p>May 16, 2025, letter from DPU indicates concrete has been repaired.</p> <p>Update August 7: Did not observe leak during site visit, concrete appeared to be repaired. (Figure 1)</p> <p>Status: Resolved</p>

Figure 1 Filter 6 wall (left- Sanitary Survey, right- August 7, 2025)

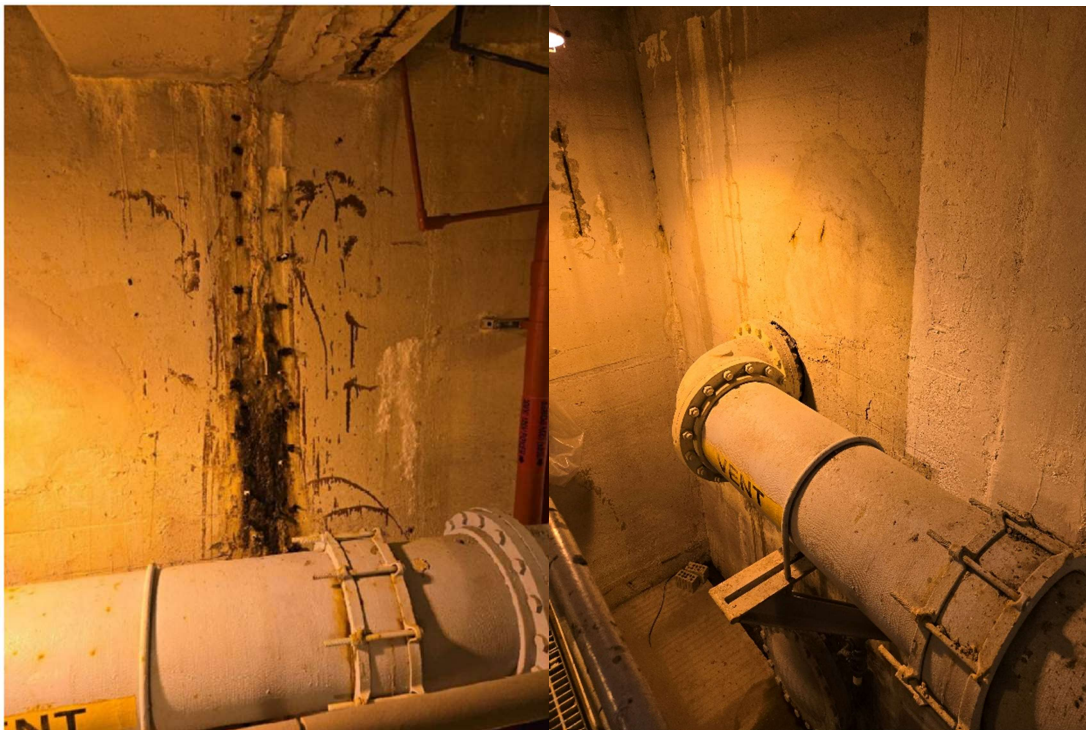
Observation Number	Observation	Source Document	Severity	Status
VDH-03	There appeared to be an active leak in the pipe gallery that appeared to have either biological growth or just appeared slimy. The leak should be investigated.	VDH Sanitary Survey Report	Significant Deficiency	<p>May 16, 2025, letter from DPU indicates concrete has been repaired.</p> <p>Update August 7: Did not observe leak during site visit, concrete appeared to be repaired. Biological growth not observed. (Figure 2)</p> <p>Status: Resolved</p>
VDH-04	One pump was out of service and removed from its pedestal. A significant leak was observed coming from the isolation valve body (with a mat appearing to divert water away from an electrical box) and through the temporary cover plate. The check valve needs to be investigated, as do the gate valve and cover plate. Failure of the cover plate could result in flooding in the backwash waste pump area and pipe gallery.	VDH Sanitary Survey Report	Significant Deficiency	<p>May 16, 2025, letter from DPU indicates repairs complete.</p> <p>Update August 7: Leak not observed from valve body, pump has been reinstalled. Standing water on floor was minimal and did not appear to originate from pump. (Figure 3)</p> <p>Status: Resolved</p>

Figure 2 Plant 1 leak and biological growth (left- Sanitary Survey, right- August 7, 2025)

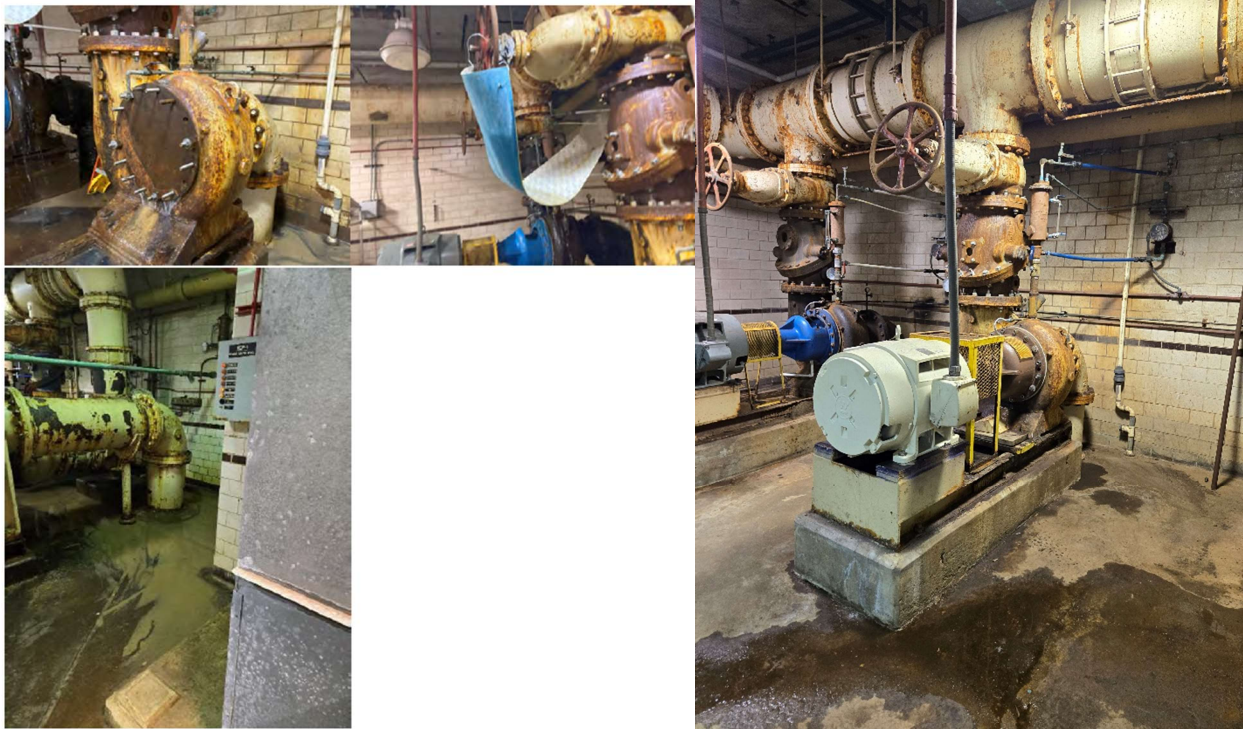
Figure 3 Backwash Waste Pump leak (left and middle- Sanitary Survey, right- August 7, 2025)

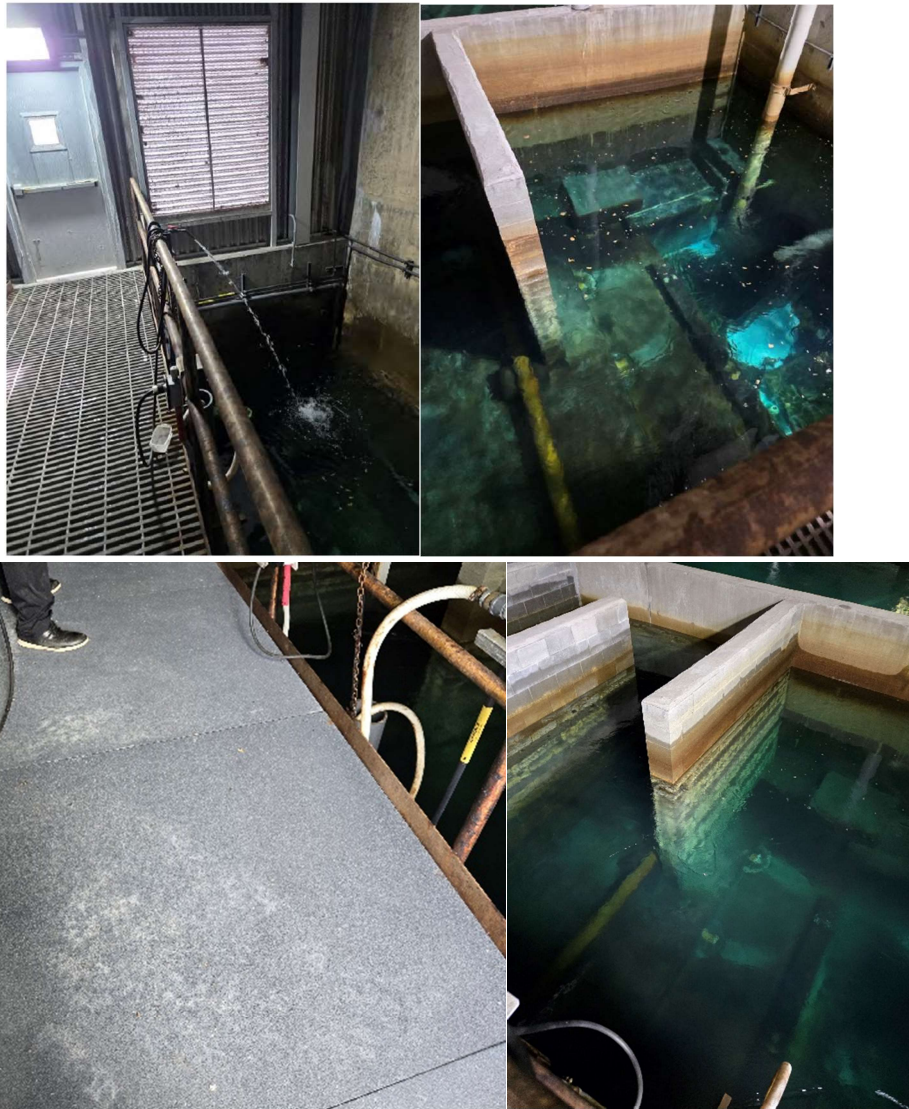
Observation Number	Observation	Source Document	Severity	Status
				<p>gallery was significantly reduced and standing water was minimized during site visit.</p> <p>Status: Continue to monitor progress.</p>
VDH- 07	<p>The walkway on Plant 2 at the end of the finished water basin did not appear to have a solid base beneath the grating, allowing dirt to fall directly into the finished water from shoes, etc. A solid base should be installed beneath the grating. Scum was observed in the water at the end of the aeration basins. The source of the scum should be investigated and addressed</p>	VDH Sanitary Survey Report	Significant Deficiency	<p>May 16, 2025, letter from DPU indicates a solid base has been installed below the walkway on Plant 2. Scum removed from aeration basin, staff will continue to identify and evaluate factors with the potential for impairing the quality as part of our normal operations.</p> <p>Update August 7:</p> <p>Solid base placed over grate to mitigate dirt falling from walkway into basin. Water was clear and free of accumulated scum at the end of the basin. Walkway</p>

Observation Number	Observation	Source Document	Severity	Status
				was clean and free of dirt and debris. (Figure 5) Status: Resolved
VDH-08	A piece of wood is supporting an altitude valve where a concrete support is heavily deteriorated. The wood and concrete support are not adequate, and a more permanent repair should be made. Damage to the valve or associated piping may impair tank operations.	VDH Sanitary Survey Report	Significant Deficiency	May 16, 2025, letter from DPU indicates concrete support has been repaired. Update August 7: See Figure 6, support has been repaired Status: Resolved
VDH-09	Several tanks equipped with overflows that were piped to stormwater drains and sanitary sewer with no knowledge of backflow prevention provided. COR should investigate connection and determine degree of hazard and provide appropriate protection.	VDH Sanitary Survey Report	Significant Deficiency	May 16, 2025, letter from DPU indicates working with Whitman Requardt and Associates and a Technical Memorandum will be completed that summarizes all overflows from these tanks and backflow prevention. Update August 7: Technical Memorandum still on schedule. Dirt and debris in pipe gallery was significantly reduced and standing water

Figure 5 Finished water basin walkway (Top- Sanitary Survey, Bottom- August 7, 2025)

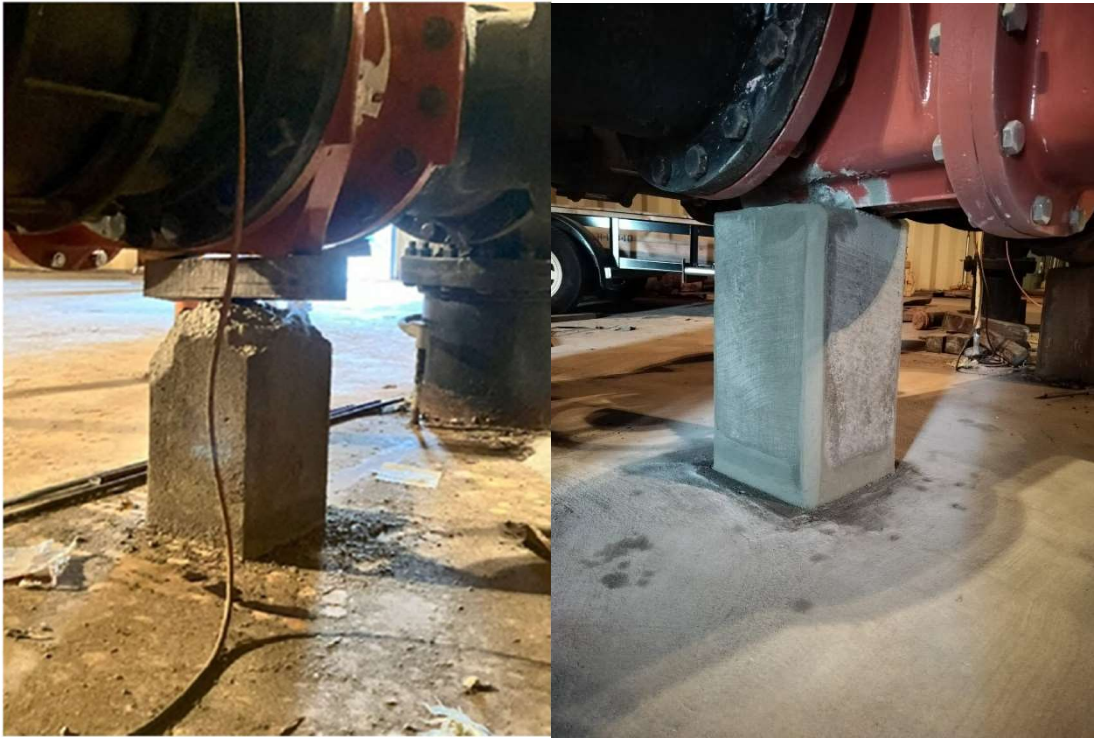
Figure 6 Warwick Road Support (Left- Sanitary Survey, Right- August 2025)

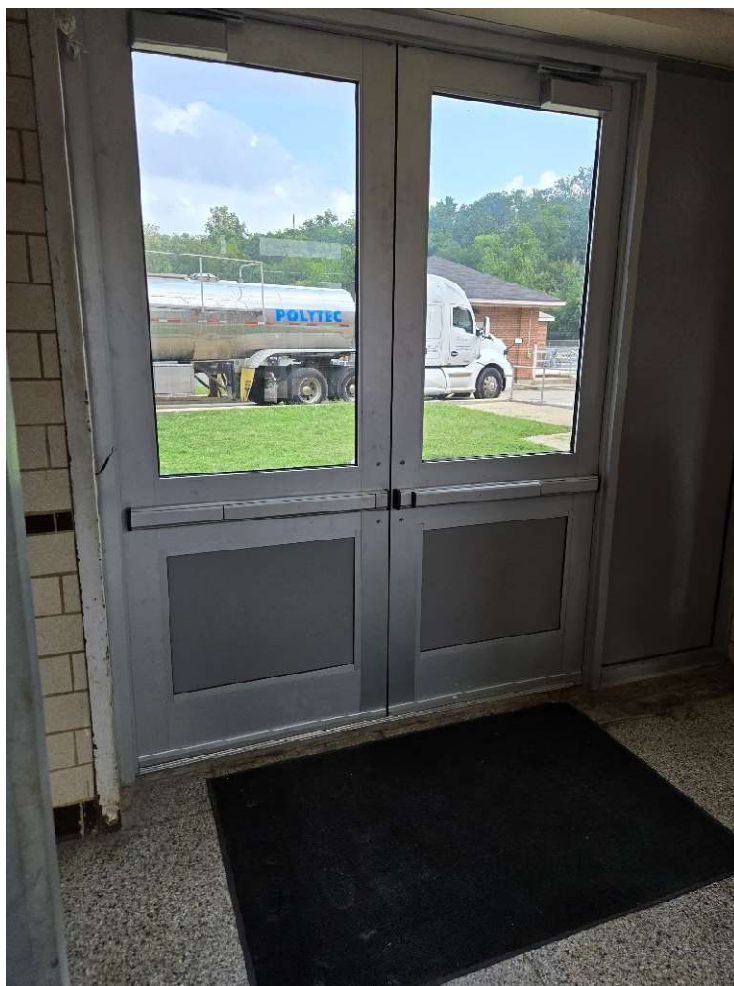
New doors were installed in the hallway between Plants 1 and 2. The installed doors provide the ability to open fully, allowing room to move large equipment without the need to completely remove the doors. See Figure 7.

Figure 7 New doors installed
