Comprehensive Waterworks Evaluation and Cost Estimate

City of Richmond, VA

Virginia Department of Health, Office of Drinking Water

VADOH 183662 | April 8, 2025

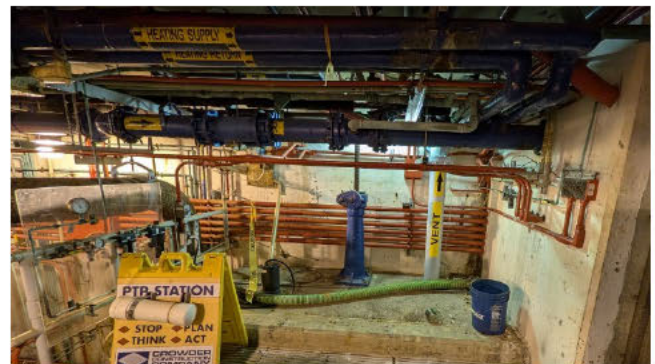
Section 1081 of the Virginia Waterworks Regulations requires new finished water tanks to be equipped with an overflow pipe to convey overflows to a drainage system. The legacy design of the filter plants, which were originally constructed in 1924 and 1950, lacks overflow

Clearwell access hatches are the primary pathway for the clearwell to overflow into the filter gallery in Plant 2.

pipes. This predates the Virginia Waterworks Regulations 12VAC5-590 which were codified and adopted in their current form in 1974.

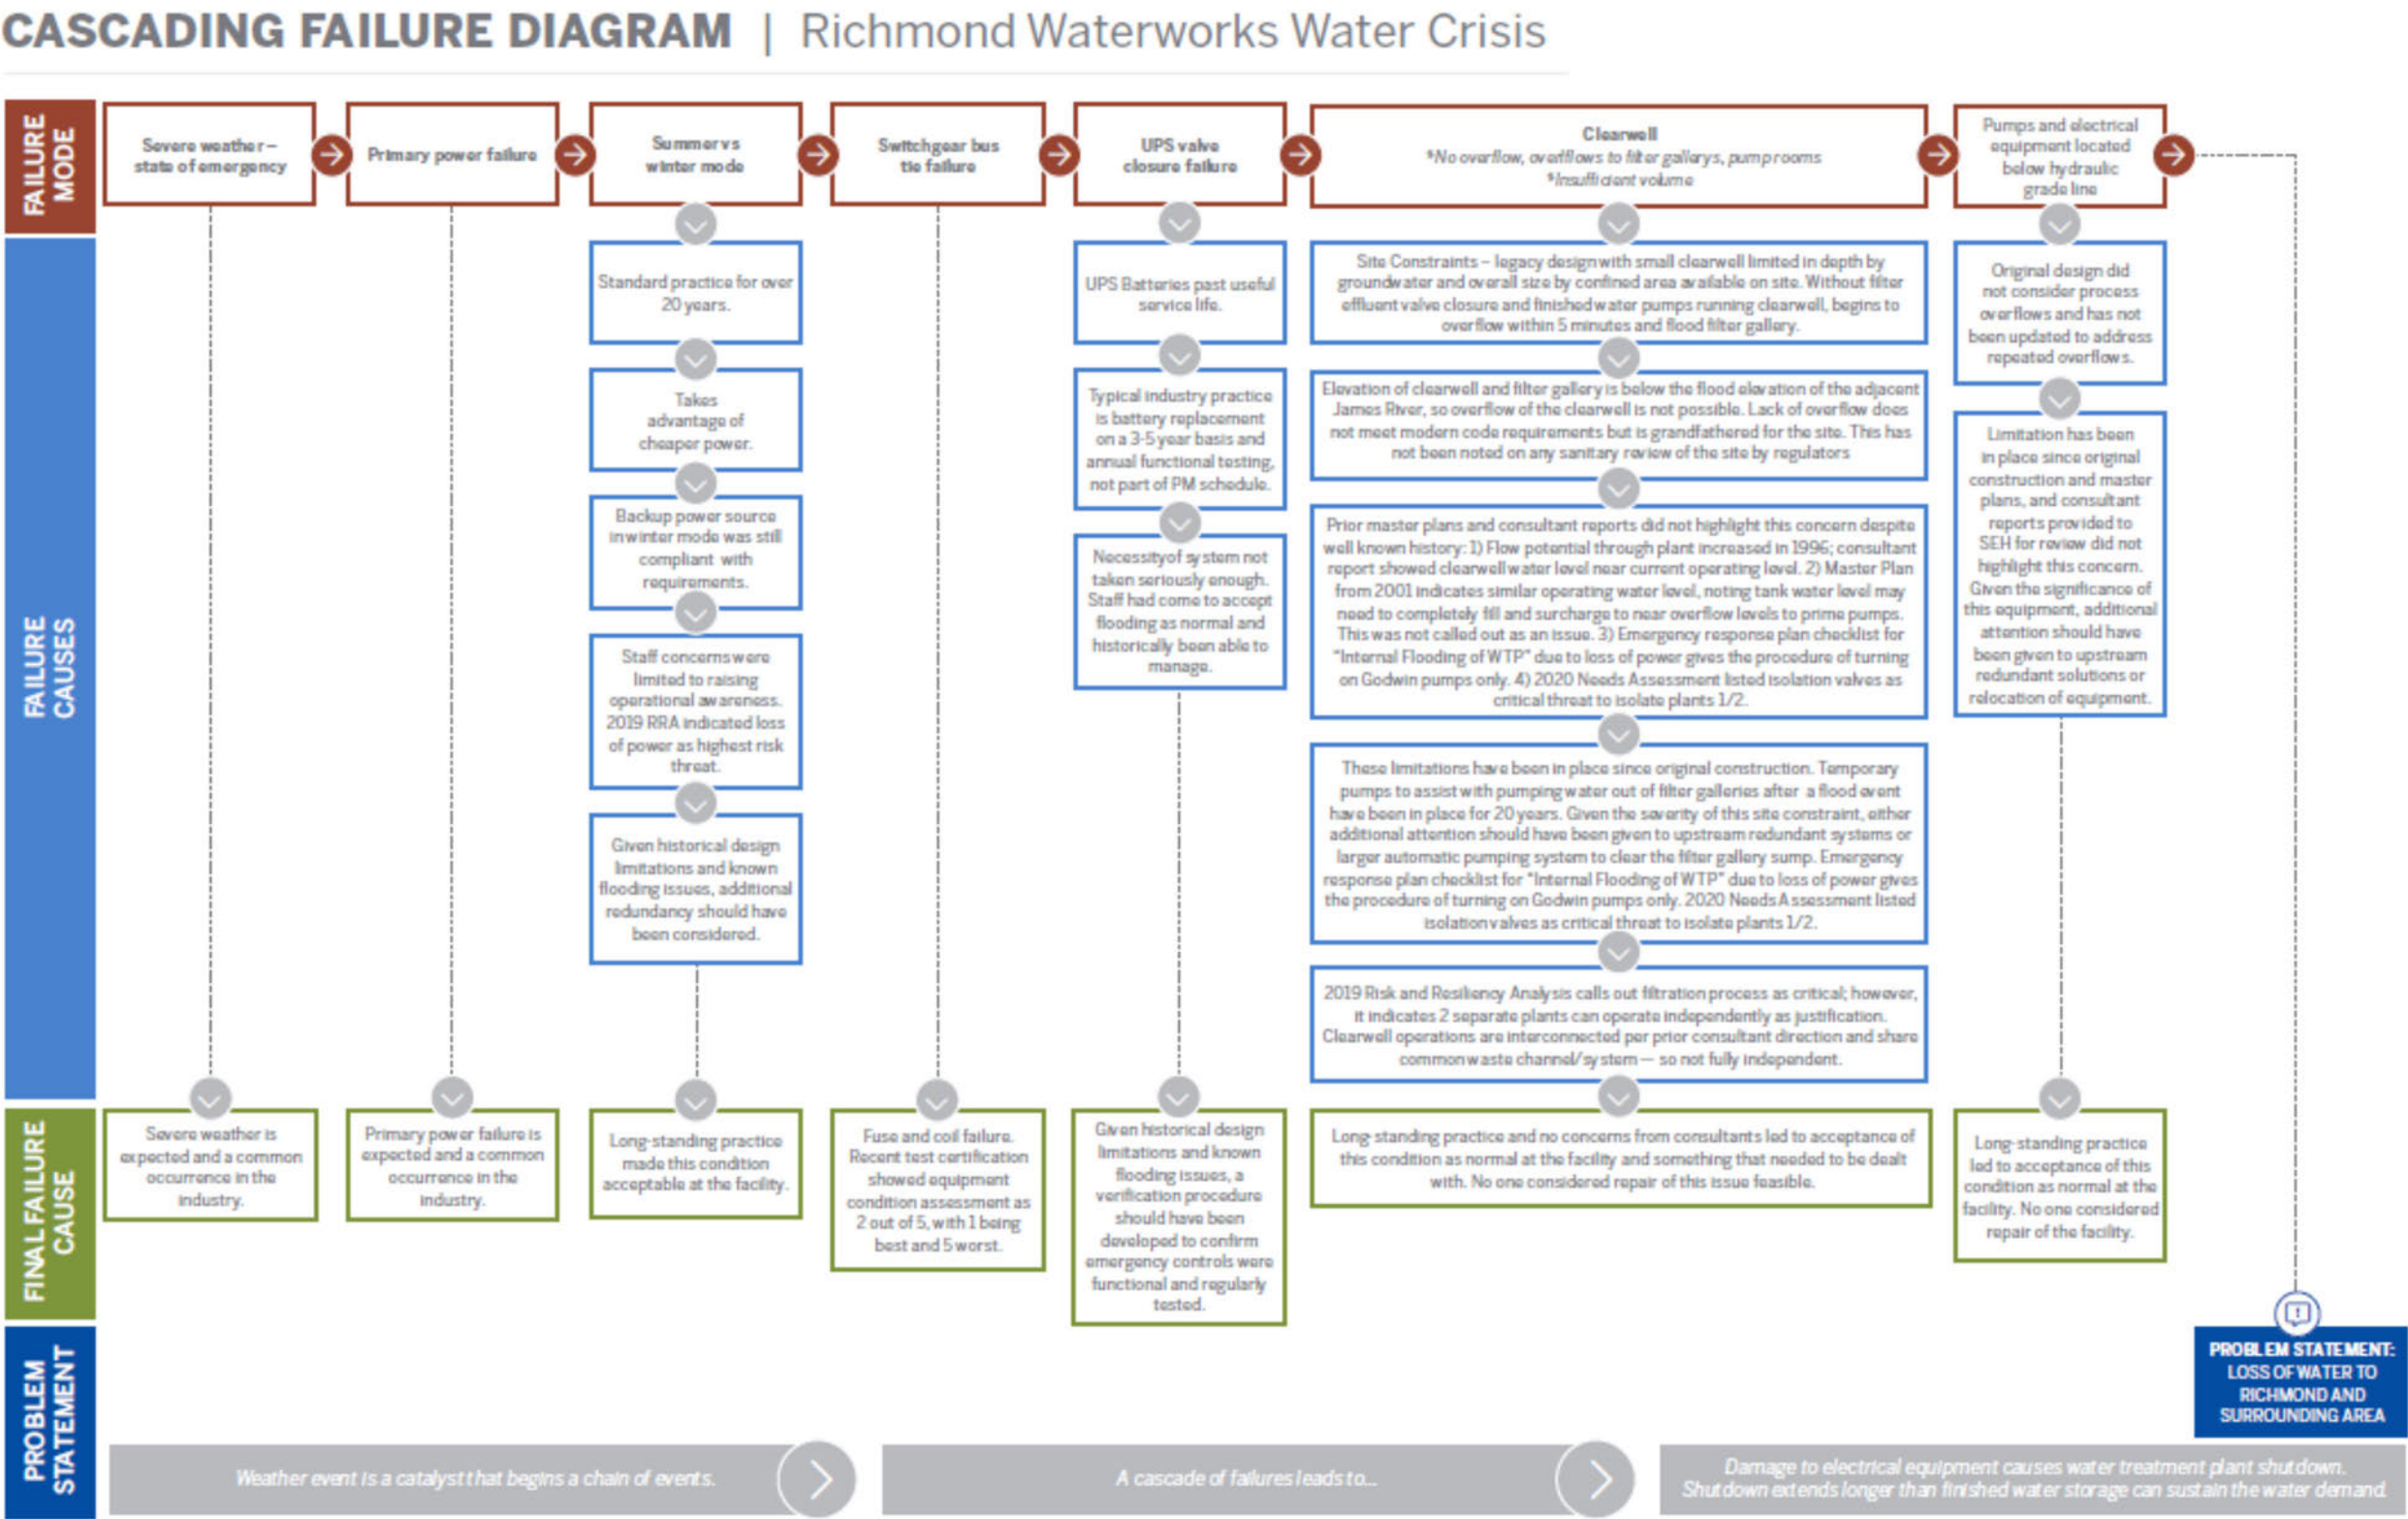
Figure 3 – Root Cause Analysis Cascading Failure Diagram

To summarize the overall failure and Root Cause Analysis, “Loss of water to Richmond and surrounding area” was caused by a production outage at the City’s main water supply, the Richmond Water Treatment Plant. The WTP outage occurred because key electrical equipment was submerged by a process water overflow. The production outage lasted 66 hours before full production flow was leaving plant, which was longer than the capacity of the distribution system to maintain adequate pressure in the system.

The plant contains a vulnerability built into the filter buildings dating to the original construction 100-years ago. At the time, the plant was built to allow gravity flow from the James River intake through the plant to the filters, although pumps were provided to supplement and control the plant flowrate. Furthermore, the plant was constructed with small clearwell volumes and suction lift filtered water pumps located underground in the filter building basement. This configuration, placed critical electrical equipment below the hydraulic grade of the plant. The water level in the clearwell must constantly be controlled by balancing the amount of water flowing in through the filters with the amount of water being pumped out. If the pumps are stopped for any reason, the filter effluent valves must be closed within minutes or the filter gallery and subsequently the pump rooms will be inundated. This vulnerability was well known, however, studies, reports, surveys and plans by consultants and regulators did not acknowledge or address this vulnerability. With no external flags and historical frequency of flooding staff came to accept this as standard practice at the WTP, staff indicated they didn’t consider repair of this issue feasible.

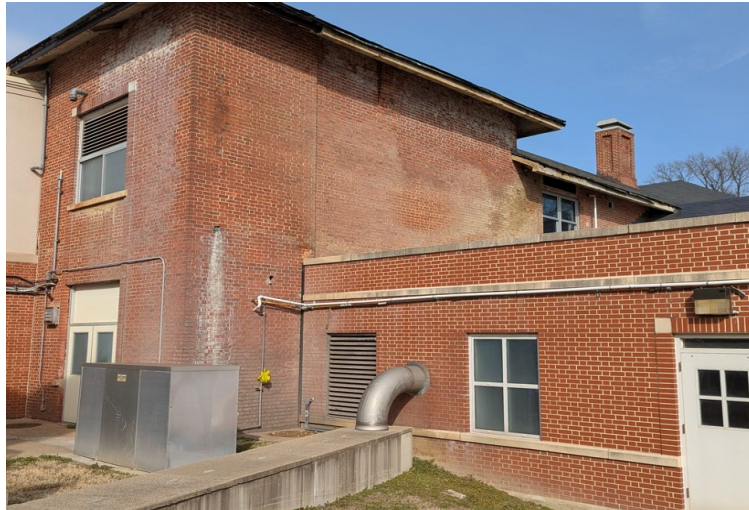
Plant #1 Exterior

11. The exterior of Plants 1 and 2 are in fair condition. There are areas with apparent damage to the wooden fascia/soffits. Recommend further roof assessment and general exterior repairs, including selective roof repairs, exterior tuckpointing, weather stripping, and roof drain/leader selective replacement.

It was noted that the roof decking and roof is in critical disrepair, with replacement options currently underway for Plant #1 and Plant #2.

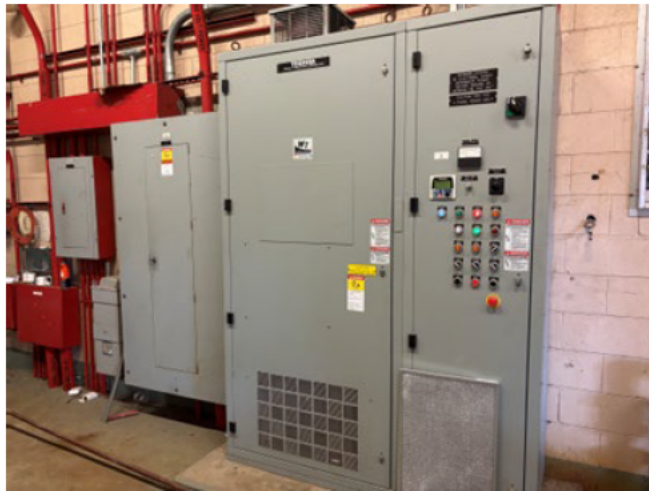
RWP 3 Electrical Equipment

Raw water pump #3 is fed from MSB-HDP-1 in Plant #1. PPA-3 is a 400A General Electric Panelboard and distributes power to the RWP-3 VFD, associated spray wash pumps and 120/240V panel LPA-3. All electrical equipment and is over 30 years old and past its expected life. Replacement is recommended within 5 years.

- Perform annual routing maintenance on electrical distribution equipment
- Replace Panelboard PPA-3 within 5 years.
- Replace Panelboard LPA-3 within 5 years.
- Replace RWP-3 VFD within 5 years.
- Replace Panelboard PPA-4 within 5 years.
- Replace Panelboard LPA-4 within 5 years.
- Replace RWP-4 VFD within 5 years.

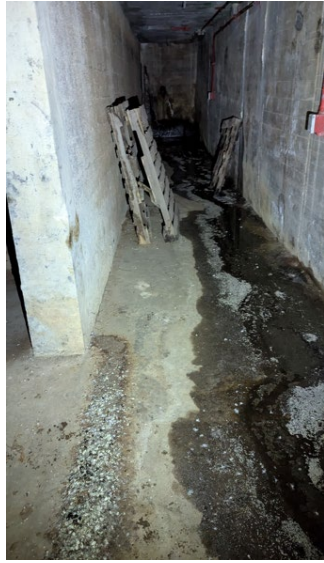
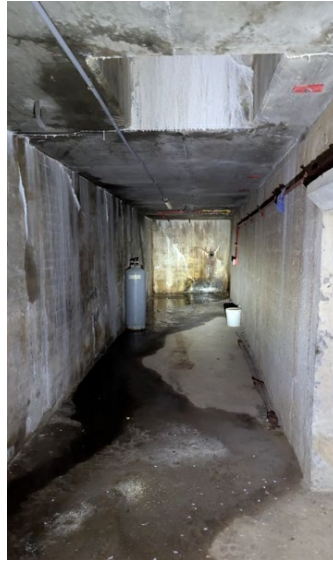
Old flocculation motor areas

3. Between the sedimentation basin control building for Plant #1 and 2, there is a below grade structure that previously housed the motors for horizontal style flocculators. The area appears to be abandoned, with multiple birds observed along with debris, hoses, stagnant water, and an old propane cylinder. The concrete walls show signs of efflorescence. Recommend removal of debris and periodic visual inspection of the area for further signs of deterioration.

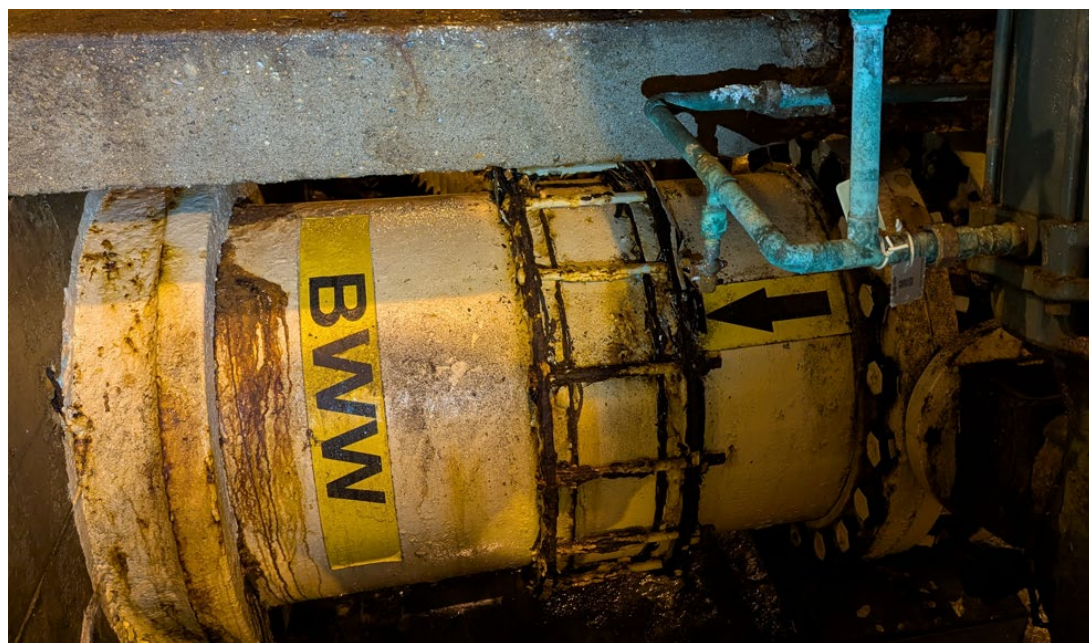
1. The filter piping, bolts, and lower-level structures of Plants 1 and 2 show signs of severe corrosion and damage and are in very poor condition. The stainless-steel air scour piping show signs of severe chlorine induced corrosion and pitting. The facility previously used chlorine gas for disinfection which would have accelerated the damage. The piping gallery in Plant #2 is in noticeably worse condition than Plant #1. Due to the age of piping and severe damage, SEH recommends rehabilitation of filter piping in both Plants 1 and 2. The piping should be blasted, thickness verified, and recoated. All corroded bolts should be replaced. The walkway in Plant #2 should be replaced as the supports are severely corroded with minimal material remaining.

Backwash Waste Water Piping in Plant #2

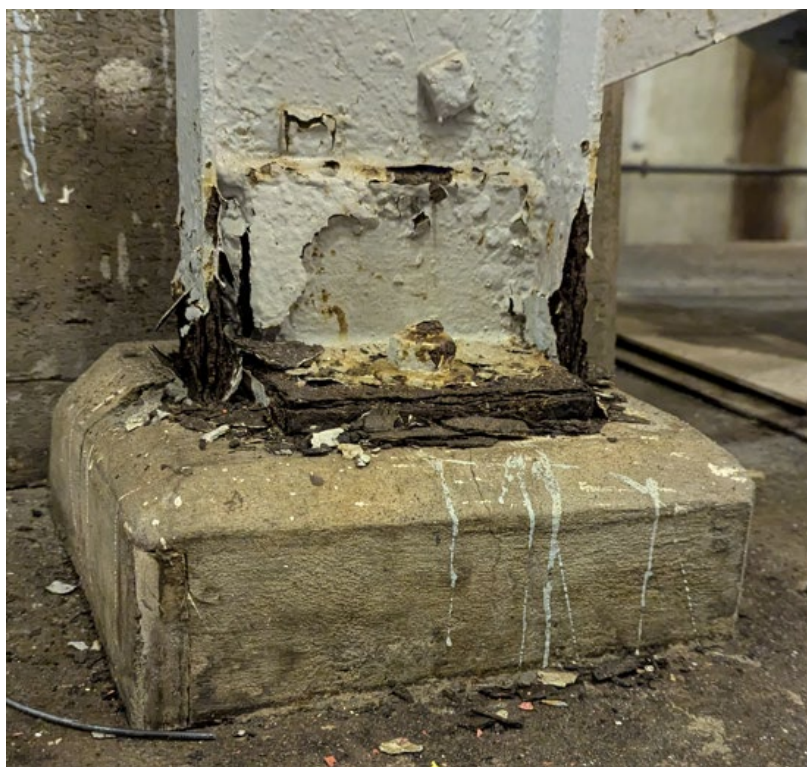
Walkway Supports – Plant #2

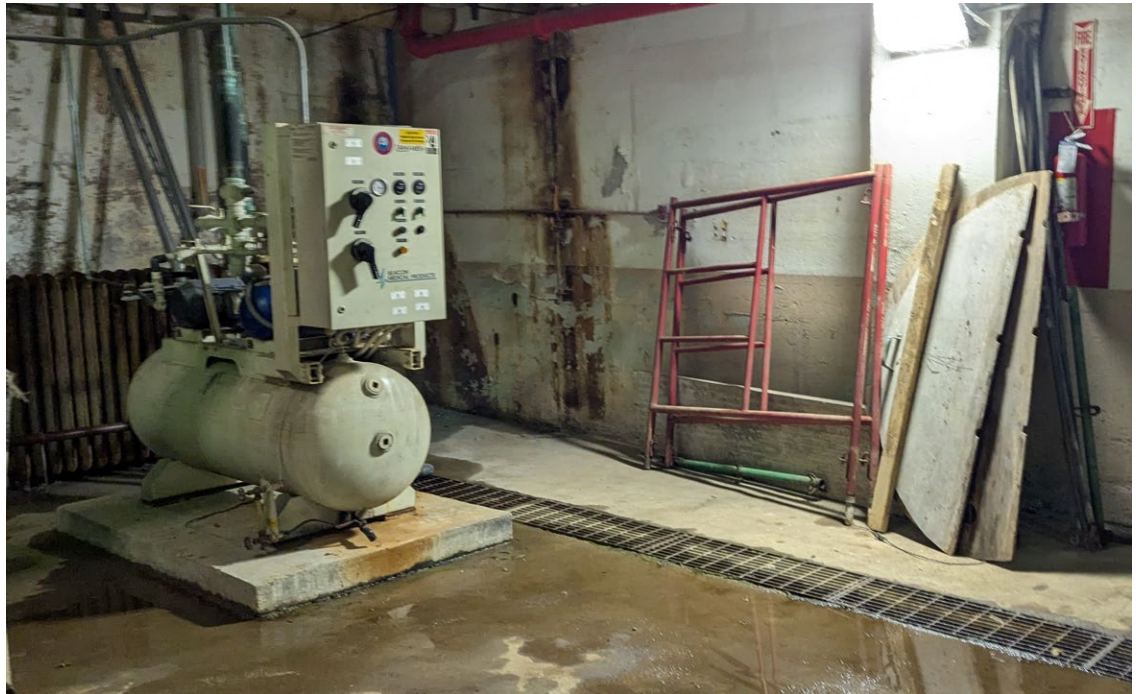
All plant operations and maintenance staff reported that the vacuum priming system is a highly unreliable, complicated, and manual process that has been an issue for many years. To start a pump, operators must first initiate the vacuum priming system located in the filtered water

Plant #1 – Vacuum Priming System

start the vacuum priming system, wait 3-5 minutes, and then start the pump from the SCADA system. Operators reported that the priming system often failed, and that they had to manually “trick” and bypass the priming system to start the pump. DPU staff noted that the facility has replaced the vacuum priming systems throughout the years and reported constant issues.

- a. If vertical turbine pumps are not installed, recommend replacing the vacuum priming system and locating the new system on the main operating floor.

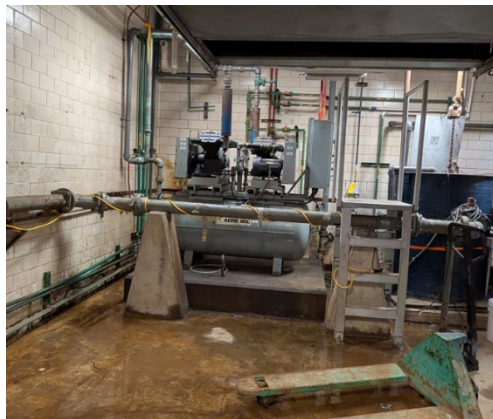
Plant #2 – Vacuum Priming System

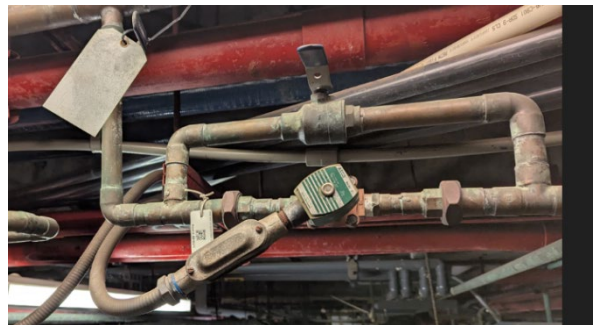
Plant #2 – Vacuum Priming Solenoid and Bypass

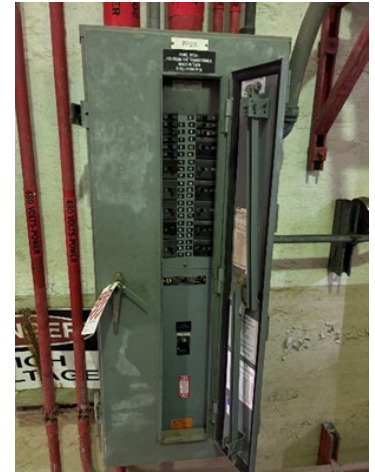
Panel PP-2A

Panelboards PP1A, PP2A and LP2A are located on the pump floor and are over 30 years old and have reached their expected life. In addition, water levels during the recent flood event reached above the bottom levels of PP1A and PP2A and accelerated corrosion can be expected. Replacement of these panelboards is recommended within the next 3 years.

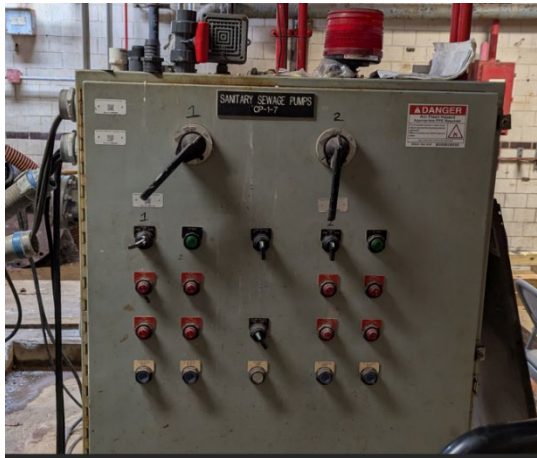
Sanitary Sewage Control Panel

5. At the north end of the Plant #2 filtered water pumping room, there is a sanitary sewage ejector system consisting of two fiberglass tanks with sewage pumps that collect sanitary waste along with laboratory drains. The sewage pumps operate on floats to send sanitary wastewater to the Douglasdale Road Pump Station. While the tanks do not sit directly above the filtered water clearwell, there is no containment wall. There is potential for domestic waste to enter the clearwell through pipe penetrations and the bolted covers in the pump room as noted. It is recommended that the condition of the domestic wastewater system is further evaluated, and a containment wall is constructed to prevent contamination. The system should be relocated if possible, to eliminate the risk of cross contamination with filtered water storage and piping.

- a. There is an on-going project to replace the sanitary sewer equipment, reported to be in the design phase.

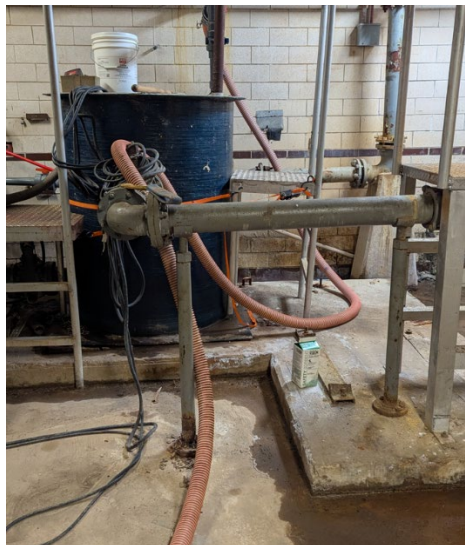
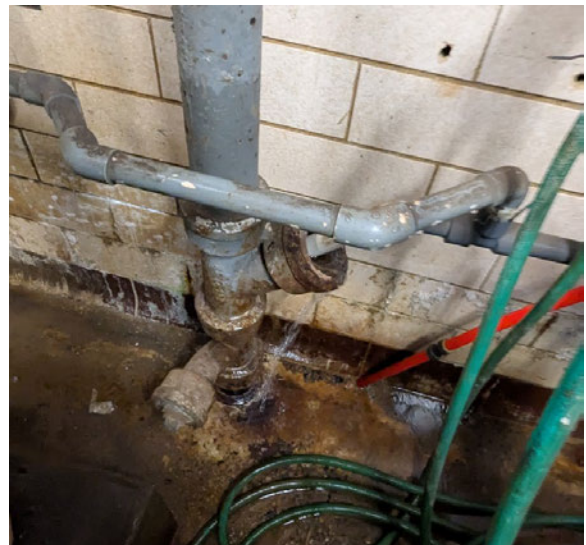
Sanitary Sewage Tank and Drains

6. Significant amounts of standing water was present in the vicinity of the sanitary waste system, along with laboratory drains that were discharged through hoses lying directly on the ground. Recommend properly routing process drains with air gaps.

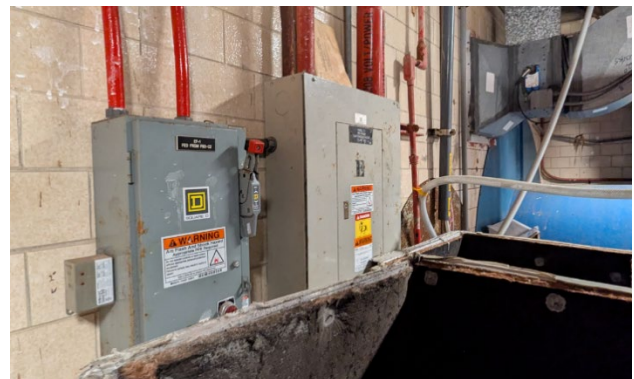
9. General housekeeping in the Plant #2 filtered water pumping room is poor. SEH observed abandoned and disconnected HVAC ducts that prevents safe access around filtered water pump S4, valves, electrical equipment, and the discharge header. Recommend removal and disposal of abandoned equipment to comply with **12VAC5-590-470. Waterworks condition.** The waterworks shall be maintained in a clean and orderly condition.

Abandoned HVAC Ducts – Plant #2

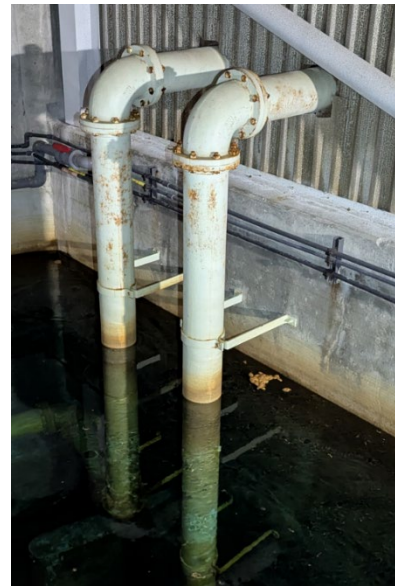
*North Chlorine Contact Basin –
Drain Suction and Discharge*

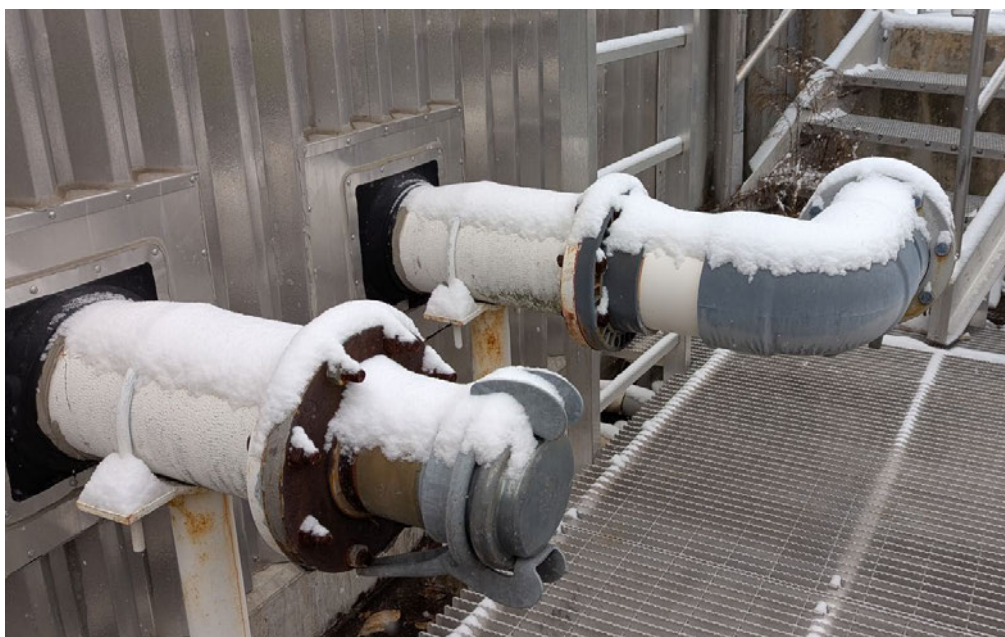
8. The chlorine contact basins utilize suction and discharge connections that allow portable dewatering pumps to be connected when the basins must be drained and cleaned for maintenance. Recommend proper signage on the connections.

Plant #1 – Drain Suction and Discharge Connection

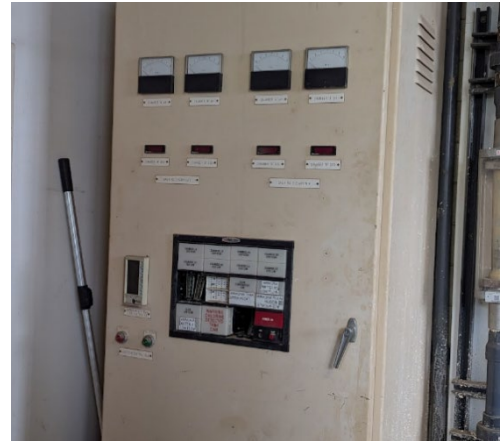
The polymer room in Plant #1 contains panelboard PP2-A fed from Panel PP2, which shows signs of corrosion and is over 30 years and at its expected life.

The polymer room in Plant #2 contains an abandoned control panel. Panel “A” in Plant #2 Polymer Room is fed from the main panelboard and shows signs of corrosion and is over 30 years old and at its expected life.

1. Replace panelboard "A" within 5-10 years.
2. Replace panelboard PP-2A within 5-10 years.
3. Remove abandoned control panel, electrical equipment, and conduits in Plant #2 Polymer Room.

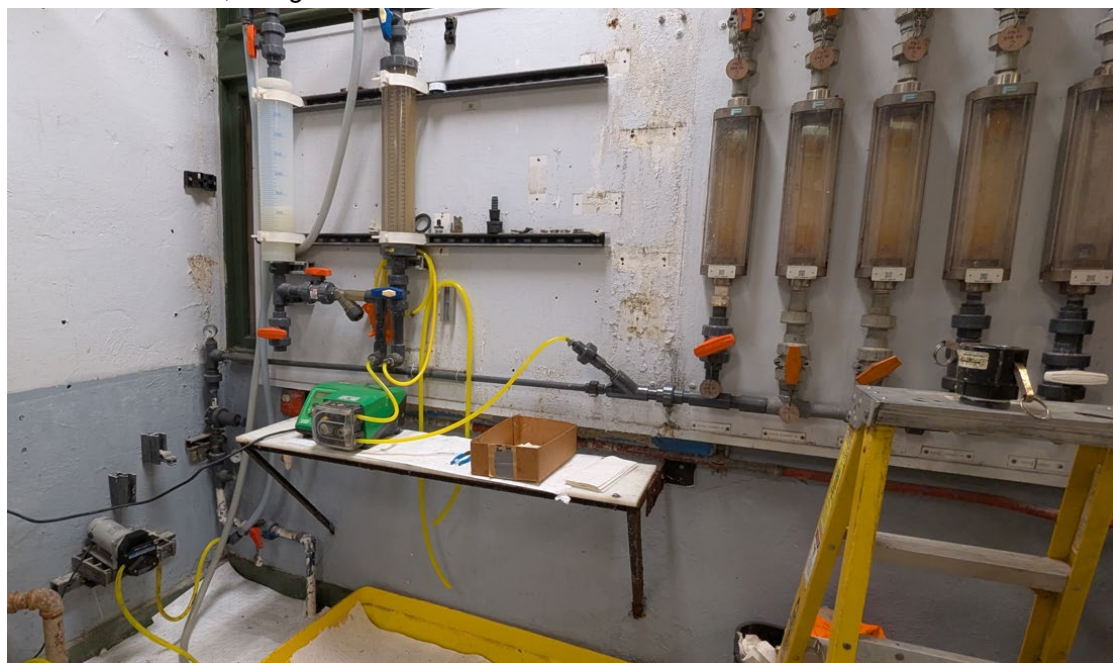
4. Polymer in each plant is injected into a common dilution/motive water header using a single metering pump without a static mixer. The header then immediately splits to each flocculation basin through the use of manual ball valves and a rotameter. There is no means for the facility to accurately ensure proper chemical feed. It is recommended that the facility construct a common polymer storage and feed room in Plant #2. A polymer blending/makedown system should be installed with dedicated dosing pumps for each flocculation basin, along with static mixers.

Plant #1 – Polymer Chemical Storage and Feed

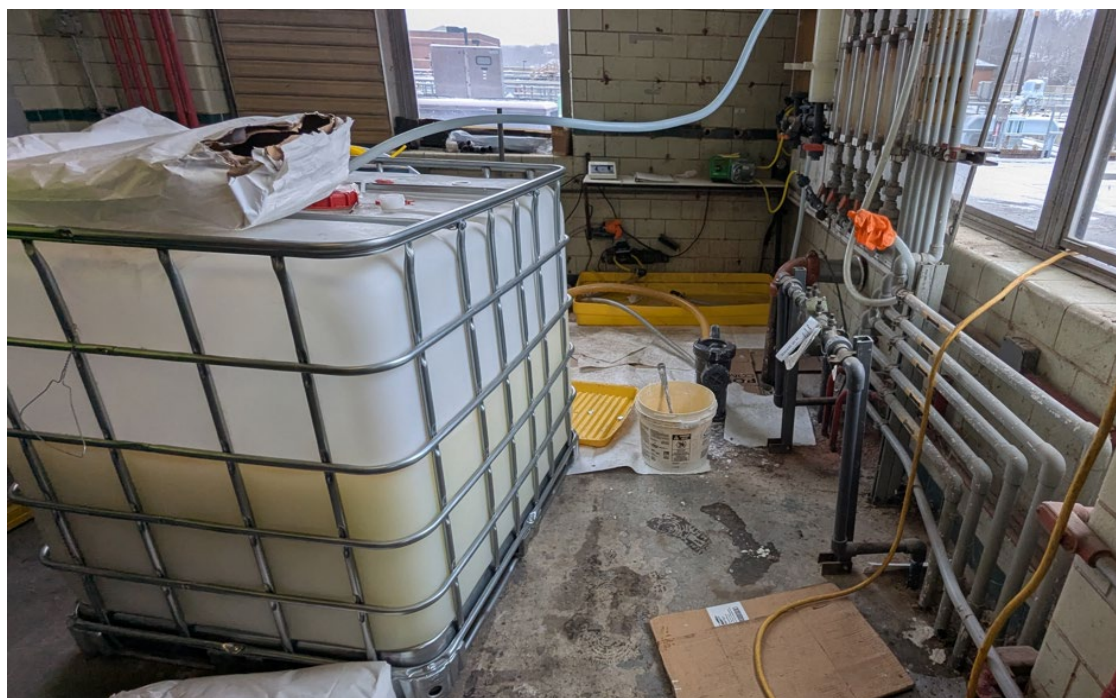
Plant #2 – Polymer Feed

5. The polymer feed system is not flow-paced and must be manually adjusted. The rotameters displaying diluted polymer flow to each basin do not have markings and appeared to be maxed out. Recommend replacing rotameters and adding flowmeters so that polymer feed to each basin can be controlled.

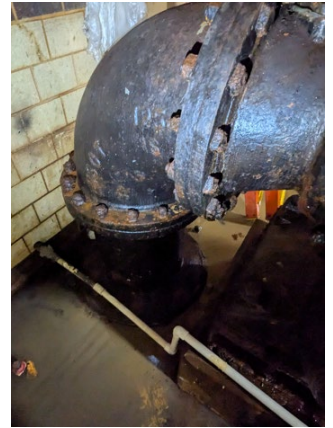
4. The wastewater piping and valves are in poor condition. Recommend cleaning and recoating.
5. There is a significant amount of standing water in the pumping station (room). The floor did not appear to be sloped properly to floor drains located in the center of the room. Recommend fixing floor drainage.

Wastewater Pump Station Piping

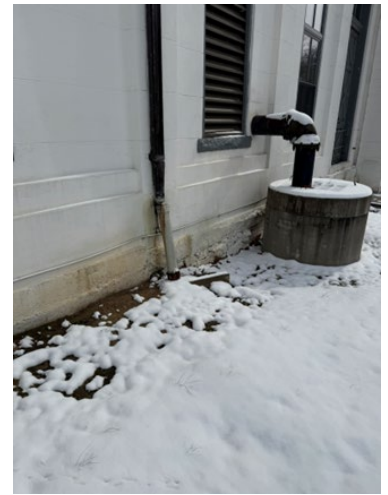
Pressure Relief Valve Discharge

- The pressure relief discharge pipe is inserted into the catch basin. It should be cut off to provide an air gap of at least one foot. It is unknown if the discharge is screened but should be screened with a corrosion resistant screen if not (12VAC5-590-1160).

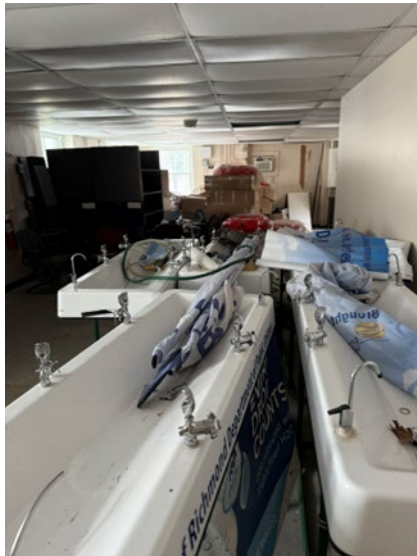
Stored Material on the First Floor

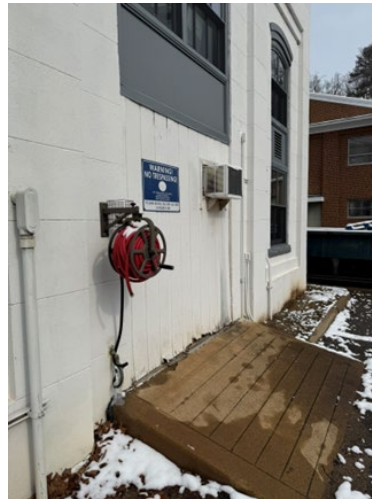
Boarded Up Double Door

- Staining and mildew was observed on the exterior of the building should be power washed.
- The boarded up double door on the east side is showing signs of rotting and should be replaced.
- Two downspouts were observed to be disconnected and should be reconnected.
- Graffiti was observed in the basement.

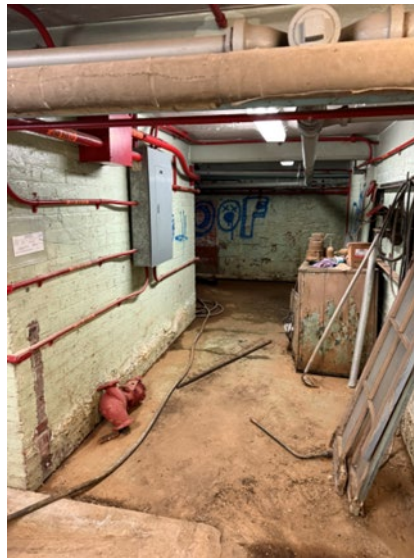
Basement Showing Graffiti

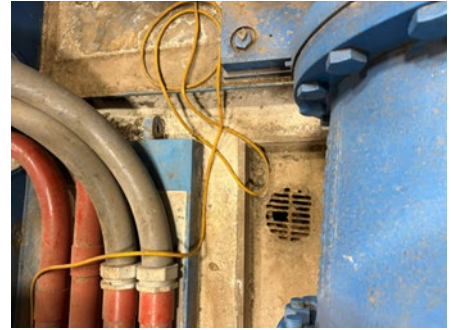
- The floor drains are damaged and recommended to be replaced.
- It is recommended that dehumidification be installed.
- Significant dust and dirt were observed within the pump station. it is recommended that good housekeeping be employed.

Broken Floor Drain

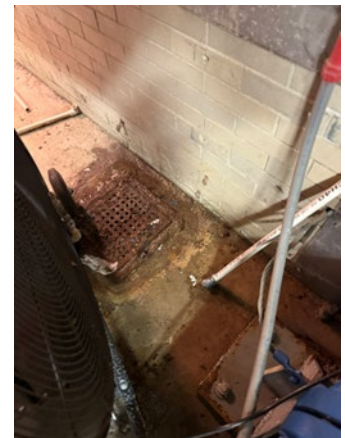
- Due to the age of the building, it is recommended that the floor drains be cleaned out. Additionally, the floor drains were observed to be severely corroded and are recommended to be replaced.

Corroded Floor Drain

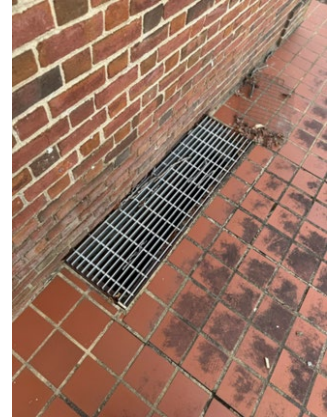
- It is recommended to remove unused equipment from the pump station.
- During the site visit, someone was camped out on the patio next to the exterior exhaust fan.

North Side Patio

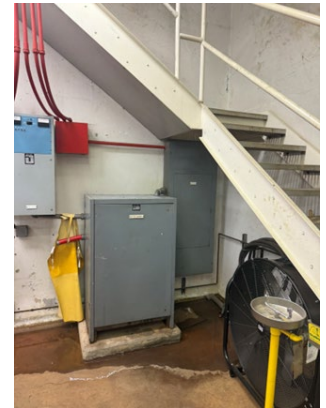
- Water was observed to be pooling around electrical equipment.
- It is recommended the unused conduit extending from the battery cabinet be capped or removed.

Water Pooling Around Electrical Equipment

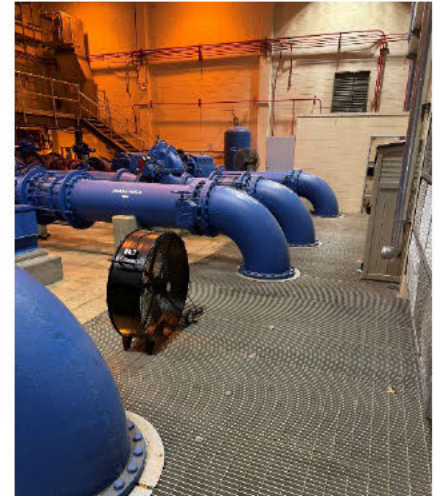
Suction Header Trench Beneath Grating

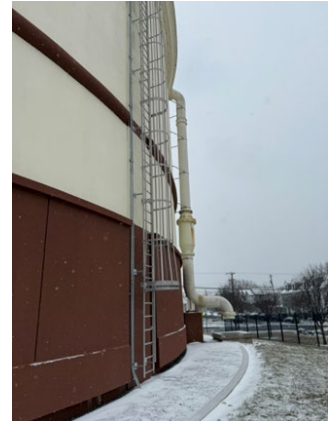
Tank Ladder

- The tank ladder extends to the ground and is protected by a locked ladder cage.
- The overflow pipe is downturned and has a flapper valve. The overflow dumps into its own catch basin that connects to the storm sewer.

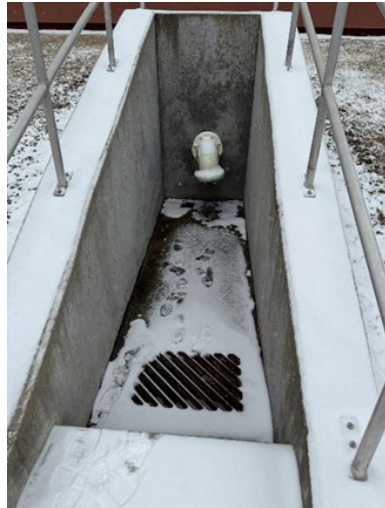
- The tank drain dumps into a drainage structure with a catch basin that is connected to a storm sewer. The tank drain discharge is protected with a screen.

Tank Drain Discharge Structure

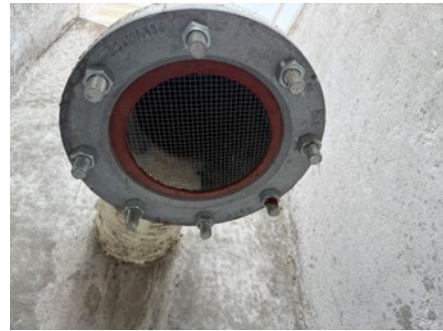
Tank Drain Discharge with Screen

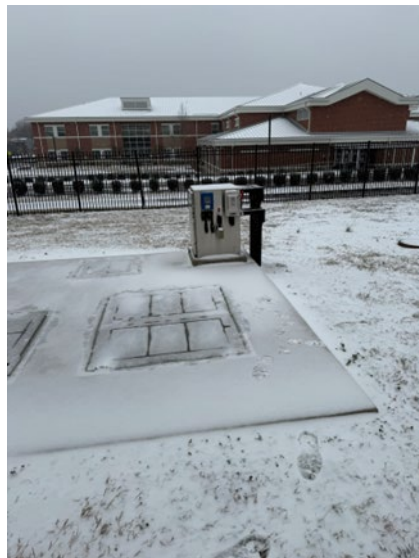
Vault

- A vault containing the inlet and outlet to the tank sits adjacent to the tank. The inlet is controlled via an altitude valve. An electrical box sits on top of the vault with the tank level transmitter and altitude valve power switch on the side of the electrical box.

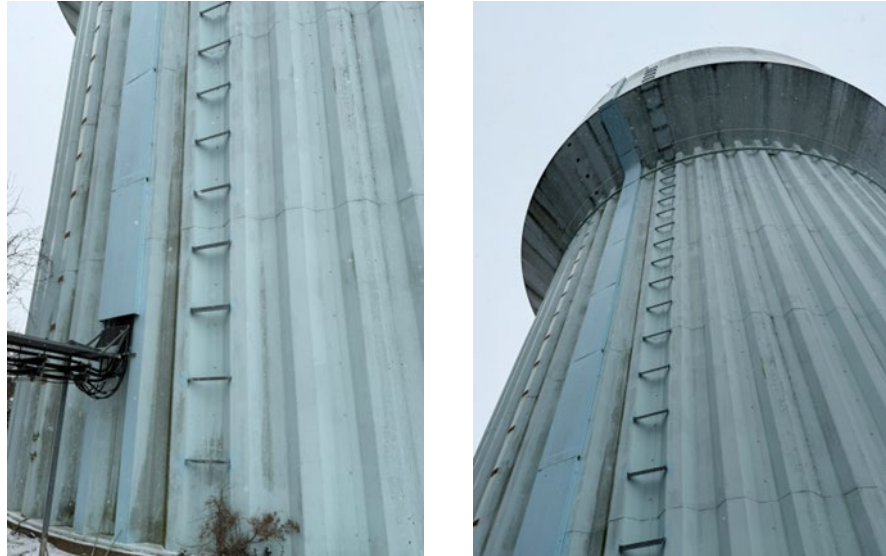
- Brackets on the exterior of the tank are unused and act as a ladder to the tank roof. It is recommended to cut off these brackets.

Unused Brackets

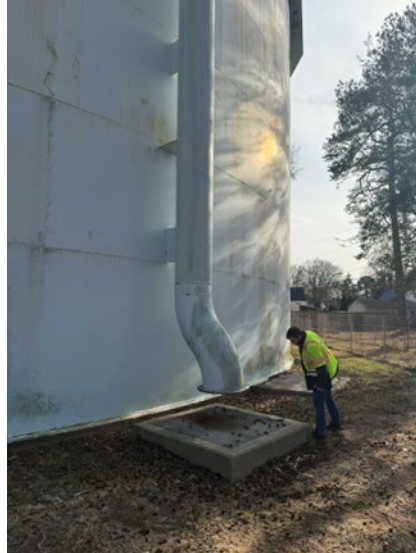
- A new altitude valve was observed to be stored at Hioaks Elevated Tank to replace one of the Jahnke Road Tank altitude valves. Staff stated that the lay length of the new altitude valve is different than the existing and will require modification of the site piping to install.
- The overflow is downturned and screened and discharges into a catch basin.

Overflow
