### System Sanitary Survey Report

April 3, 2026

SUBJECT: Richmond City  
Waterworks: Richmond, City Of  
PWSID: VA4760100

Survey Date: February 23, 2026

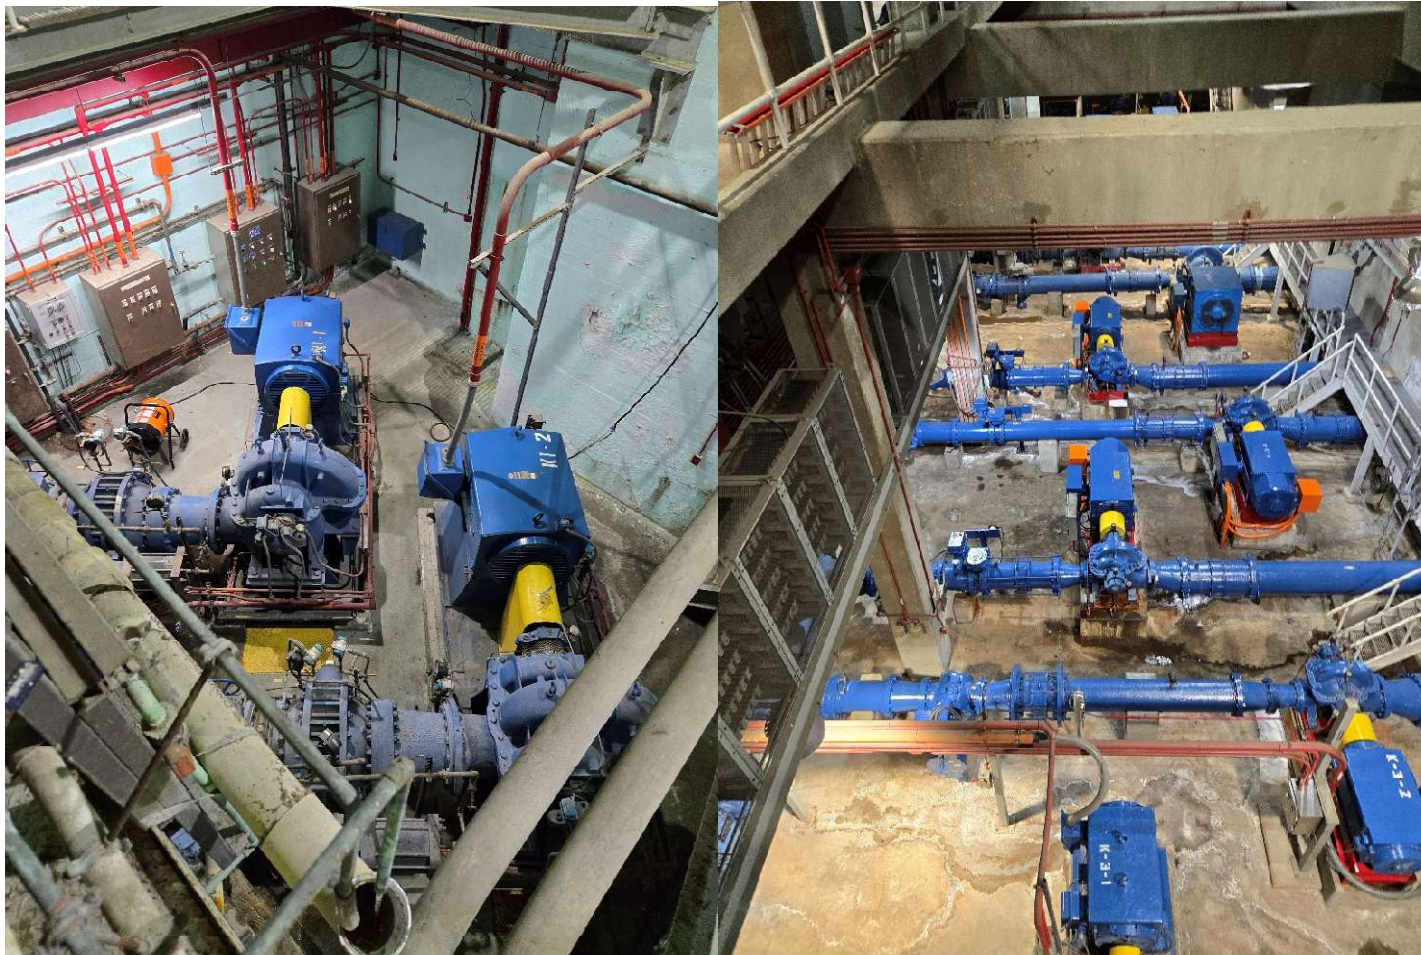
Figure 28. Korah Pump Stations

- Pumps look to be painted, no major corrosion observed (Figure 28)
- All pumps operable
- Minimal standing water
- All appurtenances look OK

| Observation Number | Facility Inspected | 2022 EPA Observation | 2026 VDH ODW Observation | Status | Accompanying Photograph (Appendix A) |
|---|---|---|---|---|---|
| <b>AOC-36</b> | Distribution System | The building that houses Korah Pump Station #2 and #3 had active water drainage to the floor from at least two sources. The pump for Korah 1-2 had exposed wiring. | No exposed wiring observed, no active water leaks observed. Standing water minimized | Resolved | Figure 28 |
