### System Sanitary Survey Report

SUBJECT: Richmond City  
Waterworks: Richmond, City Of  
PWSID: VA4760100

Survey Date: February 23, 2026

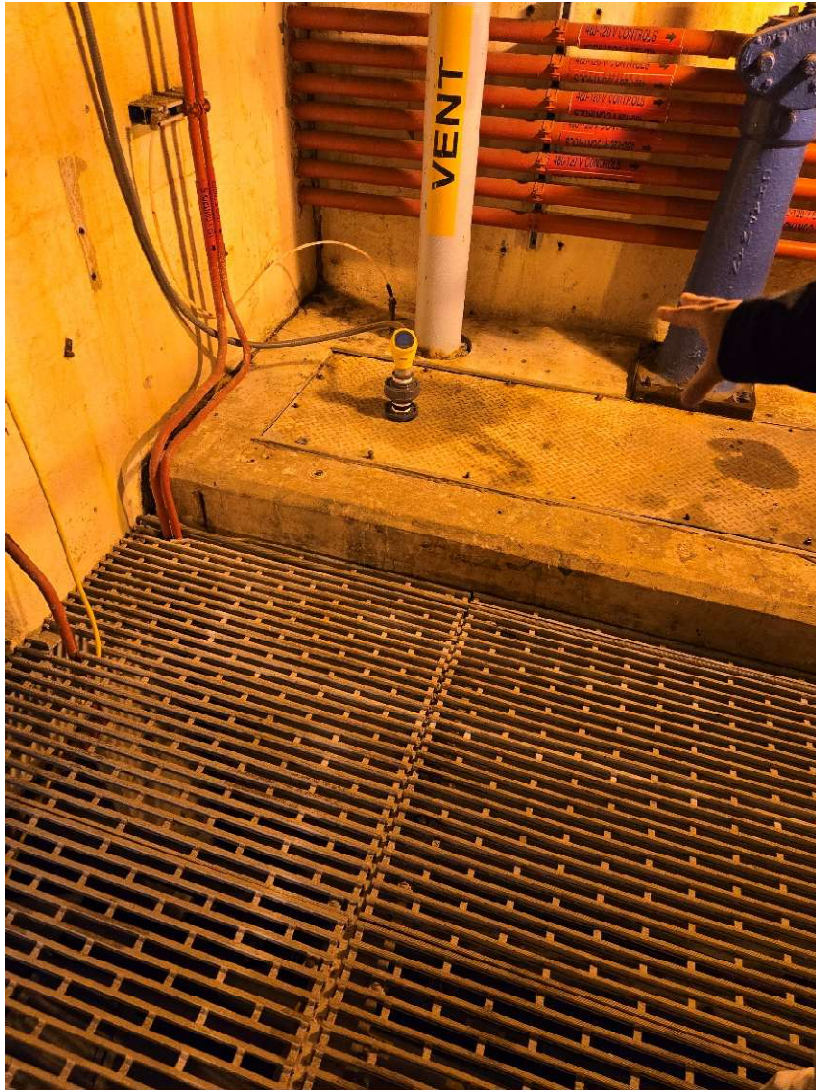
- Installation of ultrasonic clearwell level sensors (completed- Figure 18) and connection of new ultrasonic sensors and existing bubbler level sensors to SCADA. Will allow System to create controls to automatically and safely shutdown the WTP before the clearwell reaches flood levels

Figure 18. Ultrasonic level sensor for clearwell
