**COMMONWEALTH of VIRGINIA
DEPARTMENT OF HEALTH
DIVISION OF SHELLFISH SANITATION**

**THE GULF
Growing Area # 087
Northampton County
Shoreline Sanitary Survey**

Date: 29 October 2015
Survey Period: November 11, 2014 – October 9, 2015
Total Number of Properties Surveyed: 376
Surveyed By: D.P. Miller and R.F. Sloan

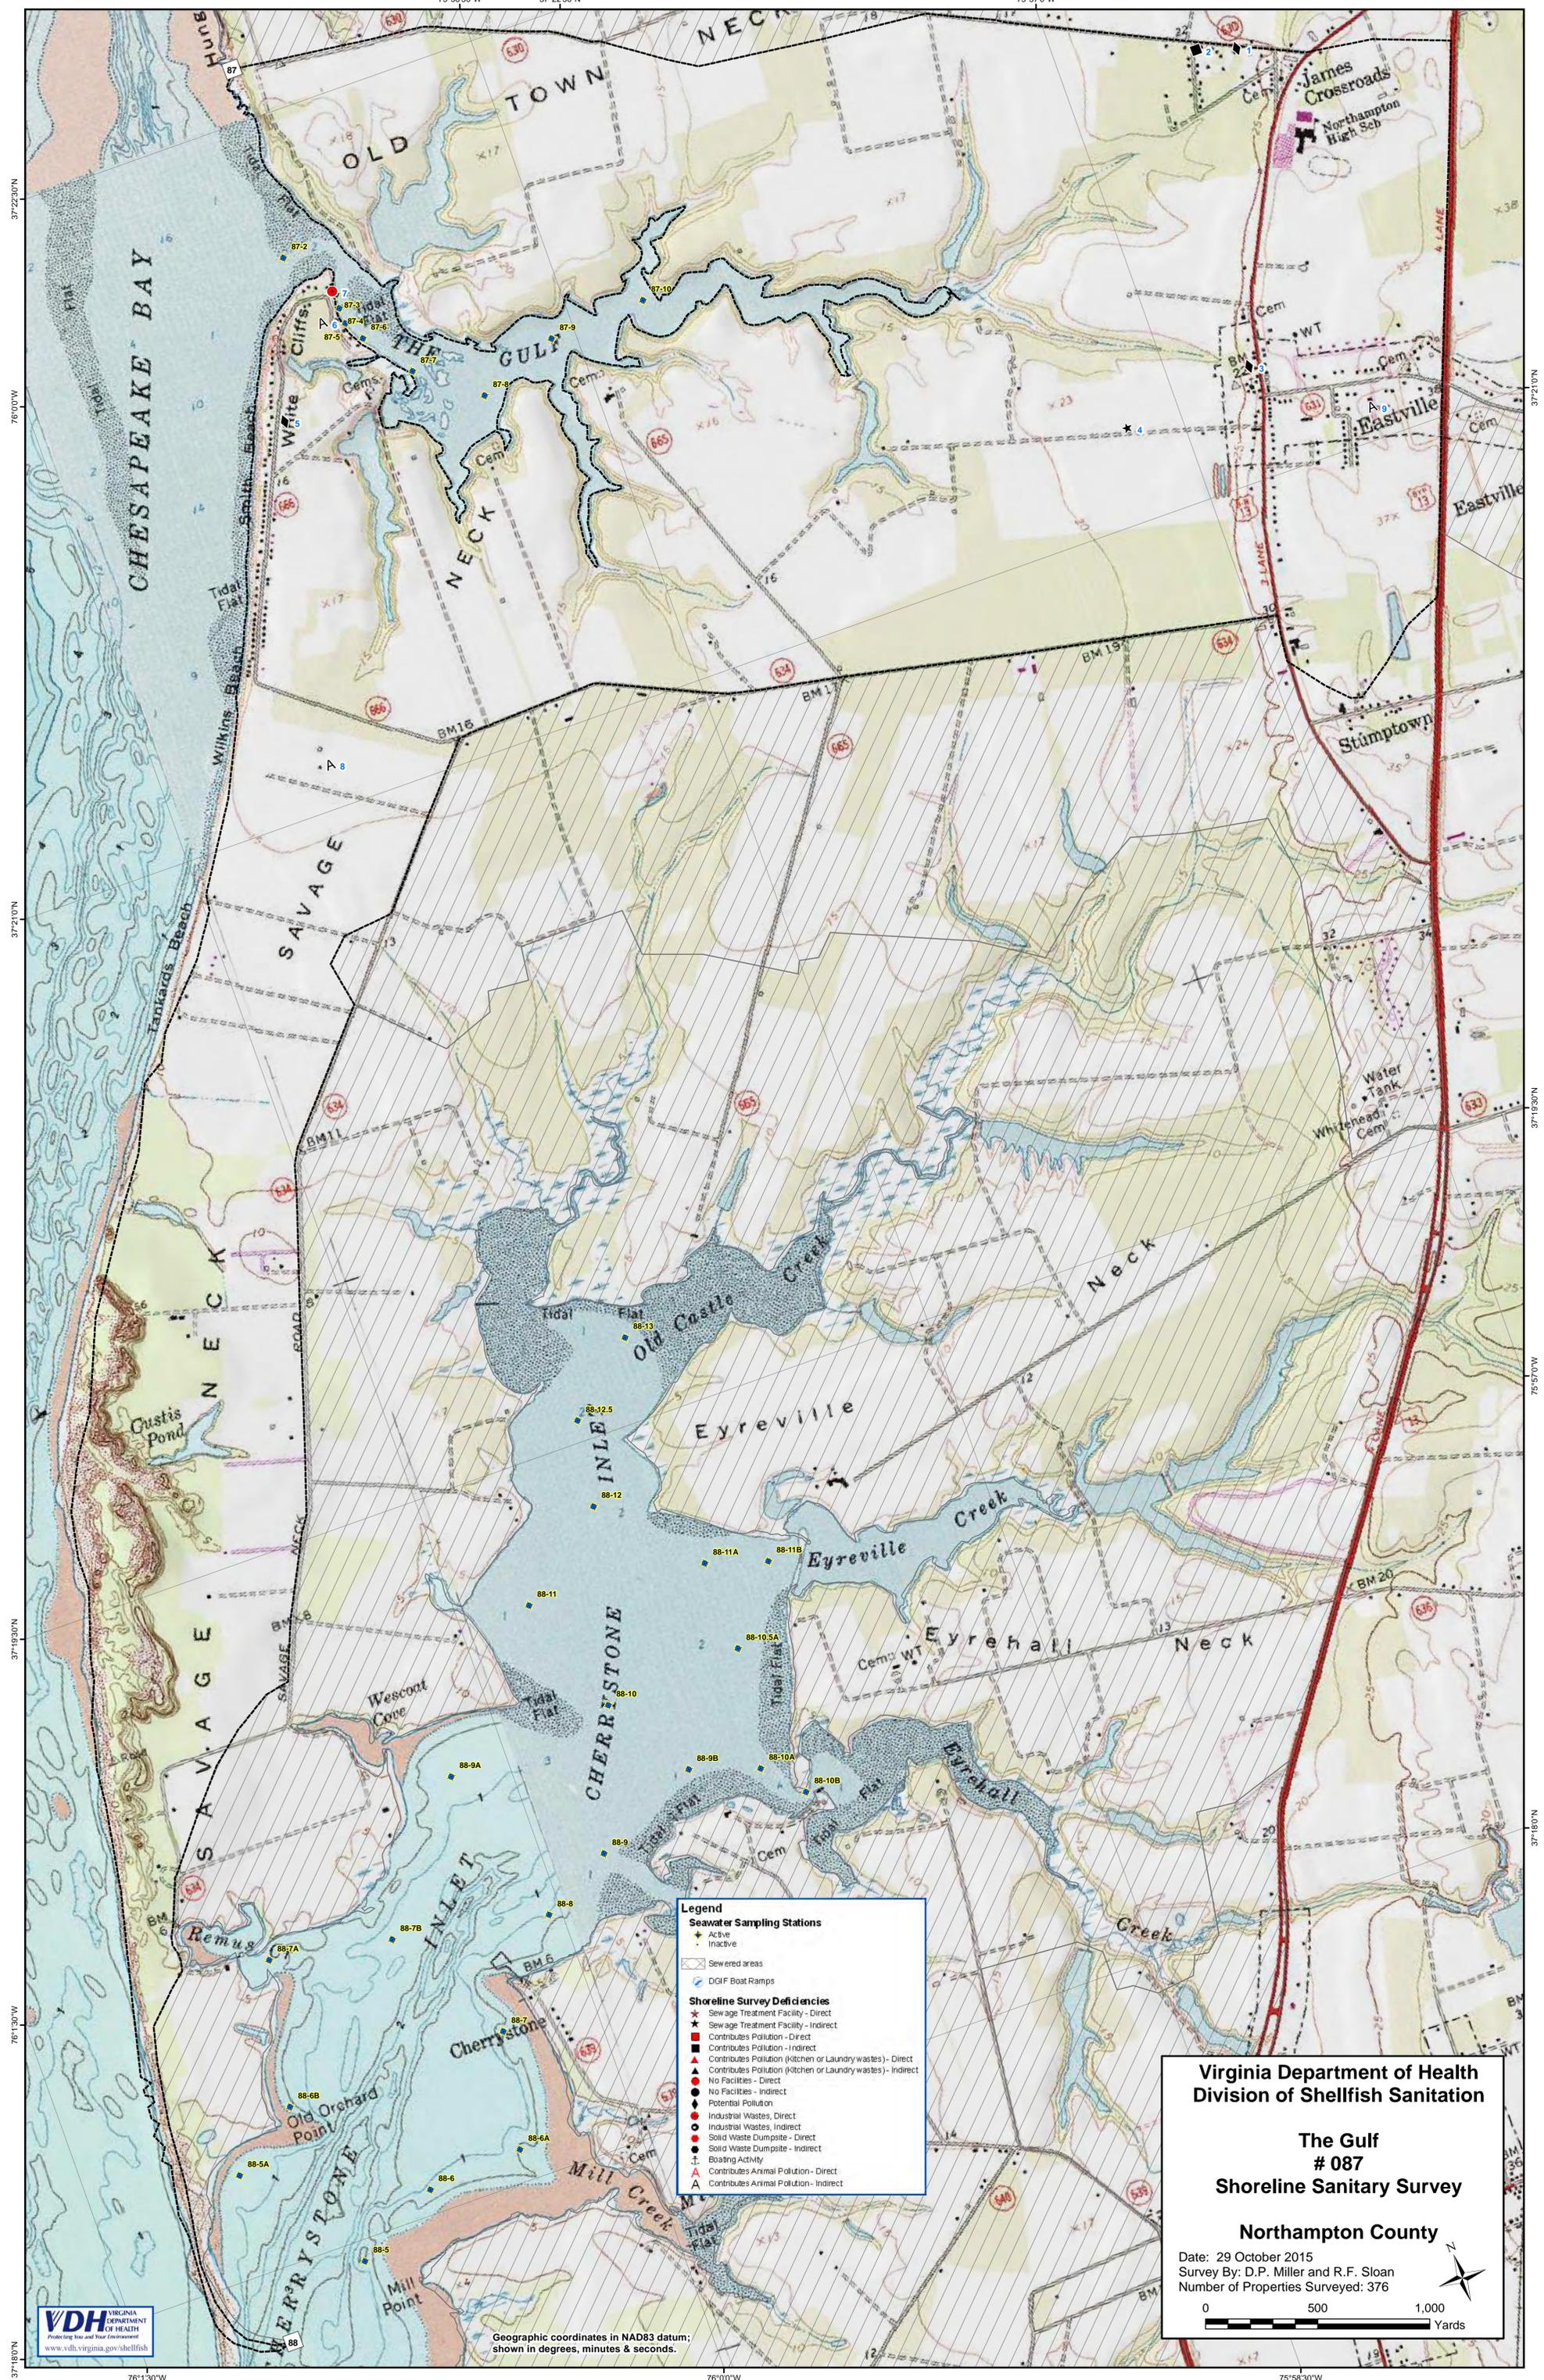
The Gulf
087
Shoreline Sanitary Survey

- 0 – DIRECT – None
- 1 – INDIRECT – # 4
- 1 – B.1. TOTAL

- 0 – CONTRIBUTES POLLUTION, DIRECT – None
- 1 – CONTRIBUTES POLLUTION, INDIRECT – # 2
- 0 – CP (Kitchen or Laundry Wastes), DIRECT – None
- 0 – CP (Kitchen or Laundry Wastes), INDIRECT – None
- 0 – NO FACILITIES, DIRECT – None
- 0 – NO FACILITIES, INDIRECT – # 7
- 1 – B.2. TOTAL

- 3 – POTENTIAL POLLUTION – # 1, 3, 5

- 1 – DIRECT - #7
- 0 – INDIRECT – None
- 1 – C.1. TOTAL

- 0 – DIRECT – None
- 3 – INDIRECT – # 6, 8, 9
- 3 – E. TOTAL
