**Subject:** Environmental Protection Agency (EPA) Safe Drinking Water Act Compliance  
Inspection Report.

**Follow-Up Site Visit Conducted by Virginia Department of Health-Office of  
Drinking Water's (VDH-ODW) Richmond Field Office**

**Author:** James Reynolds, PE- Field Director Richmond Field Office

The City of Richmond (COR) owns and operates a public waterworks (PWSID 4760100). The system is served by a Class 1 surface water treatment plant with a permitted capacity of 132 million gallons per day (MGD).

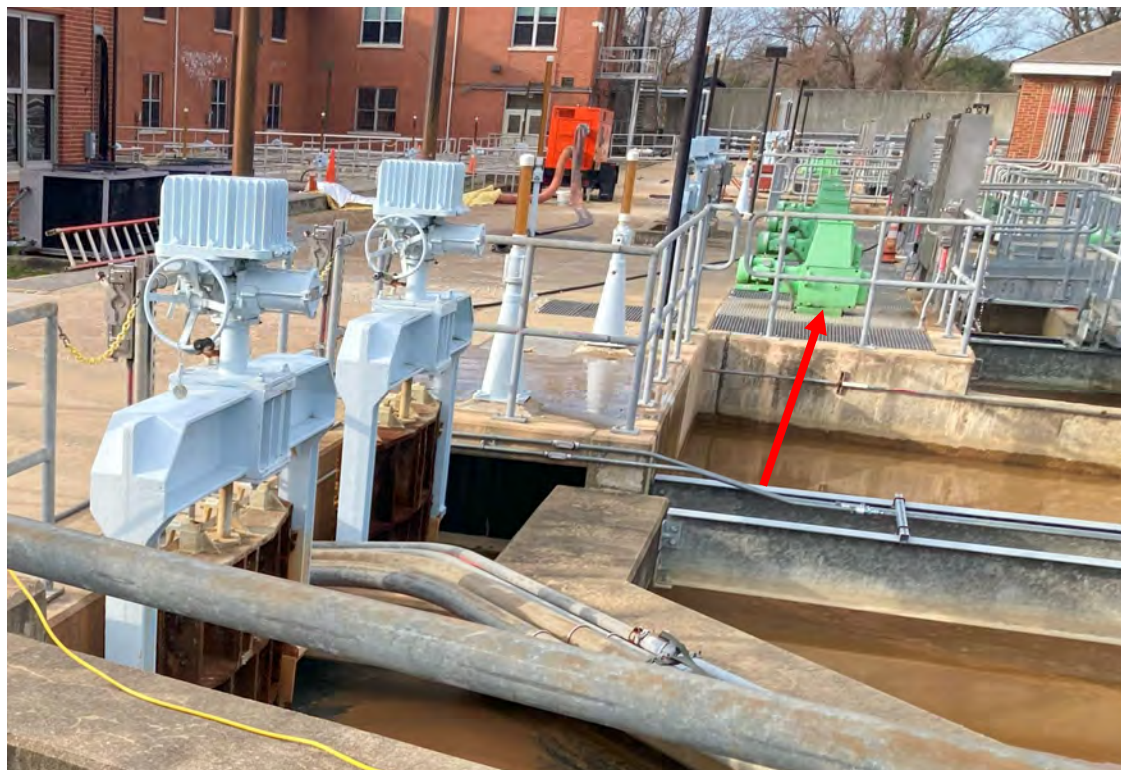
Figure 6. Rapid mix units that can be used as backup for inline mixers (VDH)

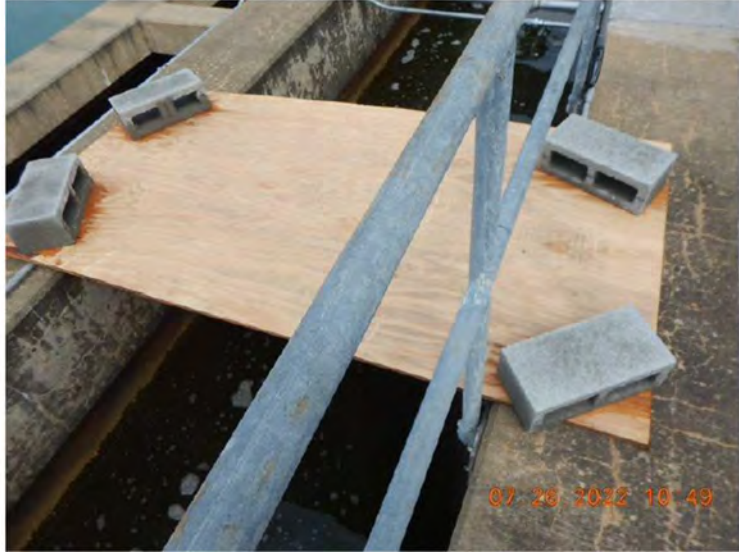
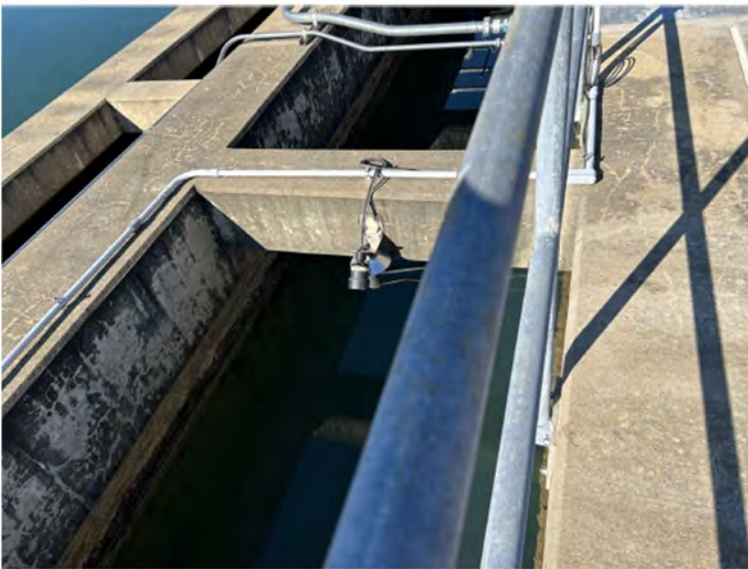
Figure 7. Plant 2 flow meter (Top- EPA, Bottom- COR)

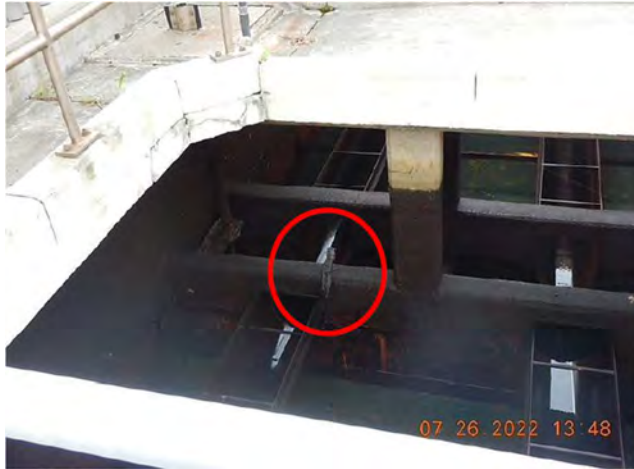
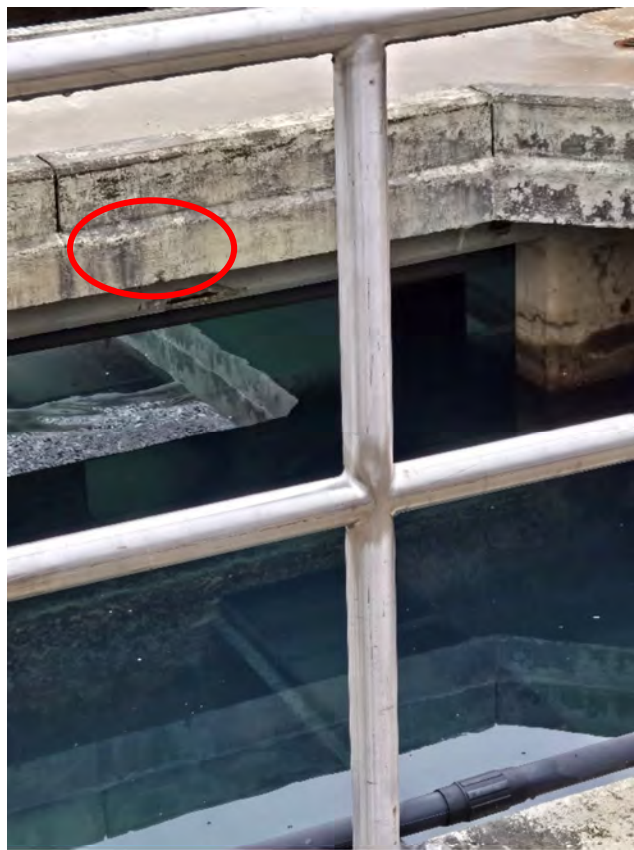
Figure 17. Plant 2 filter structure/debris (Top-EPA, Bottom- VDH)

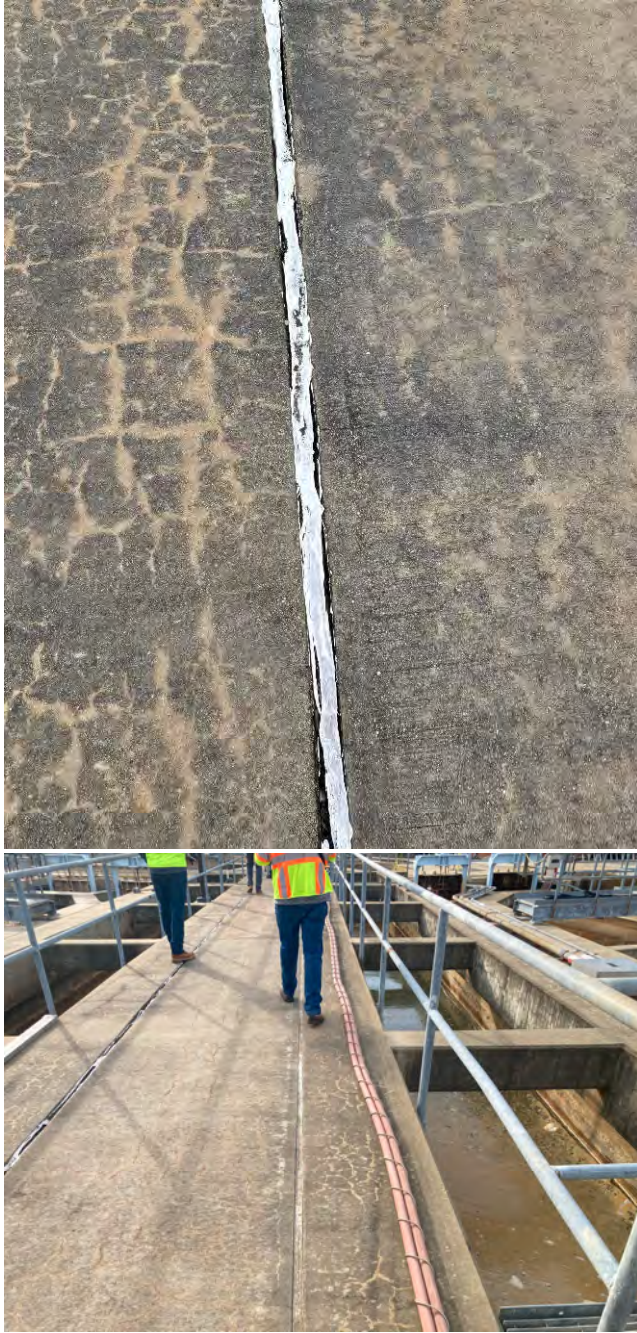
*Figure 18. Walkway between sed basins (VDH)*

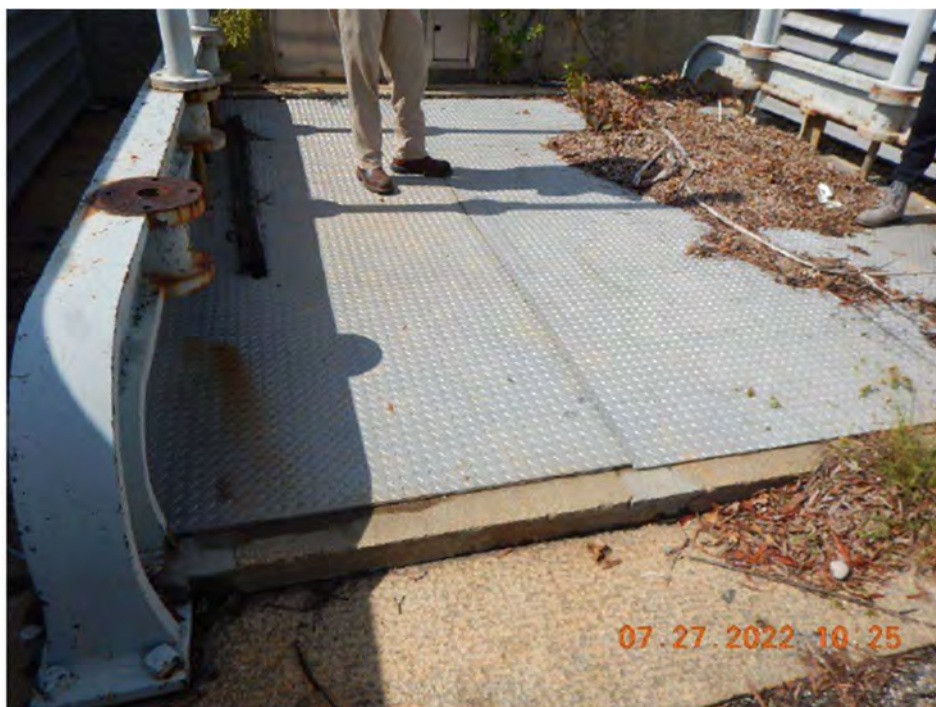
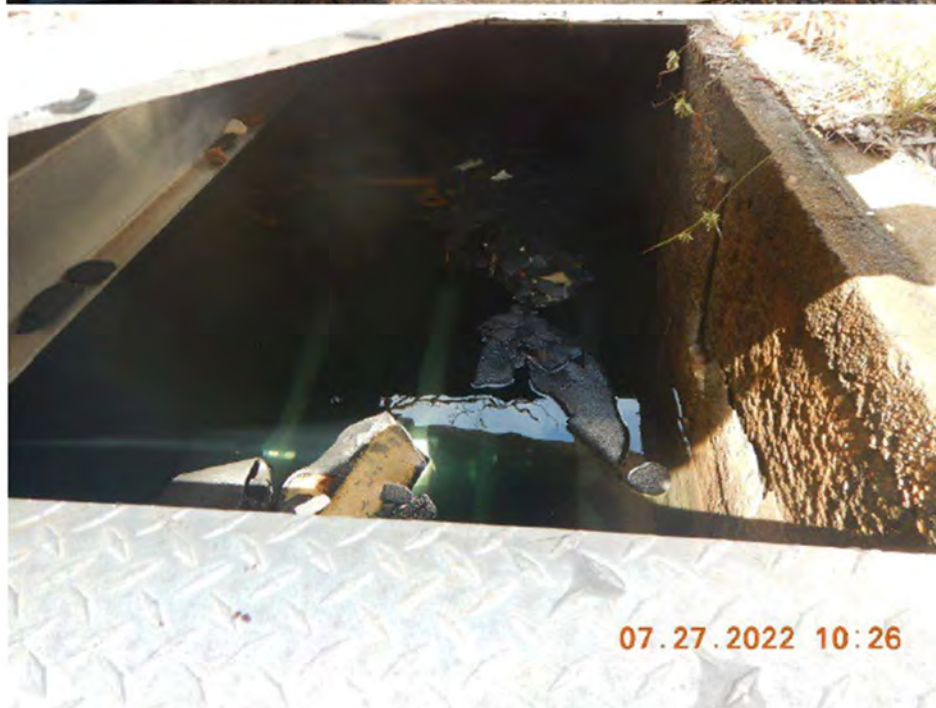
Figure 27. Byrd Park Reservoir valve pit (EPA)

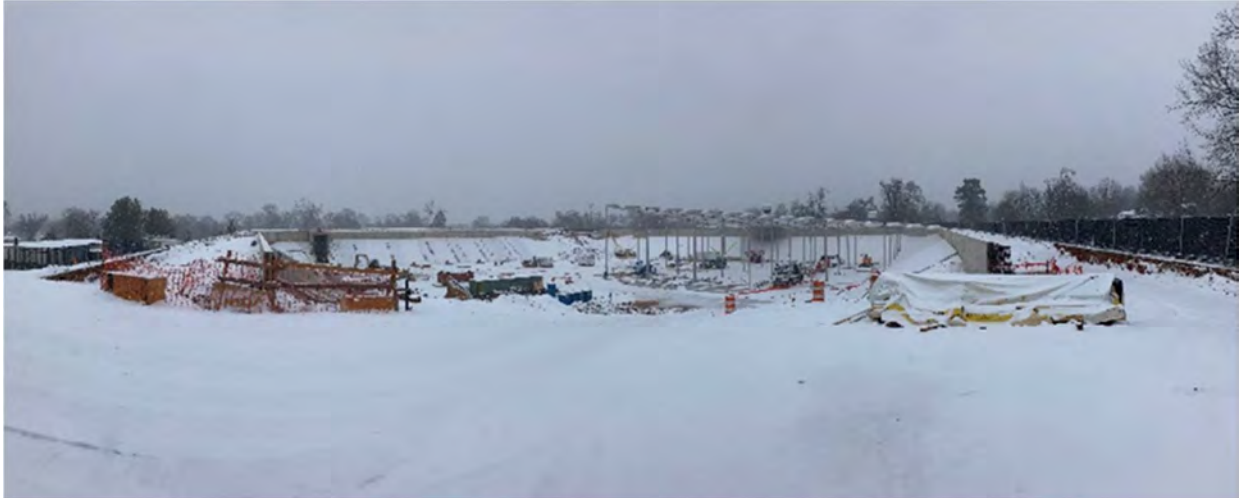
Figure 28. Byrd Park Reservoir roof construction (VDH)

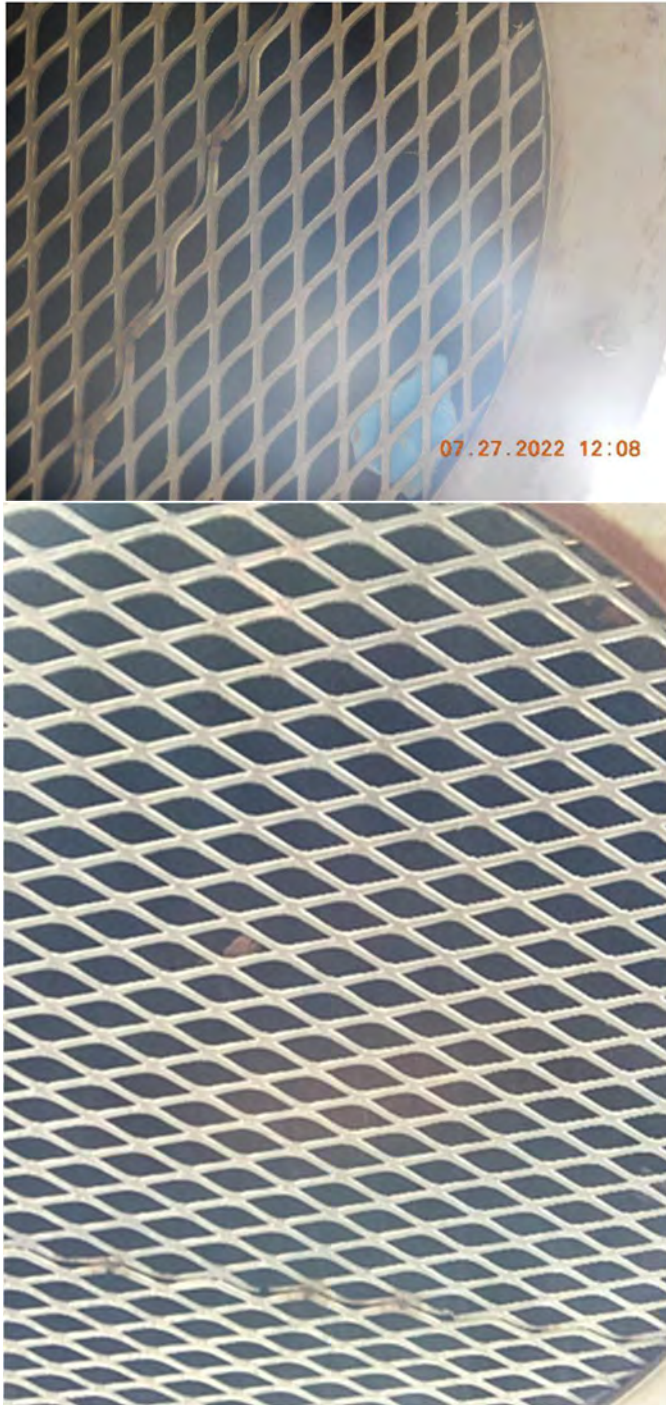
*Figure 32. Jahnke Road overflow screen (Top-EPA, Bottom-VDH)*

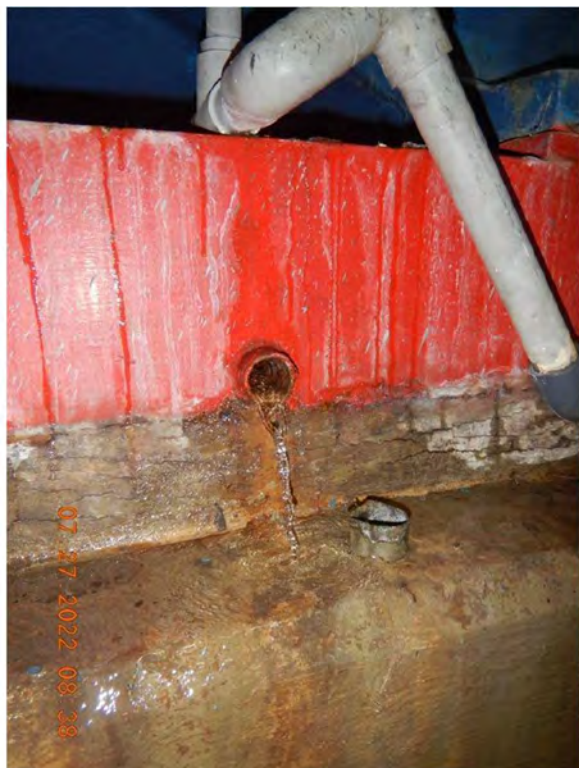
Photograph 43. Process water pipe discharging water on lower level of Korah 2 and 3 Pump Station

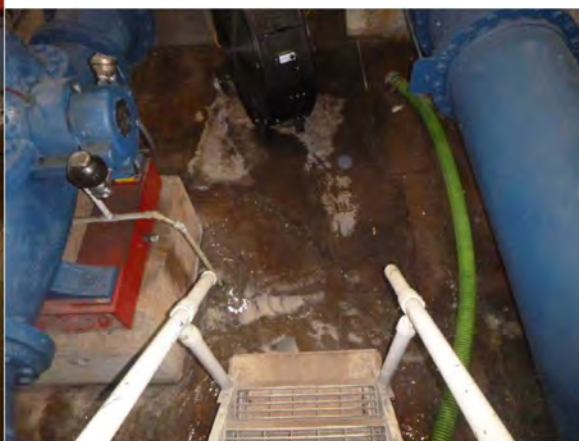
Photograph 44. Water flowing across floor near K3-2 pump, and algal growth on floor near pump motor in Korah 2 and 3 Pump Station.

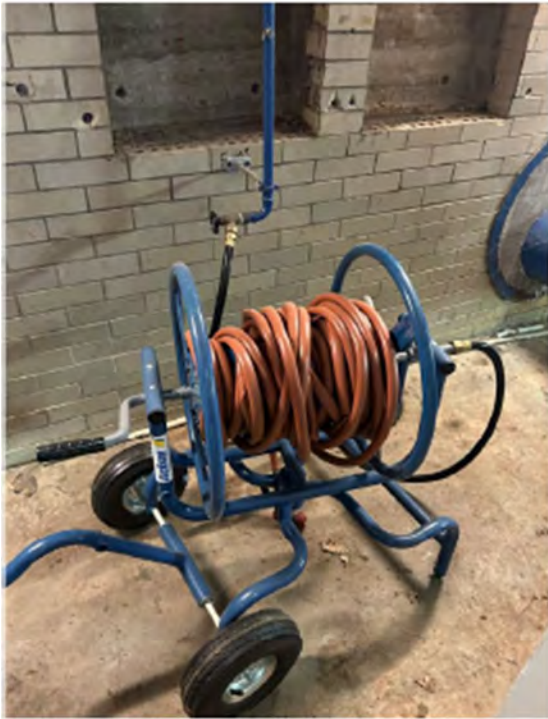
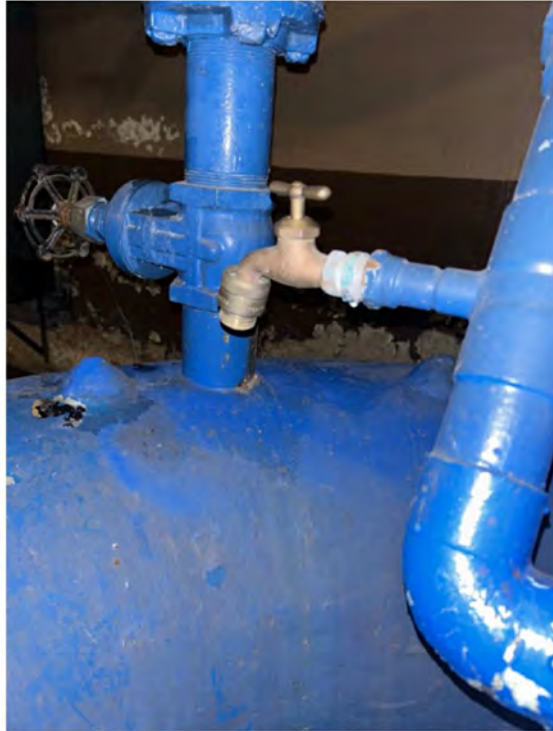
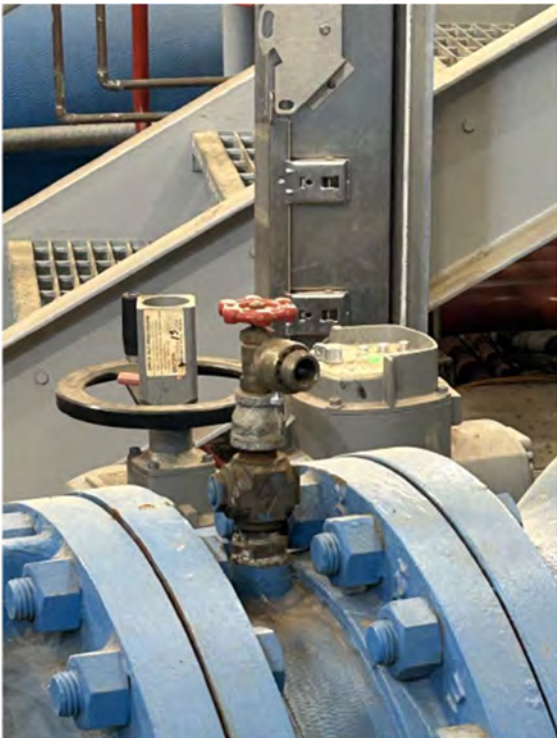
<b>AOC-41</b>	Cross Connection Control	Threaded taps were located on finished water lines without vacuum breakers, presenting cross contamination risk during pressure loss.	EPA observed several hoses without vacuum breakers that were tied to a finished water line throughout the plant and the distribution system.		Repairs of deficiencies noted during the inspection are complete. See photos: 92, 93, 105, & 109.	Follow-up needed summer 2025. VDH-ODW did not observe hoses without vacuum breakers. An inventory of water outlets at the WTP should be developed and appropriate backflow prevention device provided according to hazard determination, if not already conducted.	Figure 46 Figure 47
<b>AOC-42</b>	CMMS [Computerized	Calibration of critical instrumentation and chemical	System Representatives stated that flow	12VAC5-590-480.E states, "Process control	Staff performs cleaning / verification of online water quality instrumentation via	No change.	None

Figure 47. Threaded taps on lines with vacuum breaker installed (COR)

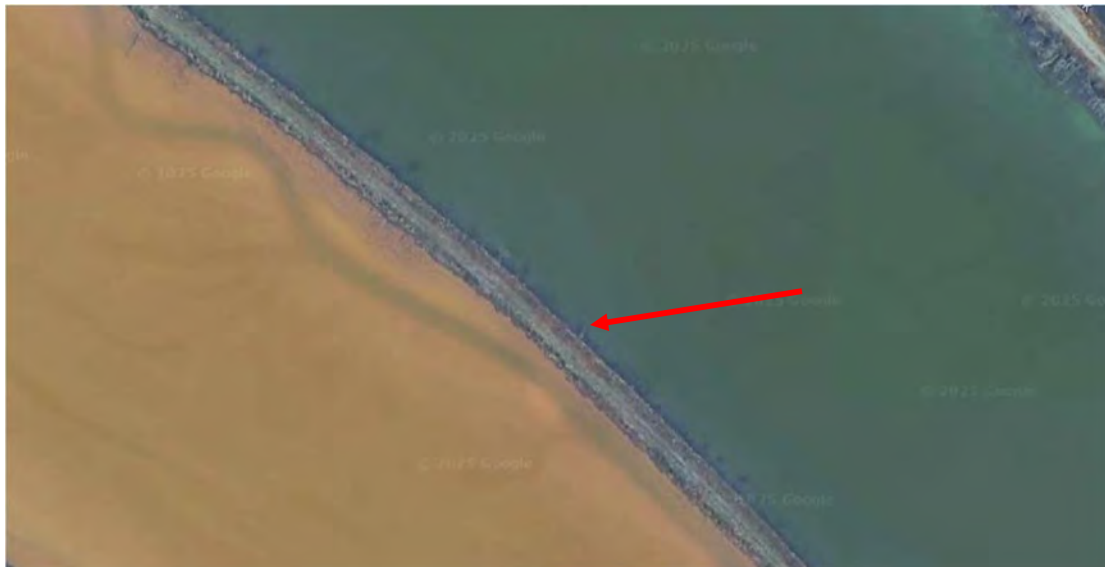
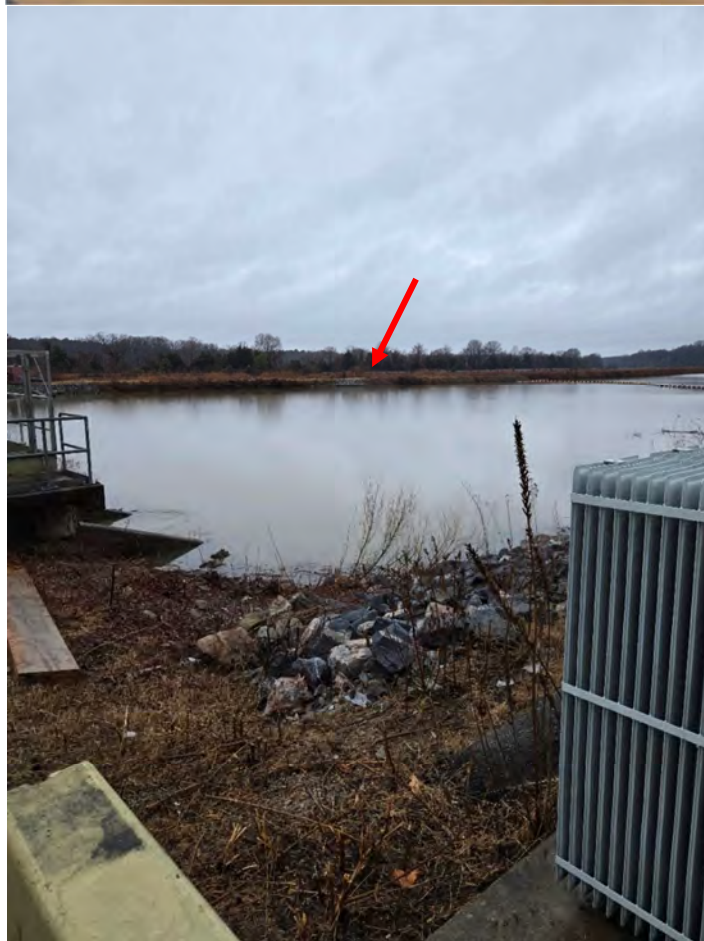
Observation Number	EPA Observations from July 26-27, 2022	ODW Follow-Up Observation from January to March 2025	Accompanying Photograph (Appendix A)
	moving toward a five-year inspection schedule. Reports provided during the inspection indicate tank inspections were last performed in May and December 2015.	COR staff indicated that tanks are on five-year inspection program. Tank reports indicate the last tank inspections were conducted in 2023. COR should evaluate the tank prioritization matrix and address items identified by tank inspections for rehabilitation and repair.	
<b>O-3</b>	EPA observed an earthen berm between the waste lagoon and pre-sedimentation basin. The Engineering Supervisor explained that the berm was compromised approximately 15 years ago and that there are not regular inspections of the berm.	No change.  Earthen berm observed with vegetation including shrubs and trees. The root systems of the trees and shrubs can compromise the berm which may result in inundation of the pre-sedimentation basin with waste lagoon water that may be a challenge to treat and impact raw water capacity.	Figure 48

Figure 48. Earthen berm between lagoon and raw water intake channel (VDH)

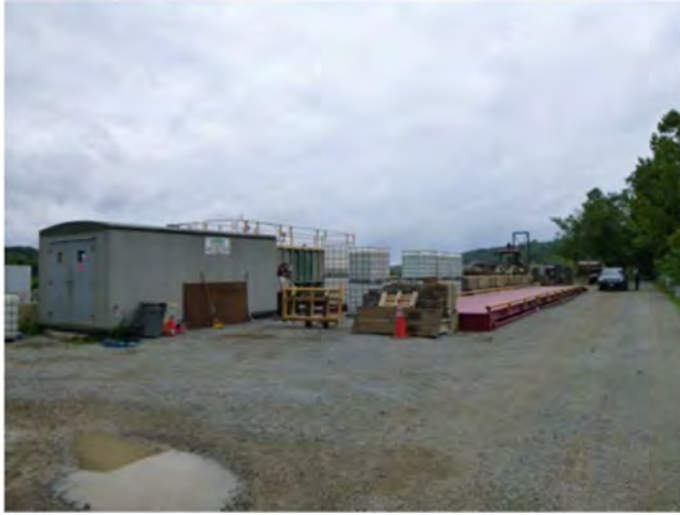
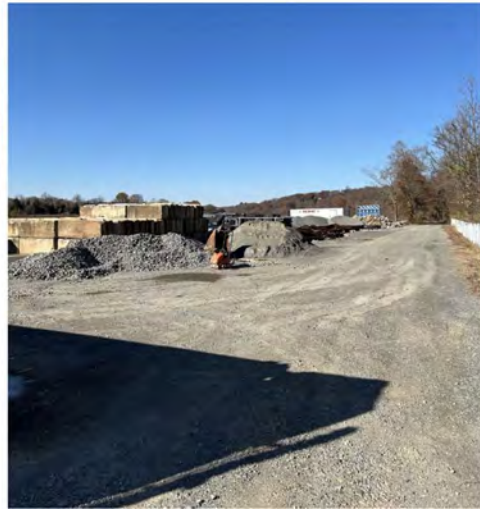
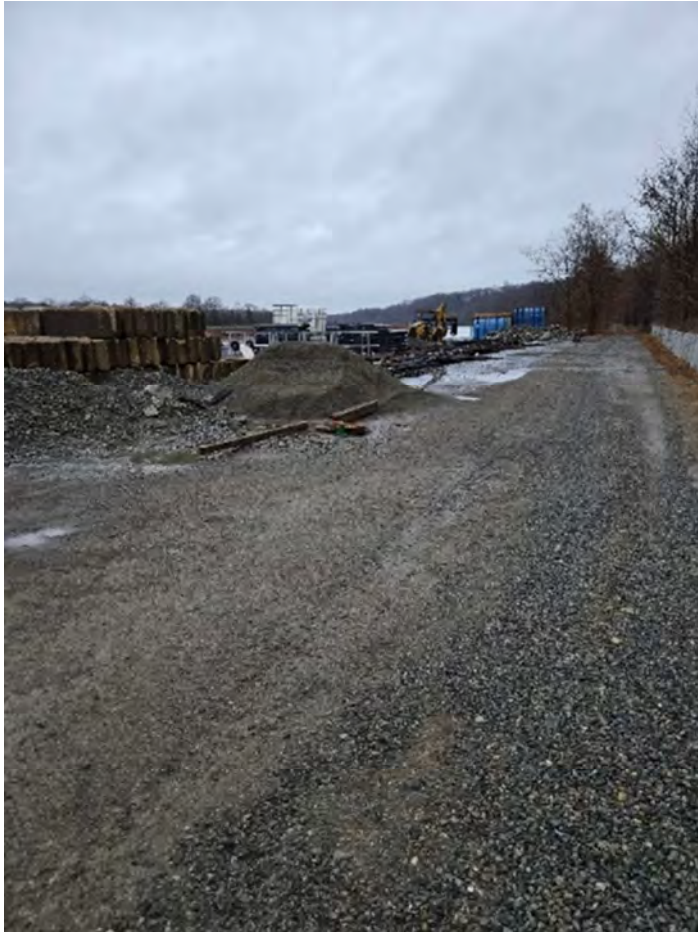
*Figure 50. Dewatering operation near raw water intake channel (Left- EPA, Middle- COR, Bottom- VDH)*

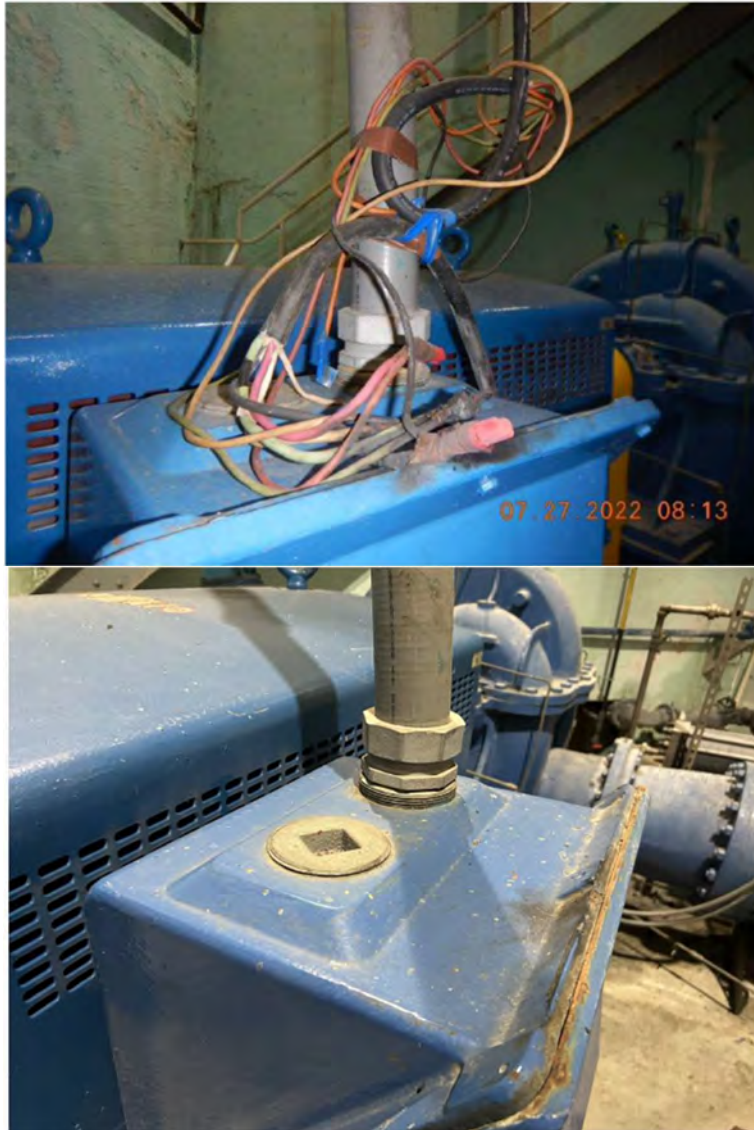
*Figure 60. Exposed wiring Korah 1 pump station (Top-EPA, Bottom-COR)*

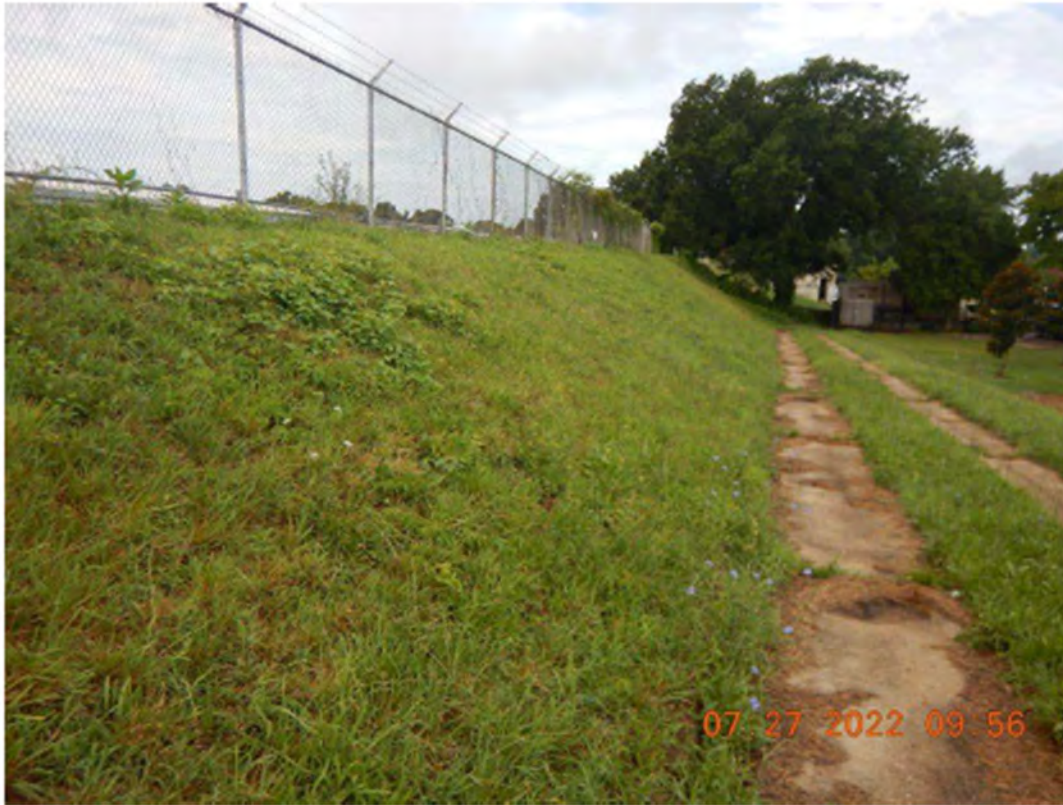
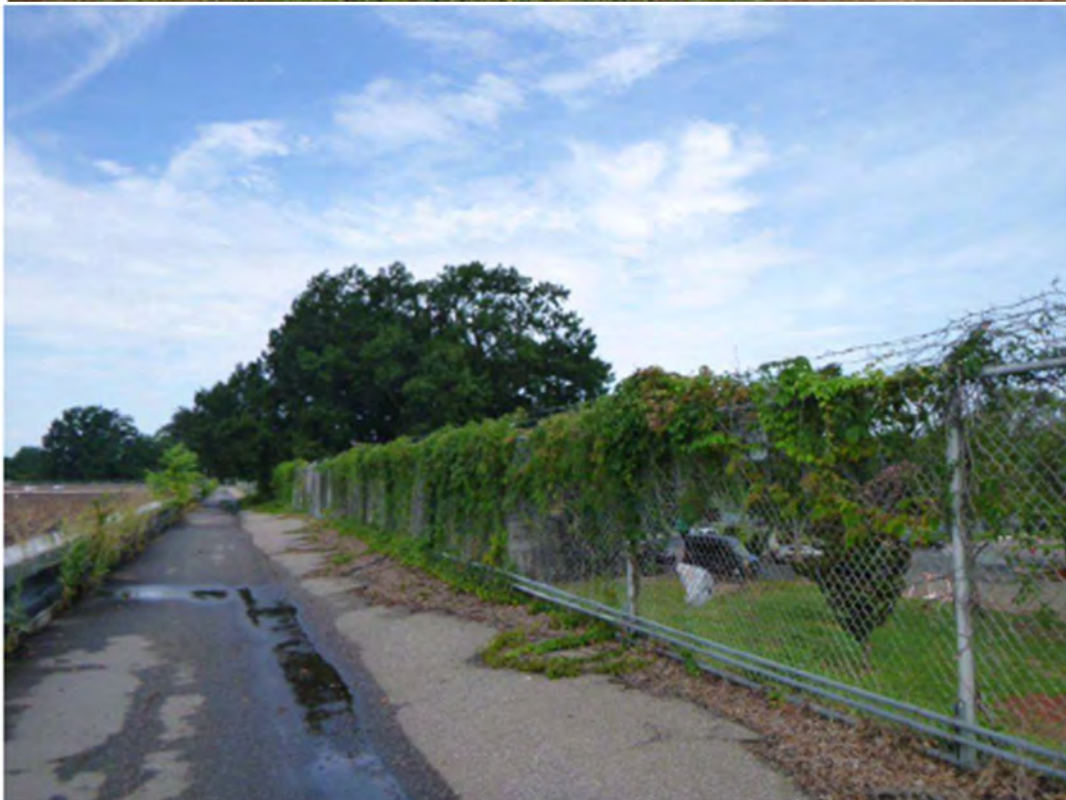
<b>O-20</b>	EPA observed security fencing around the Trafford pumphouse with barbed wire on one side. System Representatives explained that new transmission mains were recently installed, and more permanent fencing is to be installed eventually. The new transmission mains will increase redundancy and reliability of power.	Addressed.  Trafford pumphouse observed to have a gate and fencing, pump station operator can open the gate from within the pump station.	Figure 63
<b>O-21</b>	System Representatives explained that the roof of the Byrd Park Reservoir is scheduled to be replaced over the next four years, and the contract award for the project is in process. The roof will be changed from concrete to aluminum, and one side/cell will be	In progress.  The roof replacement project is underway, and one side/cell is currently under construction. This leaves the waterworks with	Figure 64 Figure 65

Figure 64. Byrd Park Reservoir fencing (EPA)

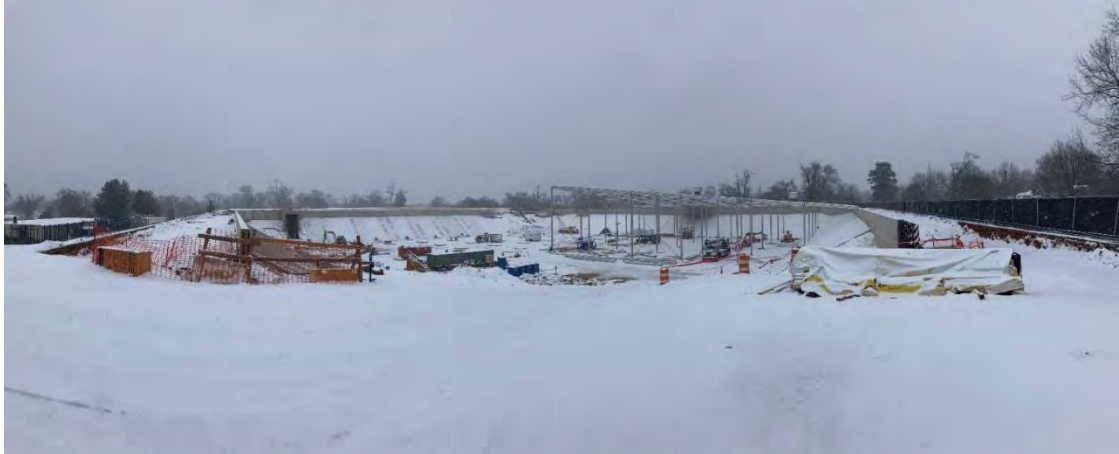
Observation Number	EPA Observations from July 26-27, 2022	ODW Follow-Up Observation from January to March 2025	Accompanying Photograph (Appendix A)
	completed at a time. System Representatives discussed the need to increase pumping rates so that supply and capacity is maintained throughout the system.	reduced water storage capacity, leaves less room for error. WTP staff is required to carefully balance water plant flows and reservoir levels through the manual operation of raw water pumps, filters, filtered water pumps, finished water pumps, and coordination with Trafford PS operator.	
<b>O-22</b>	EPA observed security fencing with barbed wire around the perimeter of the Byrd Park reservoir. EPA observed significant vegetation in some areas of the fencing. Several areas of the roof had vegetation growing in between the stones.	VDH-ODW will follow-up as part of the final inspection of construction once construction has been completed.  The reservoir is currently a construction zone.	Figure 64 Figure 65

*Figure 65. Byrd Park Reservoir Construction (VDH)*

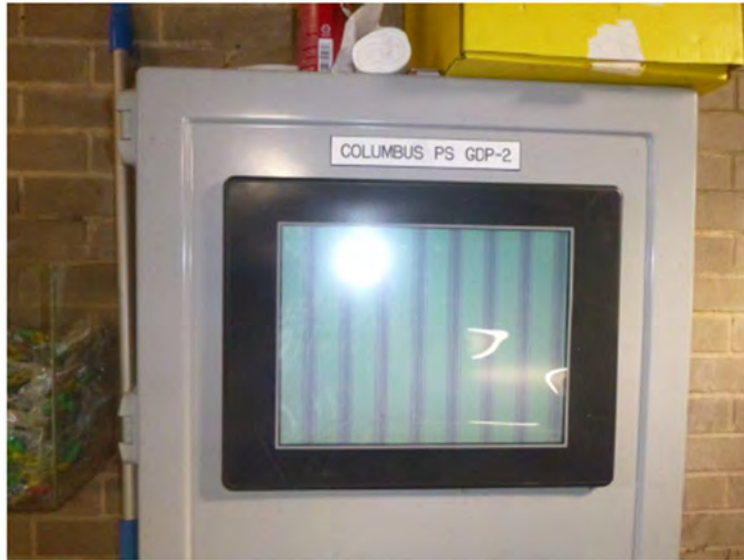
Figure 74. PLC at Columbus Pump Station (Left- EPA, Right- VDH)

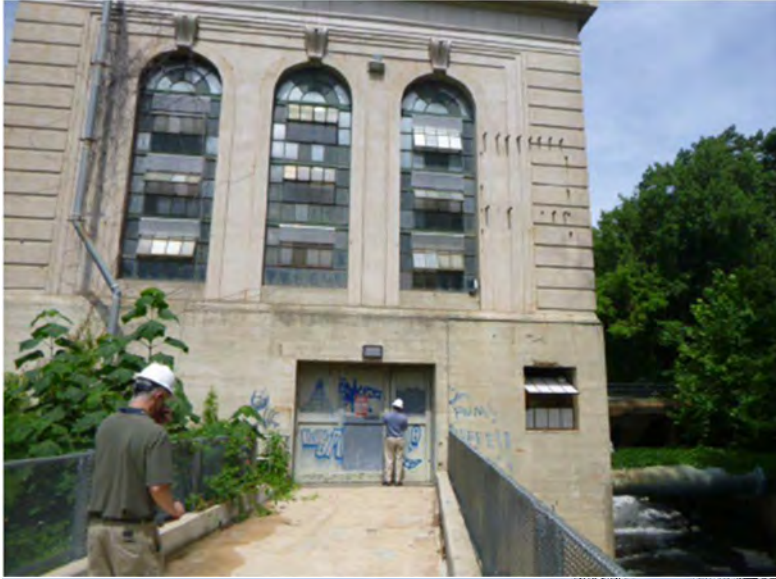
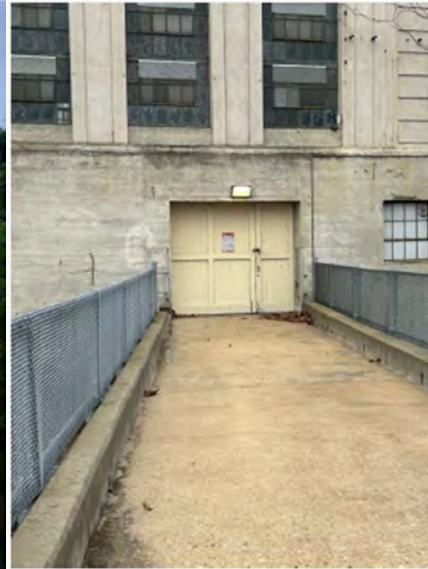
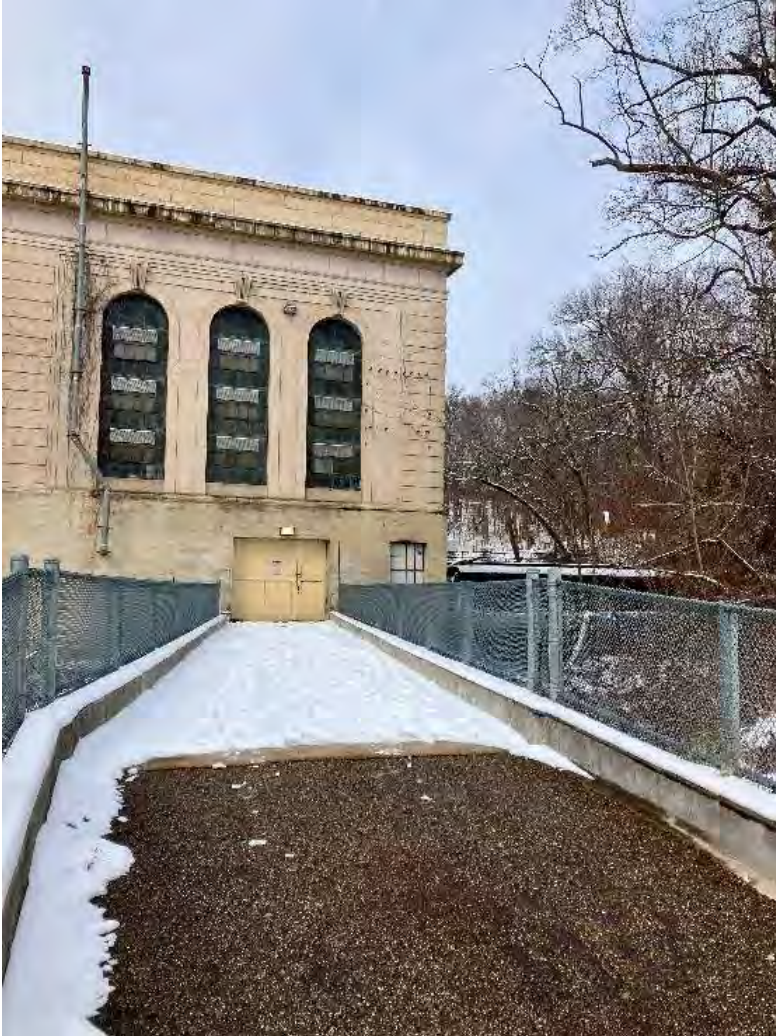
<b>O-33</b>	The Program & Operations Supervisor stated the Byrd Park Reserve pump station does not have a generator or quick connect but relies on two feeds from Dominion Power for electricity.	<p>VDH-ODW will follow-up in summer 2025</p> <p>COR should verify how pump stations with two electrical feeds are operated and if they always provide sufficient reliability.</p>	None
<b>O-34</b>	EPA observed graffiti on the door of the building, indicating security issues at Byrd Park Main Pump Station	<p>Partially addressed.</p> <p>Graffiti not observed on door of the building, however some graffiti observed elsewhere on the exterior of the building.</p>	Figure 76

Figure 76. Byrd Park Main Pump Station entrance (Top left- EPA, Top right- COR, Bottom- VDH)

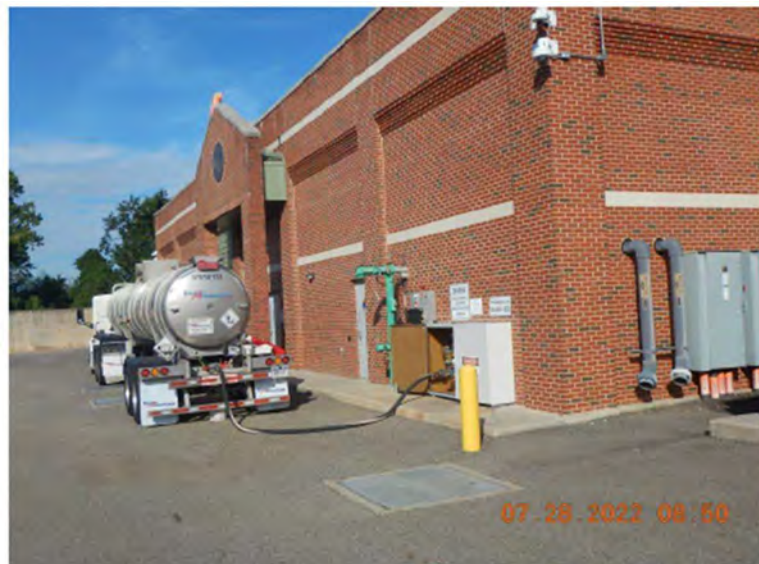
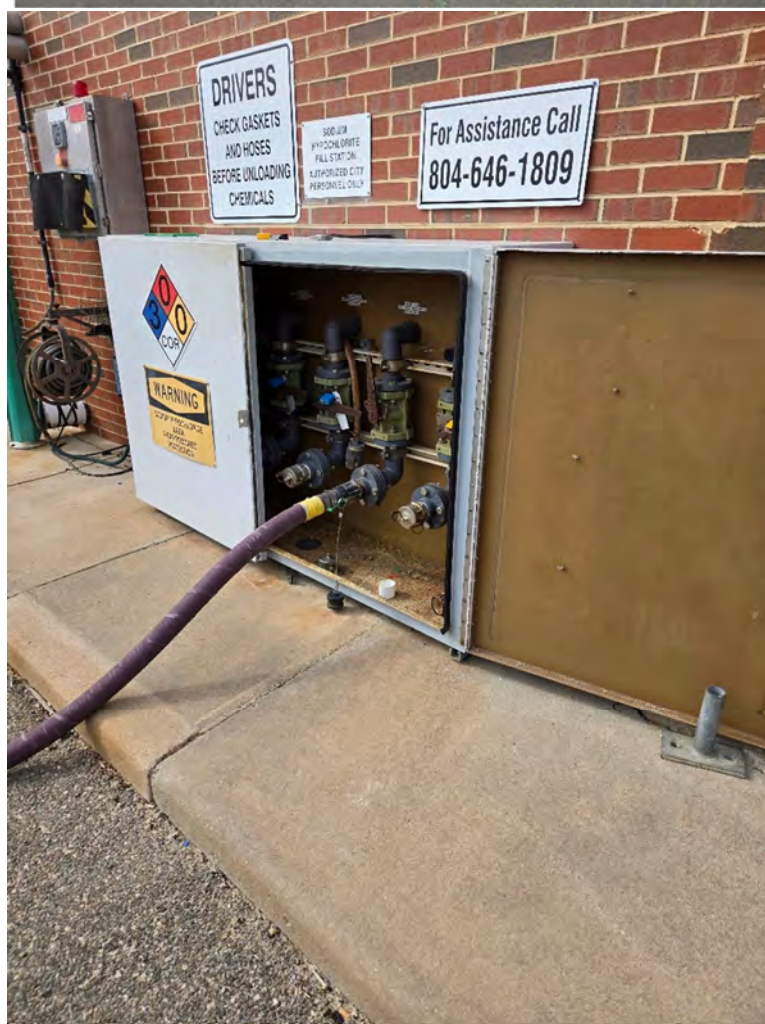
<b>O-39</b>	A coagulant polymer is added in the first stage of each flocculation basin. The Sr. Plant Operations Supervisor explained that the polymer is not flow-paced like the other chemicals, and it must be manually adjusted for the correct dosage.	No change.  Flow pacing of chemicals is not practiced for many chemical feeds due to the unreliability of raw water flow meters and other flow meters in the WTP. Operators are manually adjusting chemical feed rates. Addressing the reliability of flow meters and resuming flow pacing of chemicals is recommended. COR should improve automation of plant operations.	None
<b>O-40</b>	EPA observed a truck delivering and offloading sodium hypochlorite at the time of the inspection. While in the tank storage room, EPA observed a line in the elevated plumbing	Addressed.	Figure 81

Figure 81. Truck delivering sodium hypochlorite (Top- EPA, Bottom- VDH)

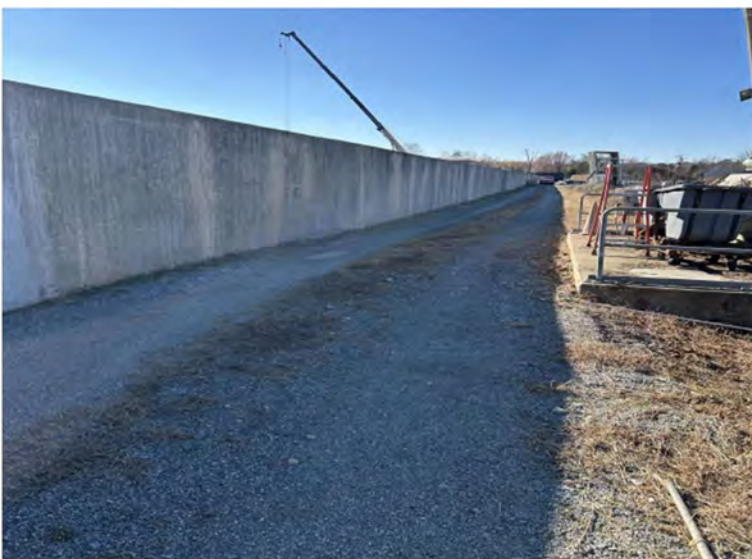
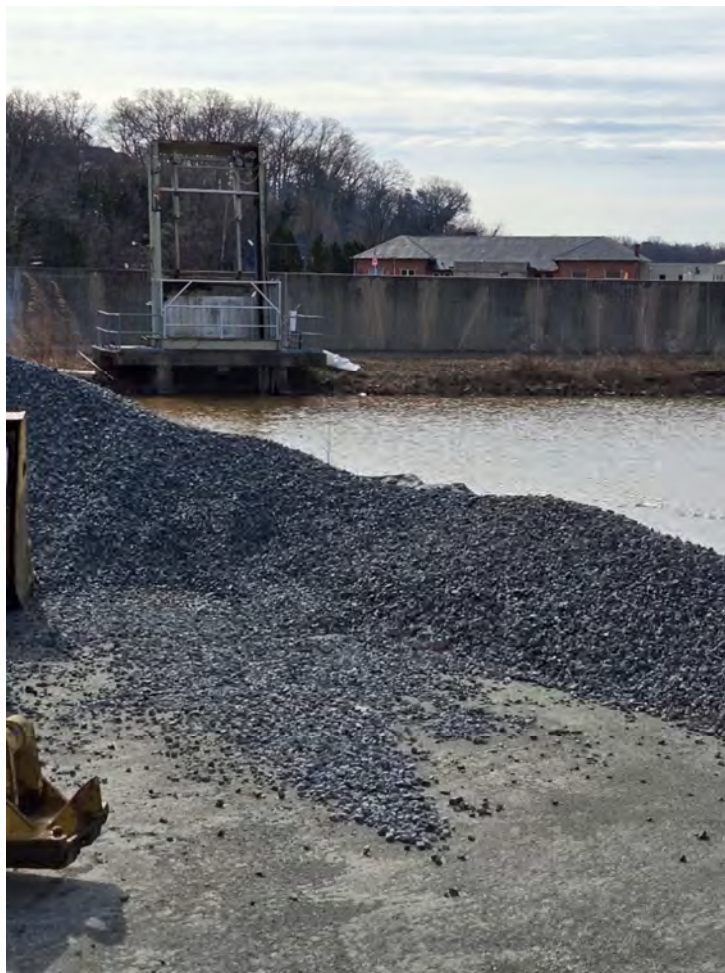
*Figure 84. Flood Wall (Top Left- EPA, Bottom Left- COR, Right-VDH)*

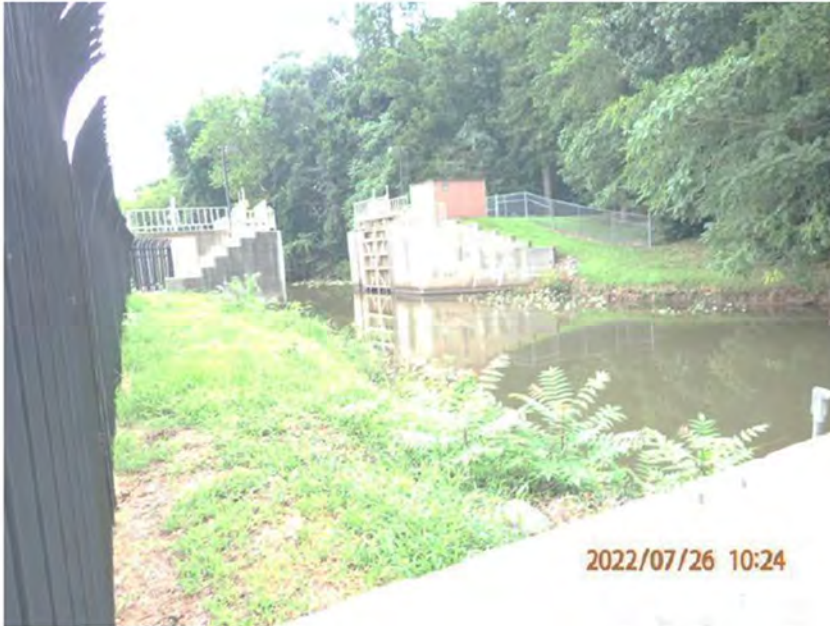
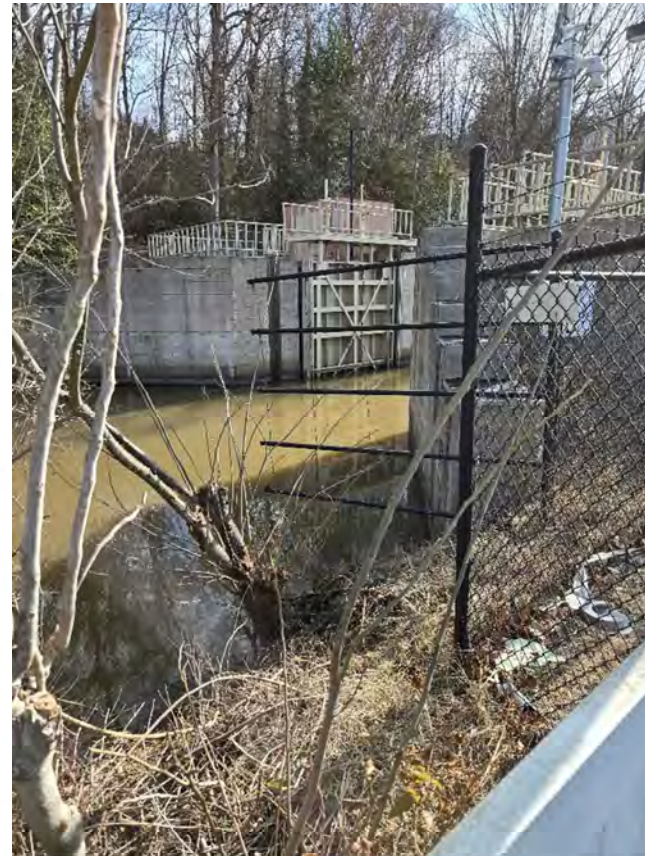
Figure 85. Kanawha Canal (Left- EPA, Right- VDH)

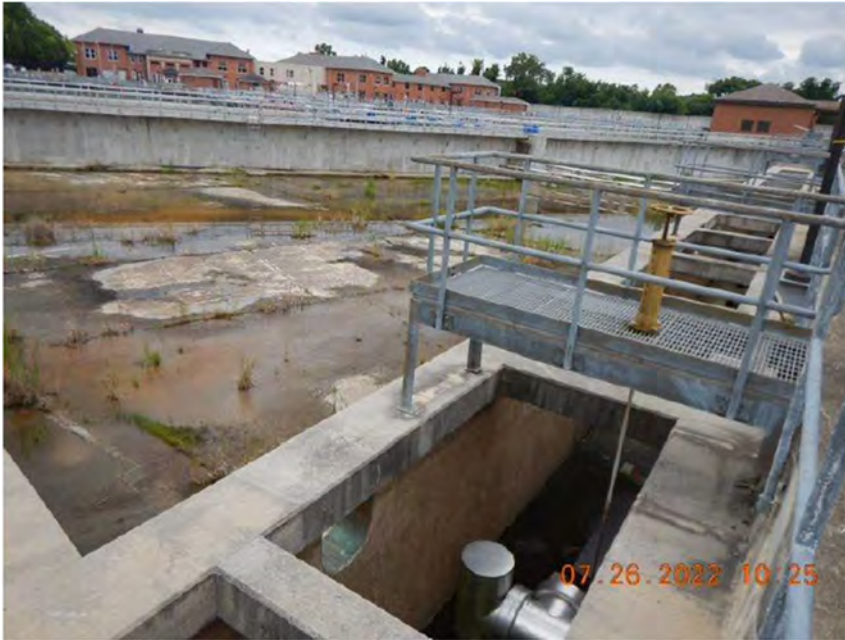
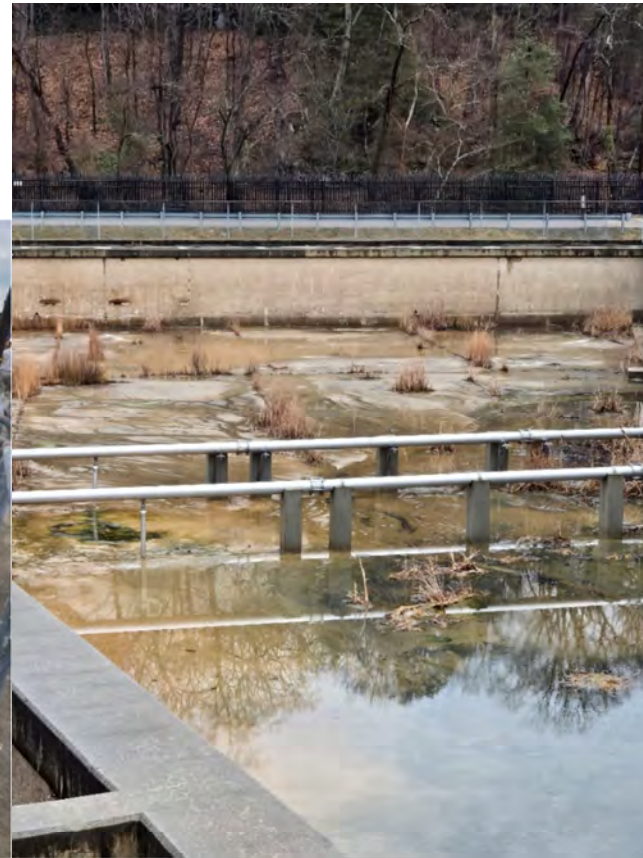
Figure 86. Inactive basin (Left- EPA, Right- VDH)

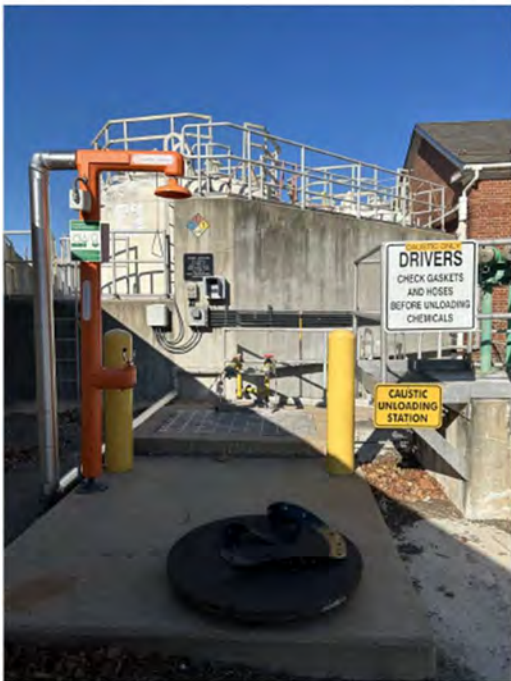
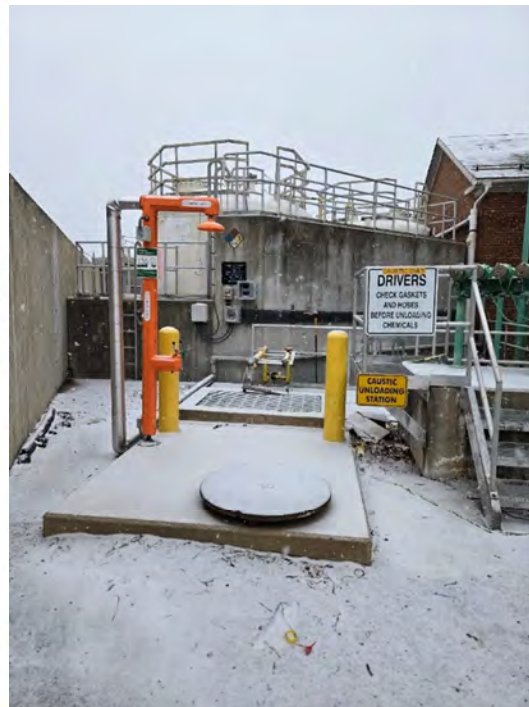
Figure 88. Caustic soda bulk storage area (Top Left- EPA, Bottom Left- COR, Right- VDH)
