**Subject:** Environmental Protection Agency (EPA) Safe Drinking Water Act Compliance  
Inspection Report.

**Follow-Up Site Visit Conducted by Virginia Department of Health-Office of  
Drinking Water's (VDH-ODW) Richmond Field Office**

**Author:** James Reynolds, PE- Field Director Richmond Field Office

The City of Richmond (COR) owns and operates a public waterworks (PWSID 4760100). The system is served by a Class 1 surface water treatment plant with a permitted capacity of 132 million gallons per day (MGD).

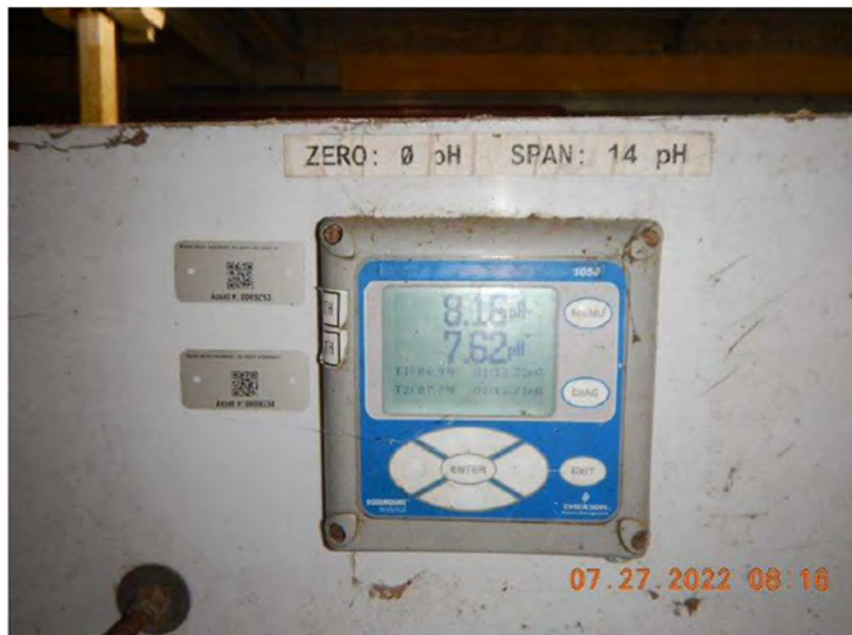
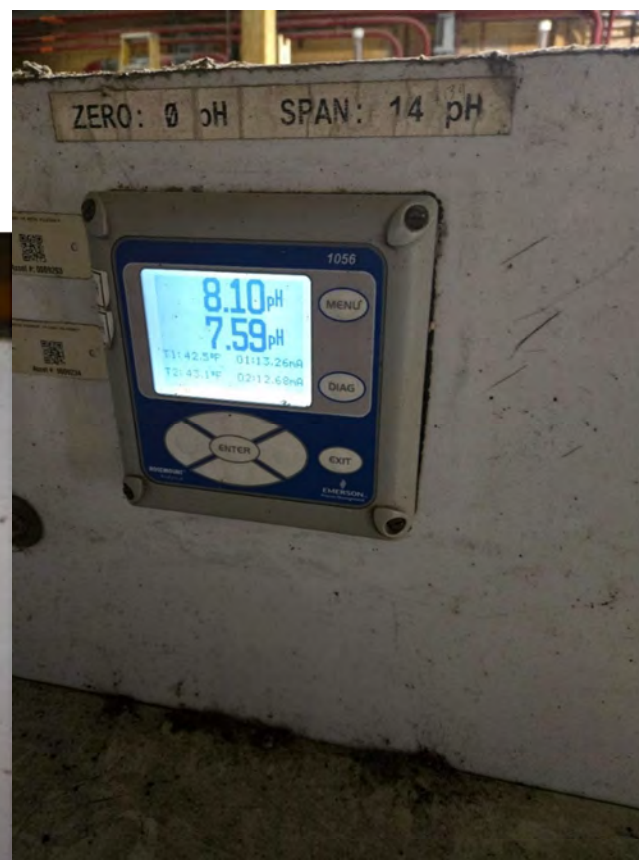
Figure 90. Korah 1 Pump Station pH analyzers (Left- EPA, Right- VDH)

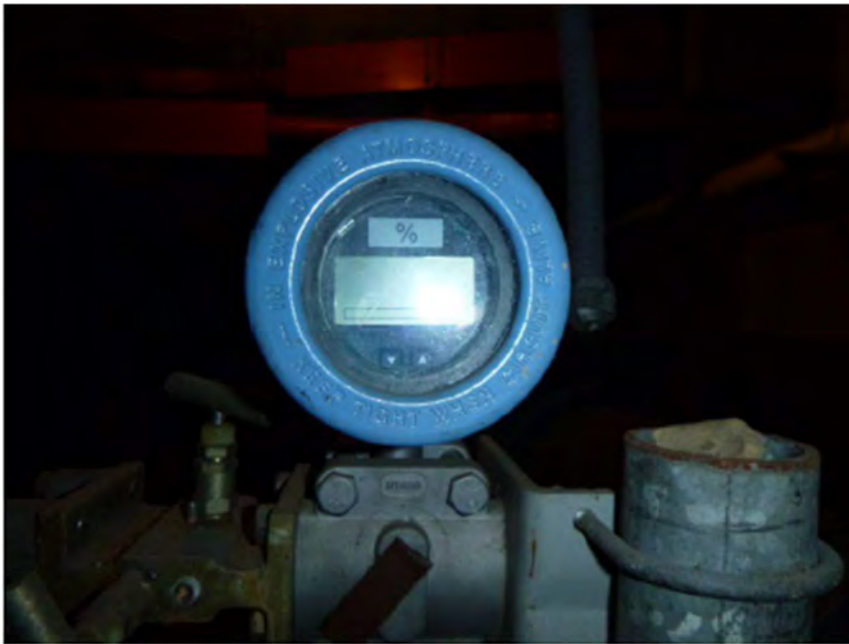
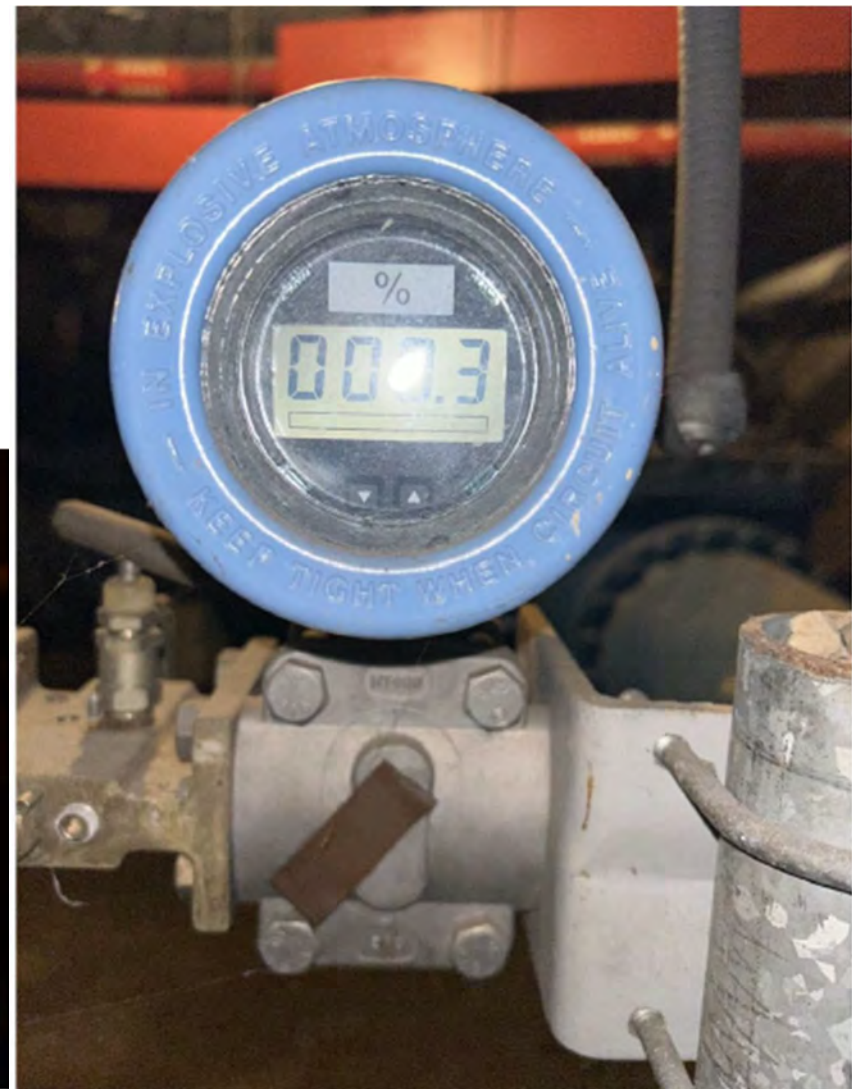
Figure 91. Gauges and flow meters in Byrd Park main pump station not operational (Left-EPA, Middle- COR)
